Underwater Sound Levels Associated with Pile Driving during the Anacortes Ferry Terminal Dolphin Replacement Project

April 2007

Prepared by:
Tim Sexton
Washington State Department of Transportation
Office of Air Quality and Noise
15700 Dayton Avenue North,
P.O. Box 330310
Seattle, WA 98133-9710

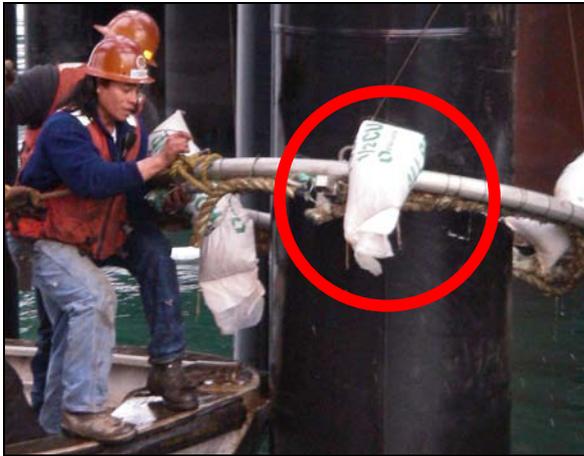
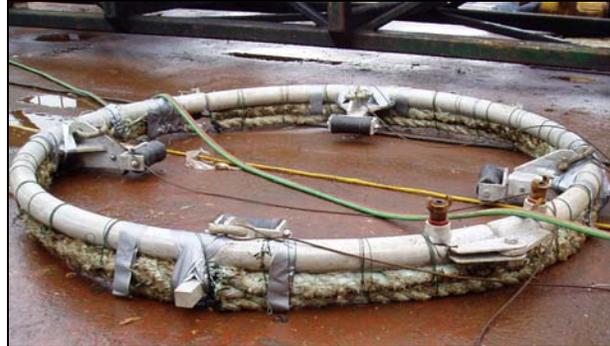
Figure 6: Photographs of the bubble curtains prior to deployment around the pile.

The red circle shows the sandbags strapped on to the metal rings for weight for bubble curtain one. Rope was strapped to the base of the bottom ring to cover the lugs and keep the ring flush with the seafloor bottom.

Bubble curtain specifications are described in Table 3 and Figure 6 shows a photograph of the bubble curtains.

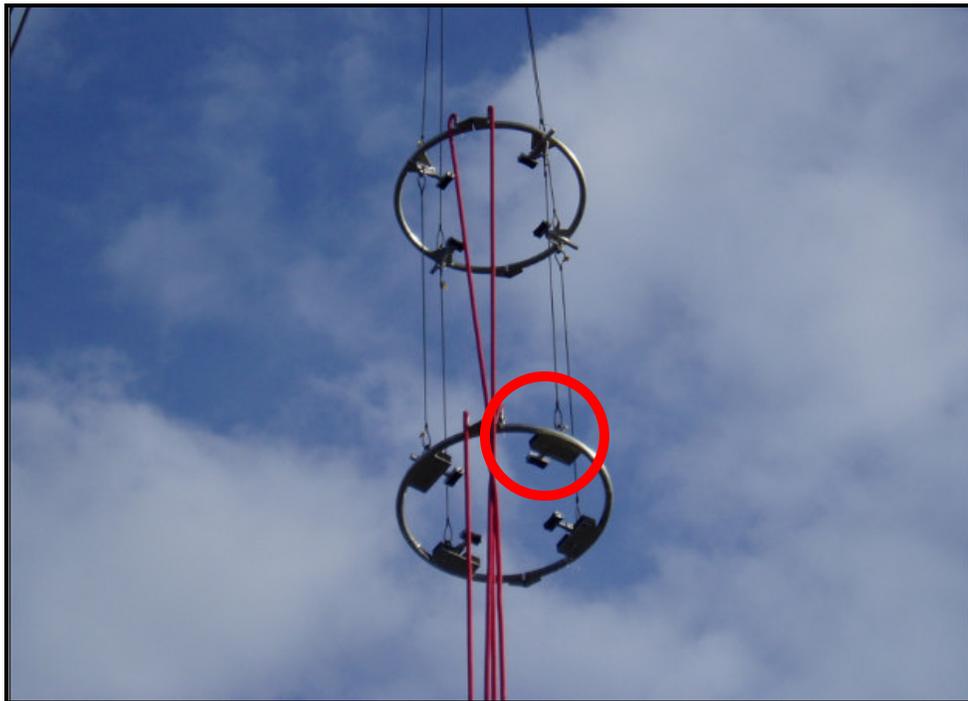
The red circle shows the weighting system for bubble curtain two.

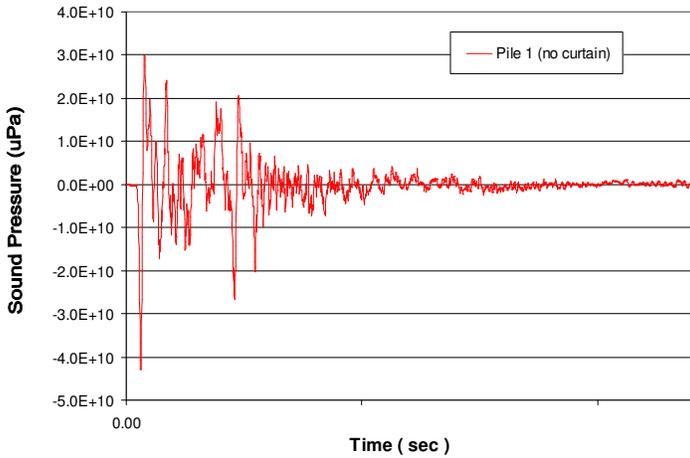
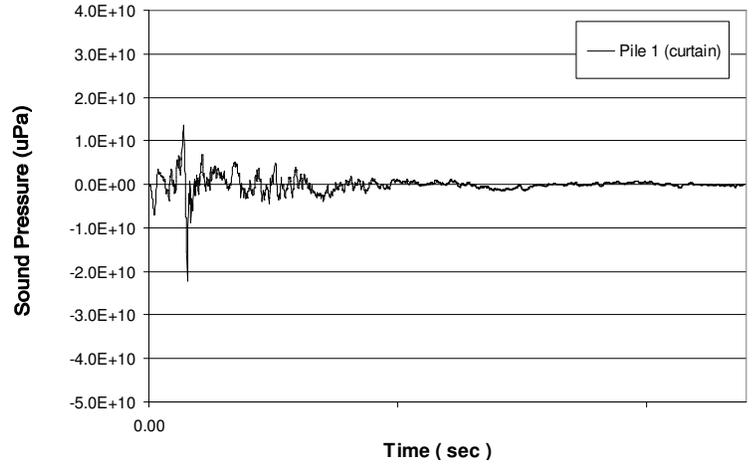
Figure 7: Waveforms and frequency spectral analysis for Pile 1 using bubble curtain one.

a. Waveform: Pile 1 no bubble curtain.

b. Waveform: Pile 1 with bubble curtain.

In Figure 7 a, b, the peak pile strike waveforms with and without mitigation are represented. When Figure 7b is compared to the peak strike waveform for Pile 1 without a bubble curtain (Figure 7a), there appears to be a decrease in the overall amplitude of the pile strike when the bubble curtain is used.

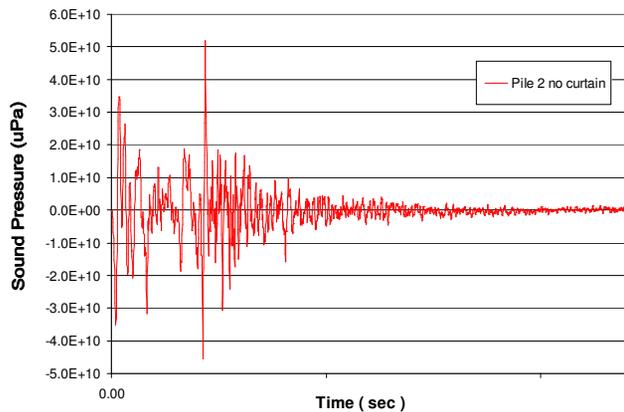
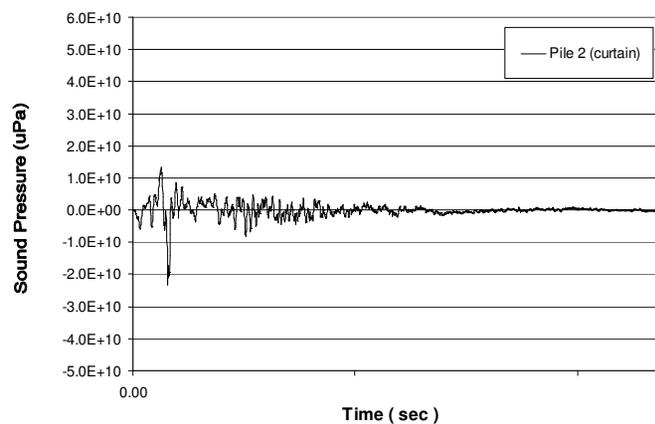
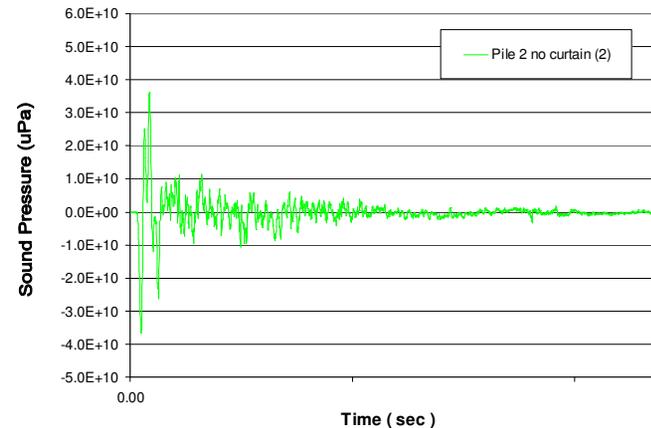
Figure 8: Waveforms and frequency spectral analysis for Pile 2 using bubble curtain one.

a. Waveform: Pile 2 no bubble curtain

b. Waveform: Pile 2 with bubble curtain

c. Waveform: Pile 2 no bubble curtain (2)

In Figures 8a, b and c, the peak pile strike waveforms with and without the bubble curtain are represented. When compared to the peak strike waveform for Pile 2 without mitigation (Figure 8a,c) there appears to be a decrease in the overall amplitude of the pile strike when the bubble curtain is used (Figure 10b).

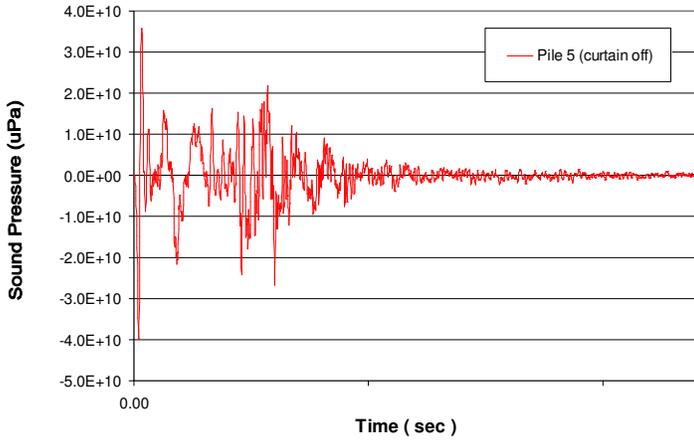
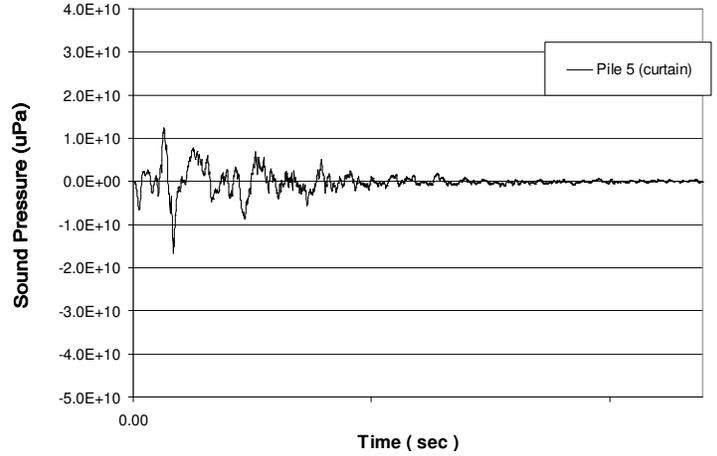
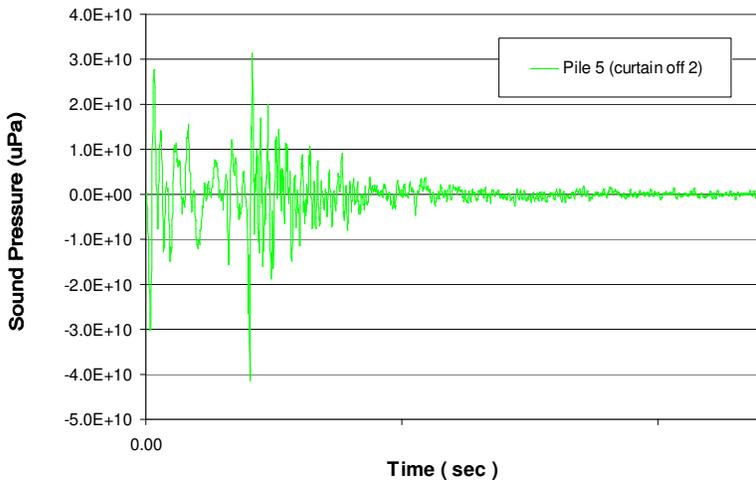
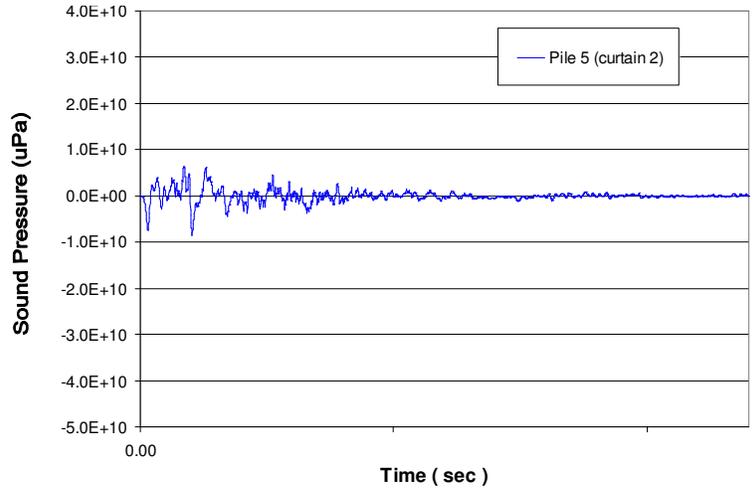
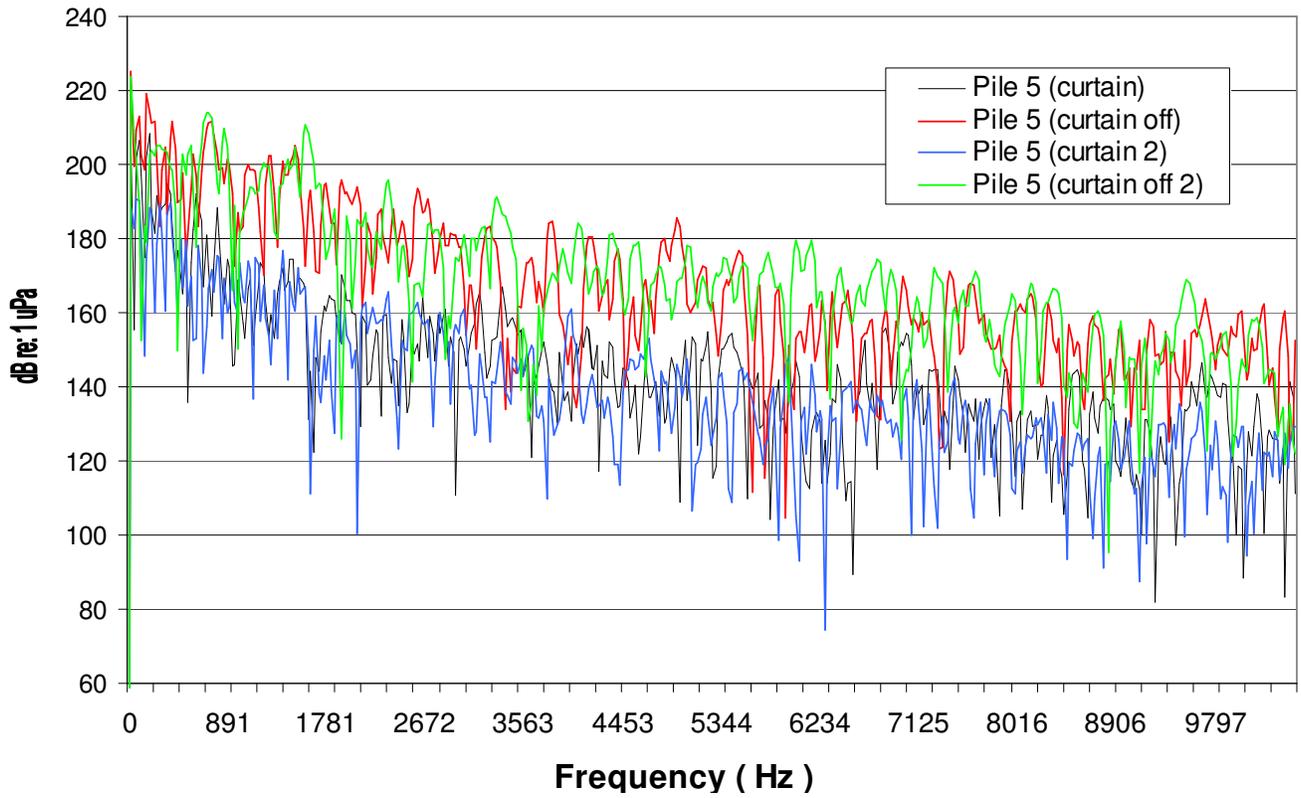
Figure 10: Waveforms and frequency spectral analysis for Pile 5 using bubble curtain one.

a. Waveform: Pile 5 no bubble curtain

b. Waveform: Pile 5 with bubble curtain

c. Waveform: Pile 5 no bubble curtain (2)

d. Waveform: Pile 5 with bubble curtain (2)

e. Frequency spectral analysis of Pile 5.

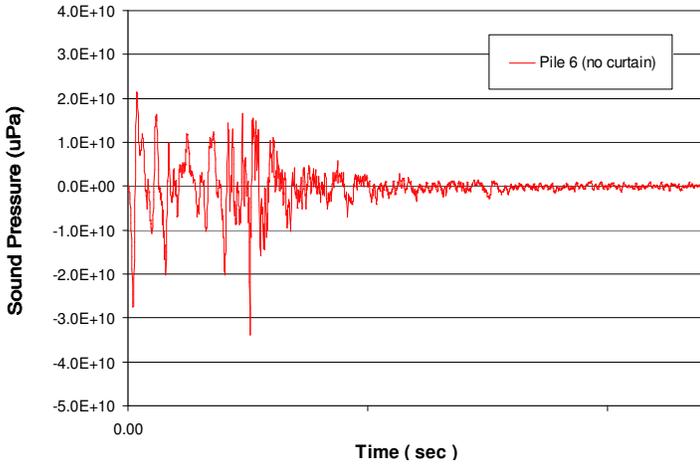
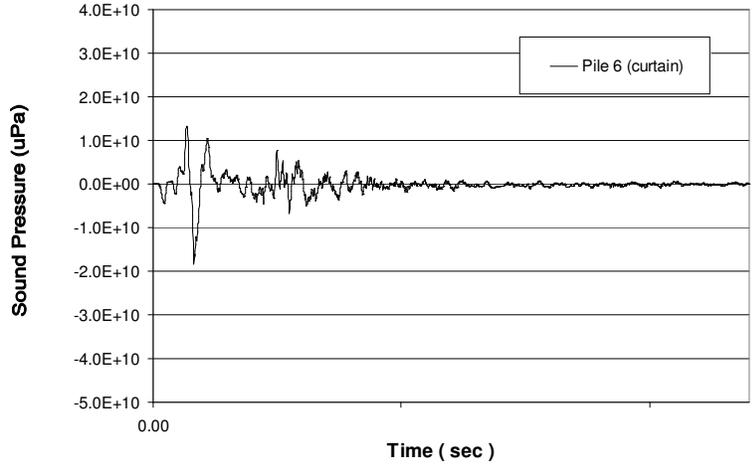
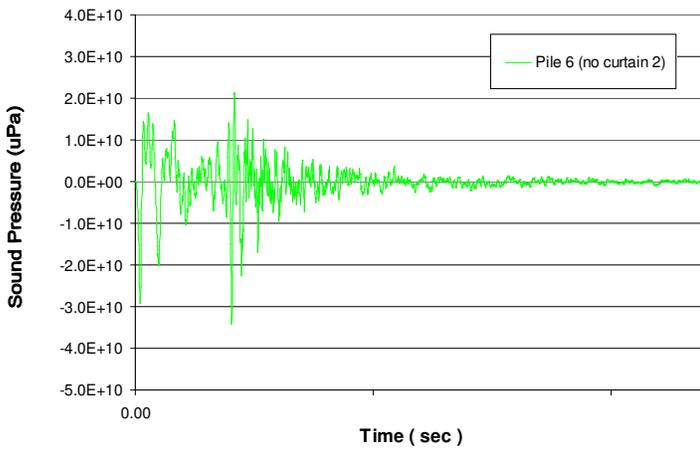
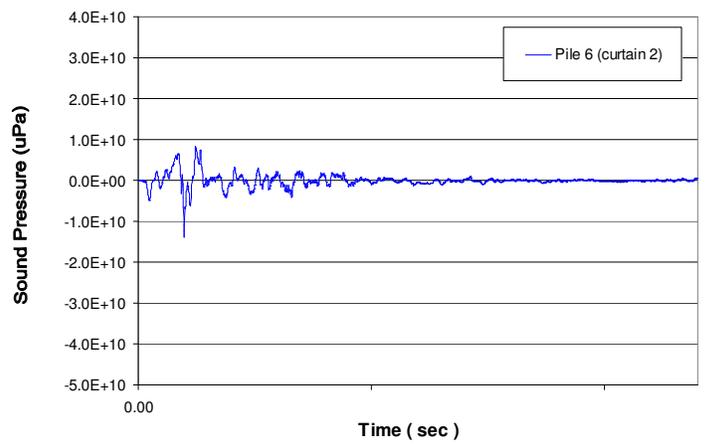
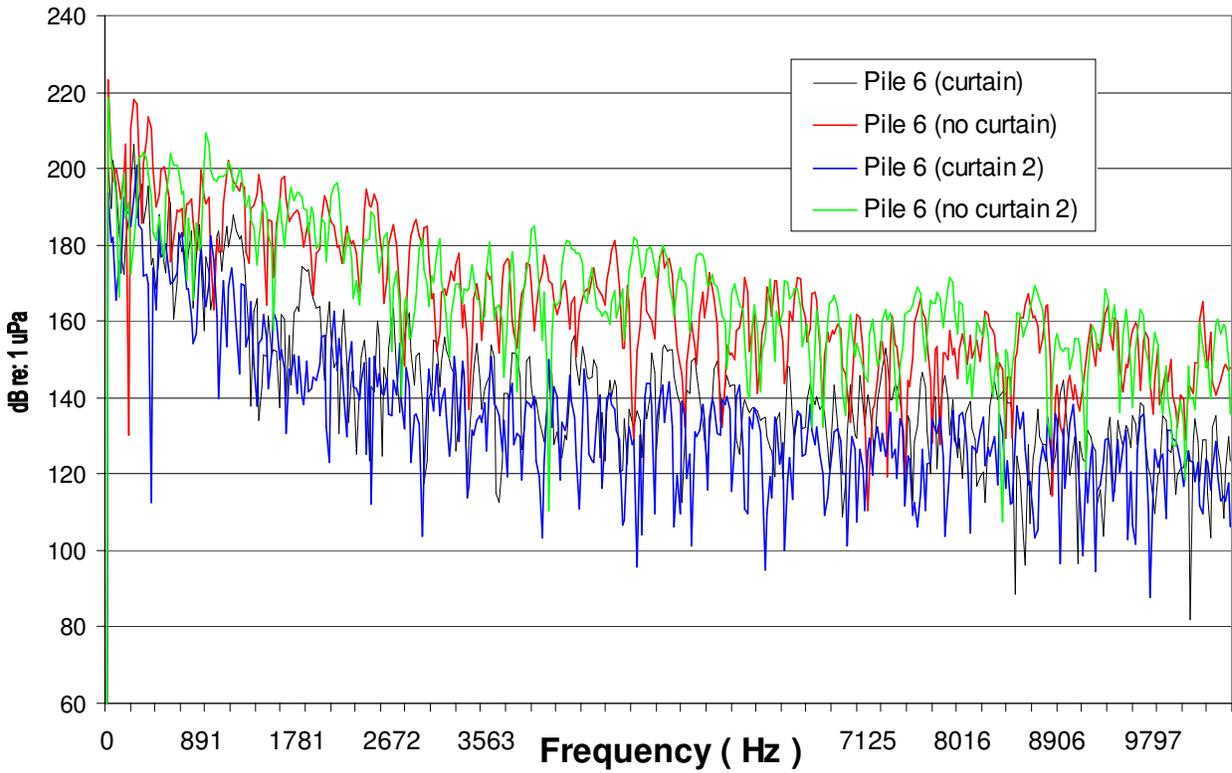
Figure 11: Waveforms and frequency spectral analysis for Pile 6 using bubble curtain one.

a. Waveform: Pile 6 no bubble curtain

b. Waveform: Pile 6 with bubble curtain

c. Waveform: Pile 6 no bubble curtain (2)

Waveform: Pile 6 with bubble curtain (2)

d. Frequency spectral analysis of Pile 6.

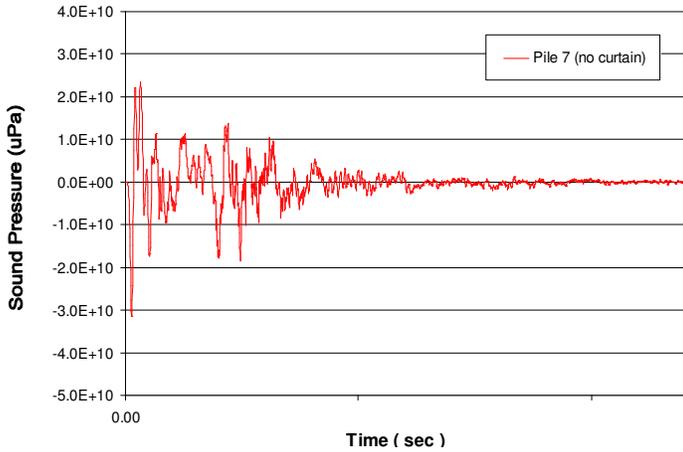
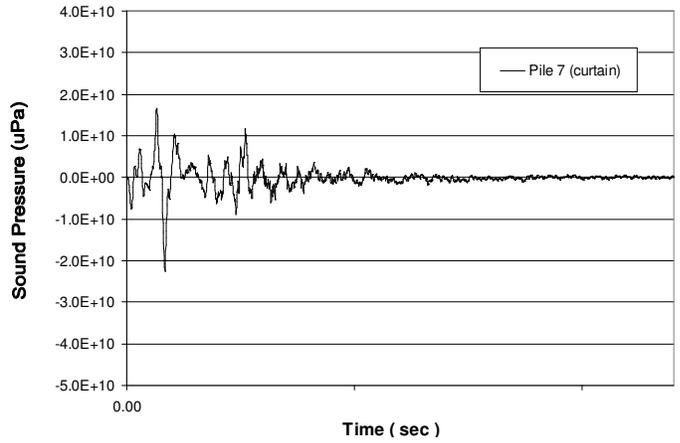
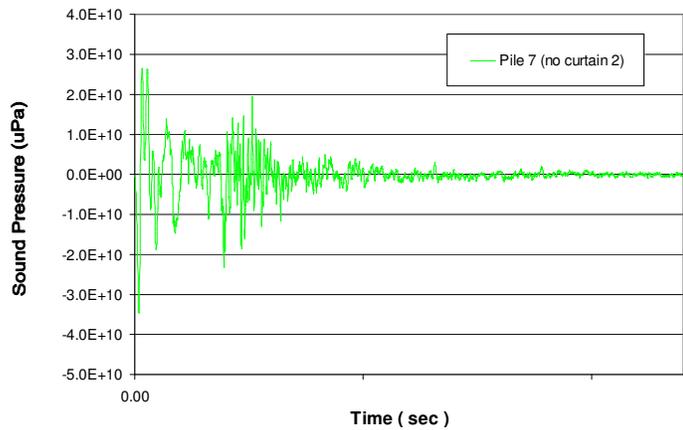
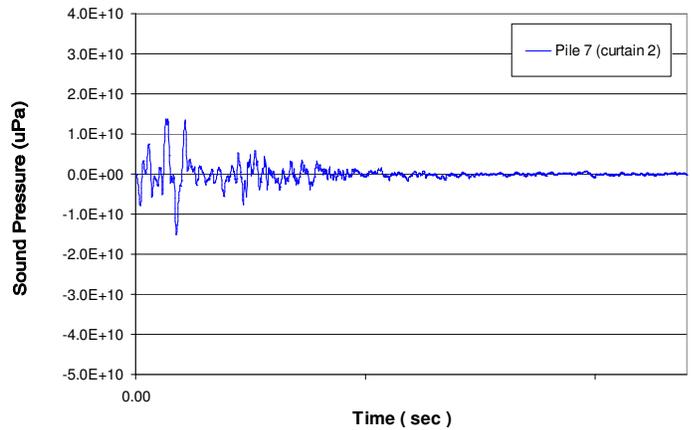
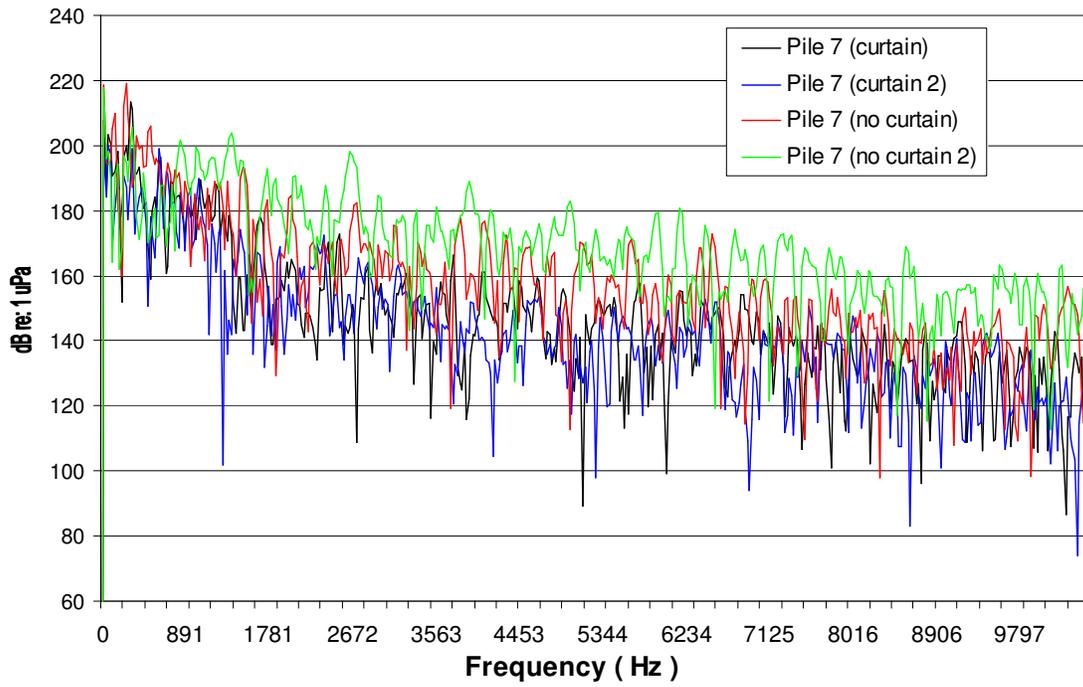
Figure 12: Waveforms and frequency spectral analysis for Pile 7 using bubble curtain two.

a. Waveform: Pile 7 no bubble curtain

b. Waveform: Pile 7 with bubble curtain

c. Waveform: Pile 7 no bubble curtain (2)

Waveform: Pile 7 with bubble curtain (2)

e. Frequency spectral analysis of Pile 7.

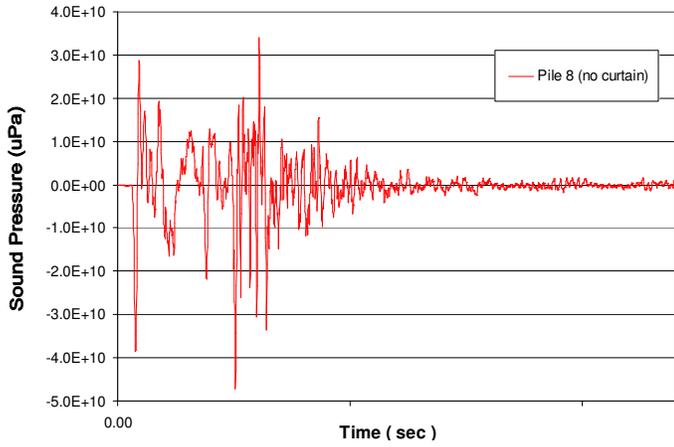
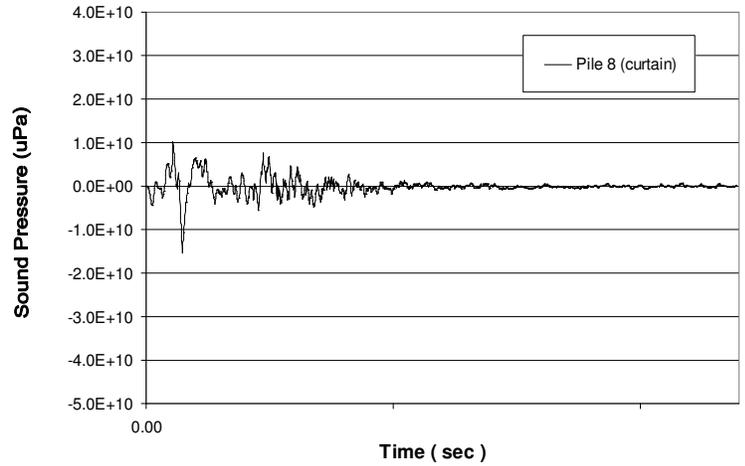
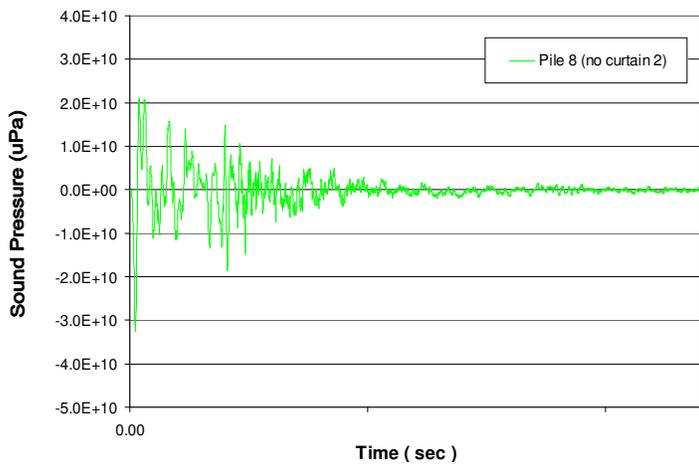
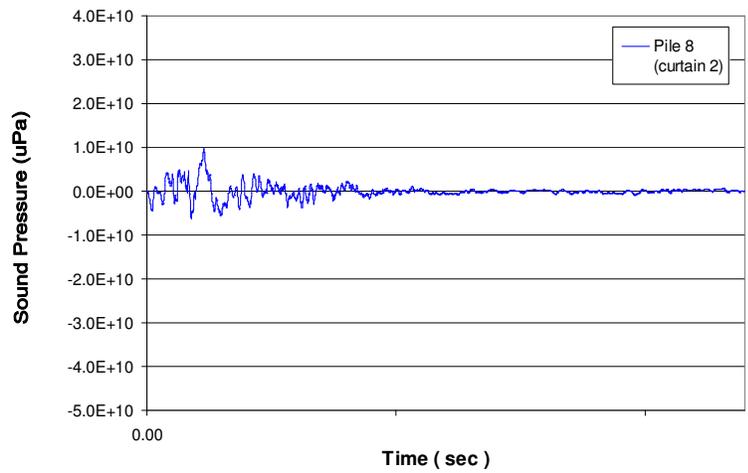
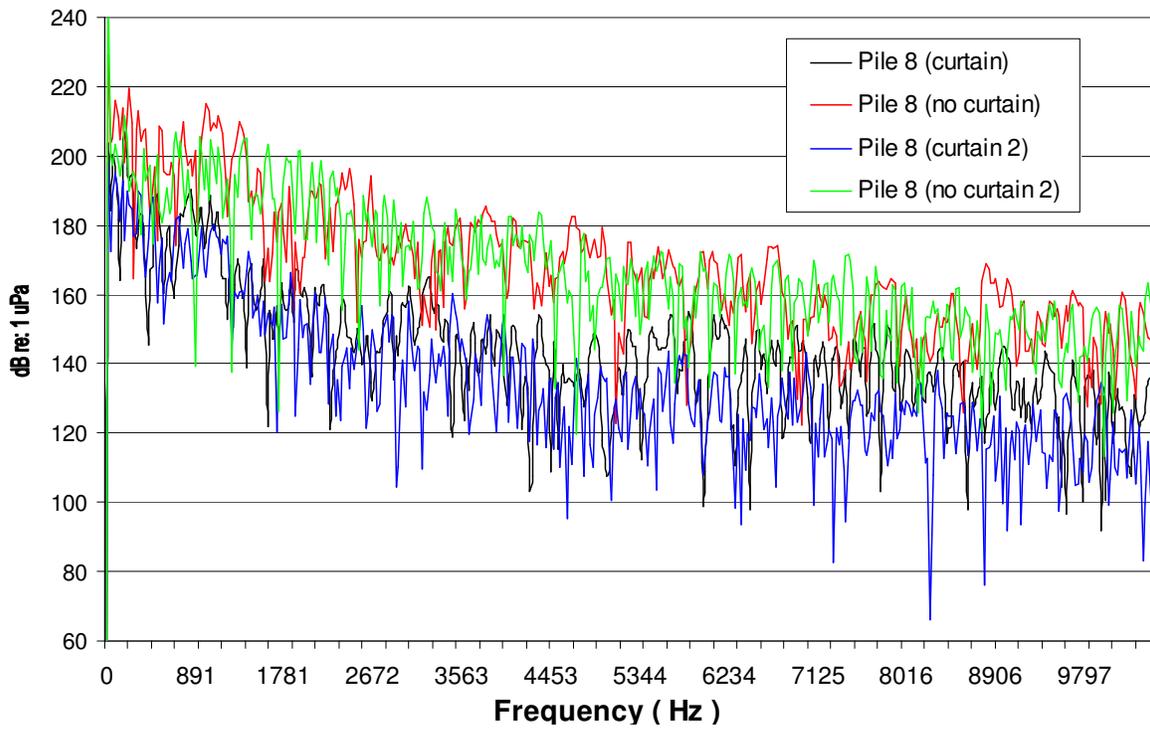
Figure 13: Waveforms and frequency spectral analysis for pile eight using bubble curtain one.

a. Waveform: Pile 8 no bubble curtain

b. Waveform: Pile 8 with bubble curtain

c. Waveform: Pile 8 no bubble curtain (2)

Waveform: Pile 8 with bubble curtain (2)

d. Frequency spectral analysis of Pile 8.
