# I-90 SNOQUALMIE PASS EAST PROJECT

## Final Report – Slide Curve Rock Slope Design 2007 Geotechnical Analysis & Reporting

January 2009

Wyllie & Norrish Rock Engineers Inc.  
17918 NE 27<sup>th</sup> Street  
Redmond, WA 98052

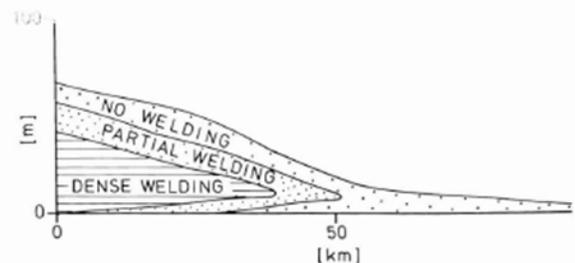
Idealized lateral and vertical configuration of welding zones (Fisher, 1984).

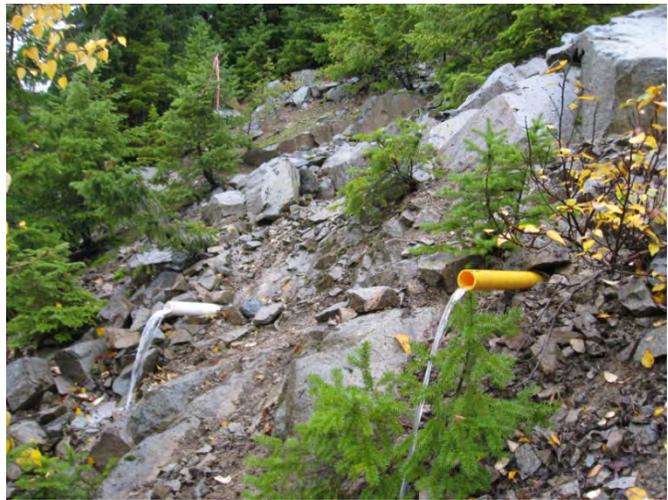
- 7. Intermittent surface springs were observed at approximately 1397+30 WB; 175 feet left (upslope). The locations are shown on Figure 3 and in the margin photograph. The springs are highly responsive to precipitation events with discharges at zero during dry periods and greater than 25 gallons per minute during heavy rainfall.

**Spring Discharge after heavy rainfall.**

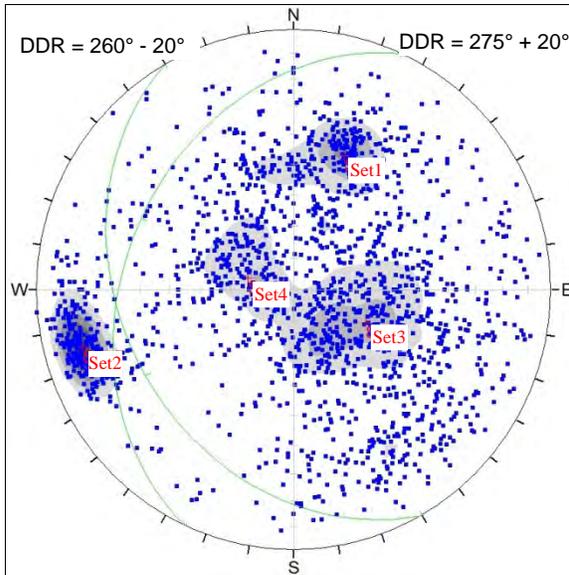
Extensive data set consists of 1778 discontinuity measurements. Structural mapping reported 55 measurements with balance of 1723 derived from COBL data from RKS, SI series boreholes as well as H-101-06, H102-06, H103-06 and H108-06.

Joint sets: Set 1: 46°/201° Set 2: 74°/075°  
Set 3: 25°/294° Set 4: 15°/104°

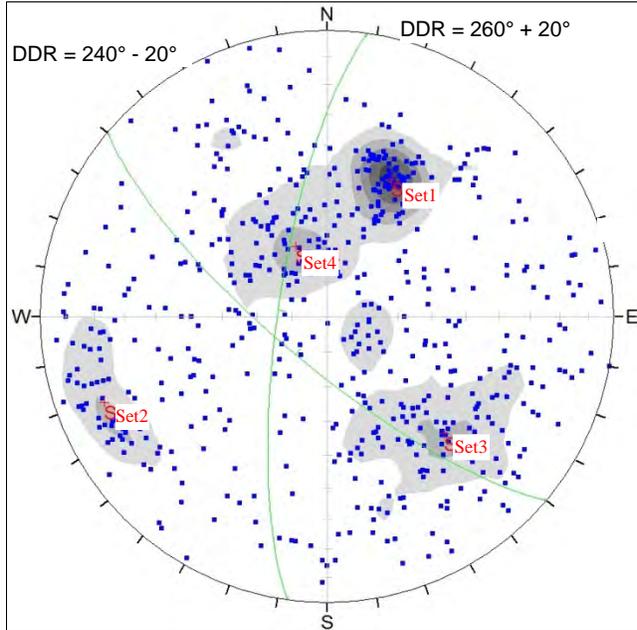
Extensive data set consists of 589 discontinuity measurements. Structural mapping reported 55 measurements with balance of 534 derived from COBL data from RKS-23-07 to RKS-27-07, SI-06-07 and SI-11-7 series boreholes as well as H-103-06 and H-104-06.

Joint sets: Set 1: 44°/205° Set 2: 72°/069°  
Set 3: 48°/315° Set 4: 22°/156°

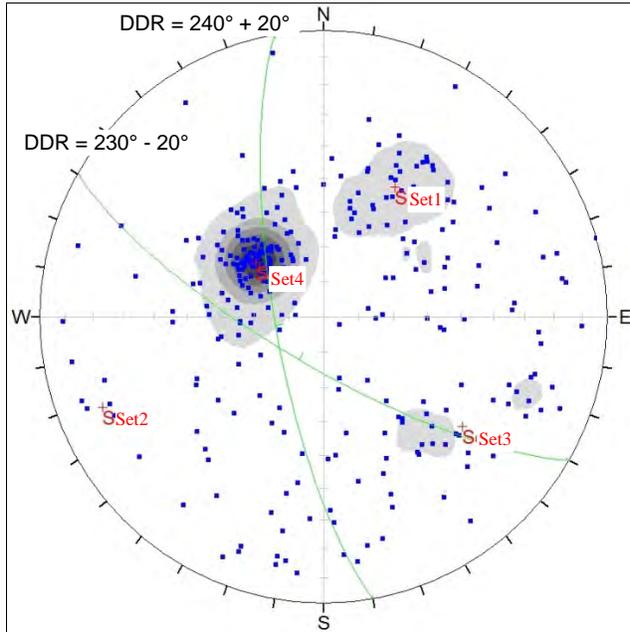
Extensive data set consists of 301 discontinuity measurements. Structural mapping reported 5 measurements with balance of 296 derived from COBL data from RKS-28-07 and RKS-29-07 boreholes as well as H-109-06.

Joint sets:           Set 1: 43°/209°   Set 2: 73°/068°  
                          Set 3: 52°/308°   Set 4: 25°/128°

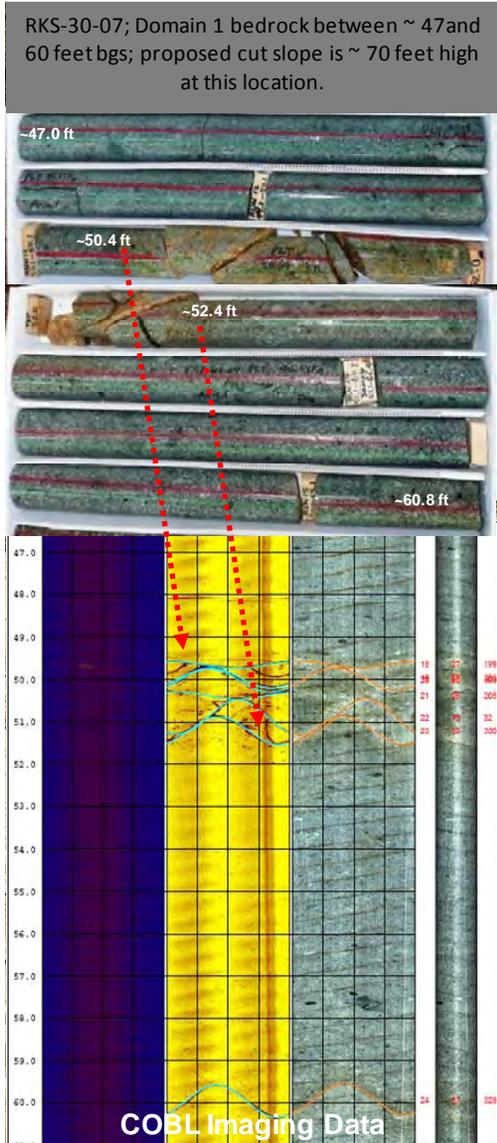
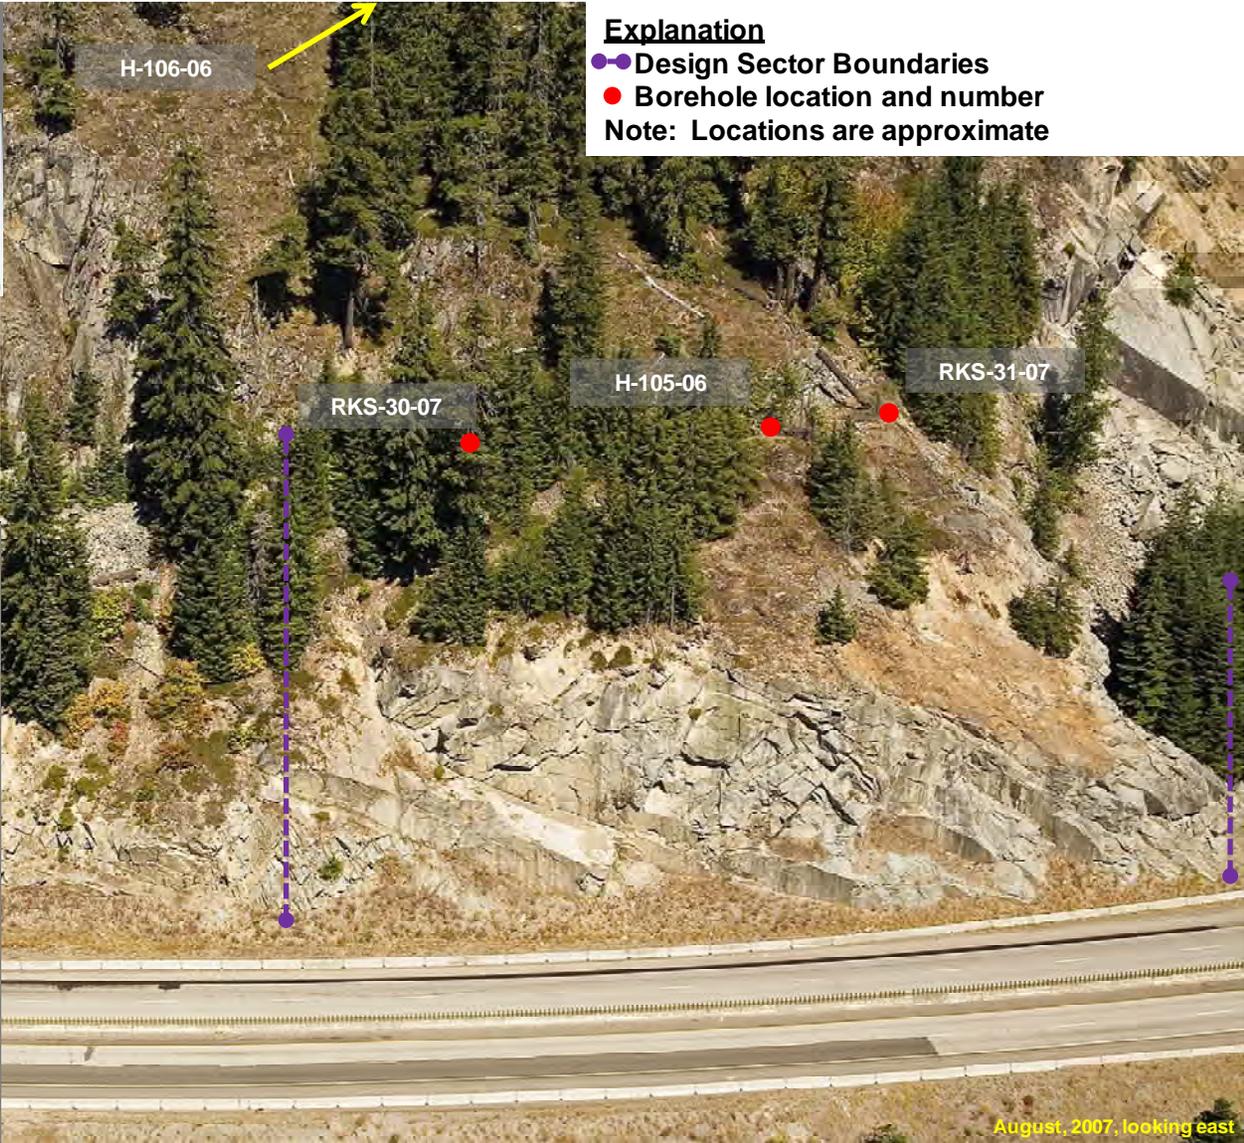
**Explanation**  
 ●● Design Sector Boundaries  
 ● Borehole location and number  
 Note: Locations are approximate

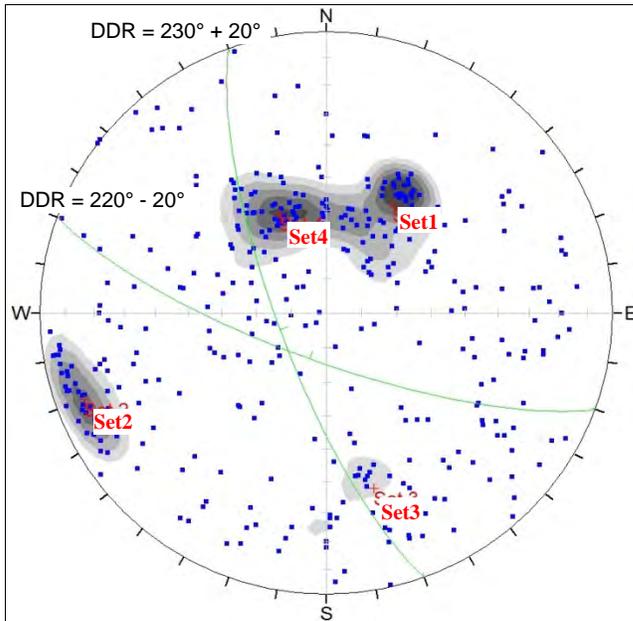
Extensive data set consists of 386 discontinuity measurements. Structural and Sirovision mapping reported 77 and 33 measurements, respectively, with balance of 276 derived from COBL data from boreholes RKS-30-07 and RKS-31-07 as well as H-105-06 and H-106-06.

Joint sets:           Set 1: 37°/211°   Set 2: 79°/070°  
                          Set 3: 54°/345°   Set 4: 32°/155°

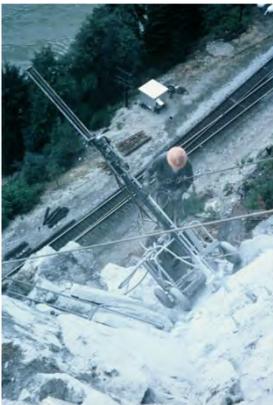
To facilitate drilling for rock reinforcement, small diameter cement-grouted bars are recommended. Dowels and rock bolts will use the same materials with the selection contingent on rock quality at the face. Dowel and bolt holes could be drilled from an air-powered “spider” with personnel suspended from ropes as shown in the margin photograph. For worker safety, reinforcement should be sequenced from the top down.

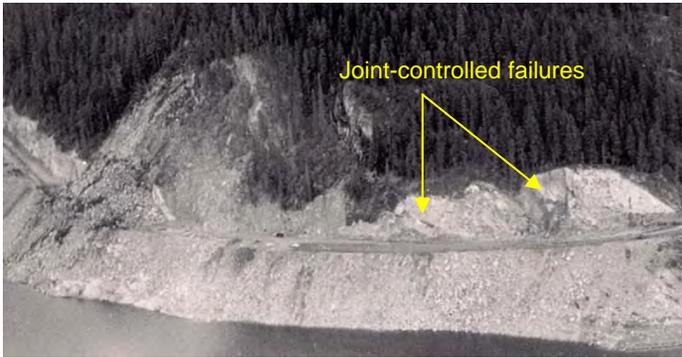
The photograph to the left shows that during construction in 1957, slope failures were experienced along Joint Set 1 surfaces in the vicinity of current Station 1412+00 WB, coinciding with the abandoned quarry site.
