BIOLOGICAL ASSESSMENT REFERENCE

WASHINGTON STATE FERRIES CAPITAL, REPAIR, AND MAINTENANCE PROJECTS

May 2022

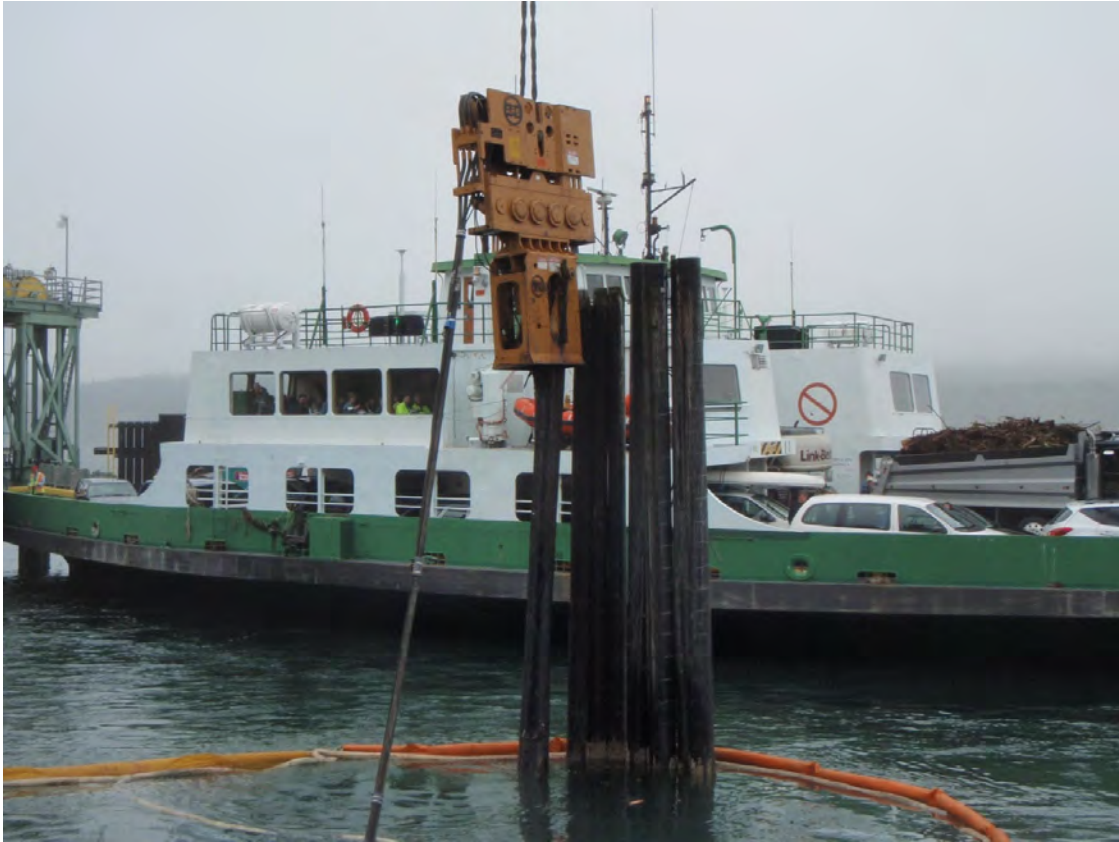
Figure 2-1
Vibratory Hammer Removing a Timber Pile

pile from the sediment. When the pile is released from the sediment, it is pulled from the water and placed on a barge. Figure 2-1 shows a timber pile being removed with a vibratory hammer.

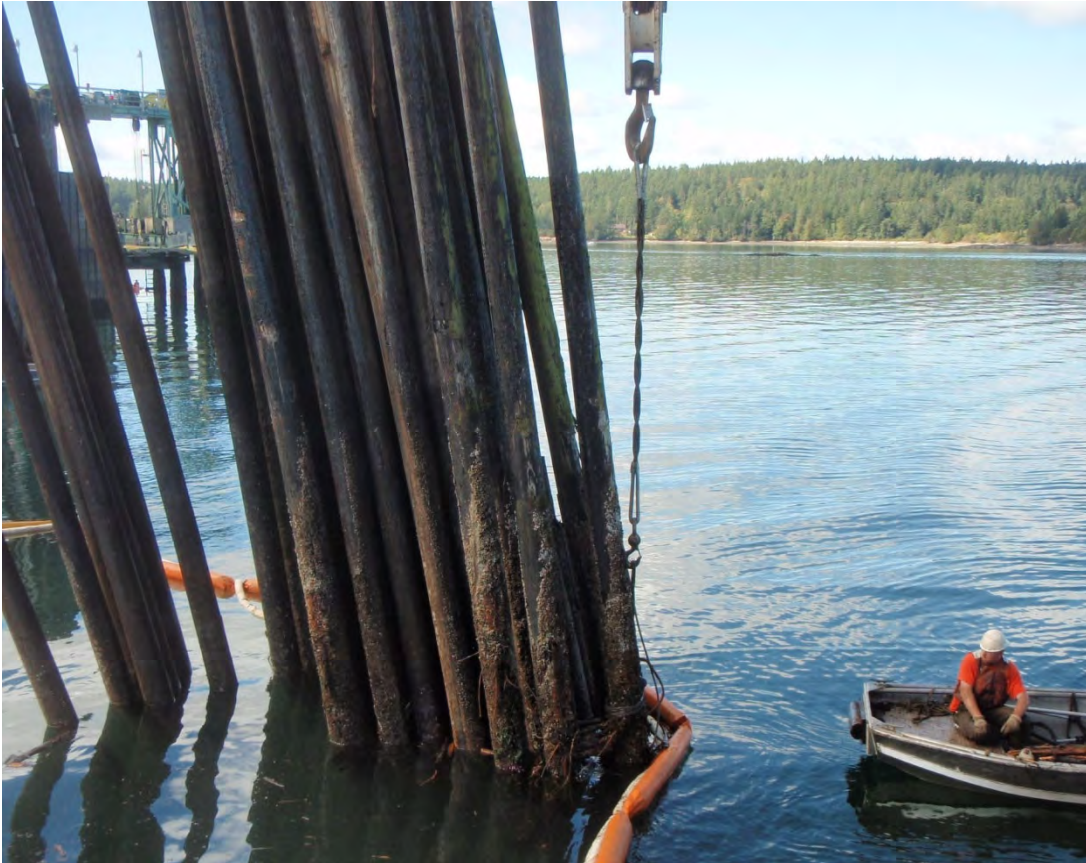
Figure 2-2
Direct Pull of Timber Piles

possible because the pile will break apart from the force of the clamp and the vibration. Broken or damaged piles may be removed by wrapping the piles with a cable or chain and pulling them directly from the sediment with a crane (Figure 2-2).

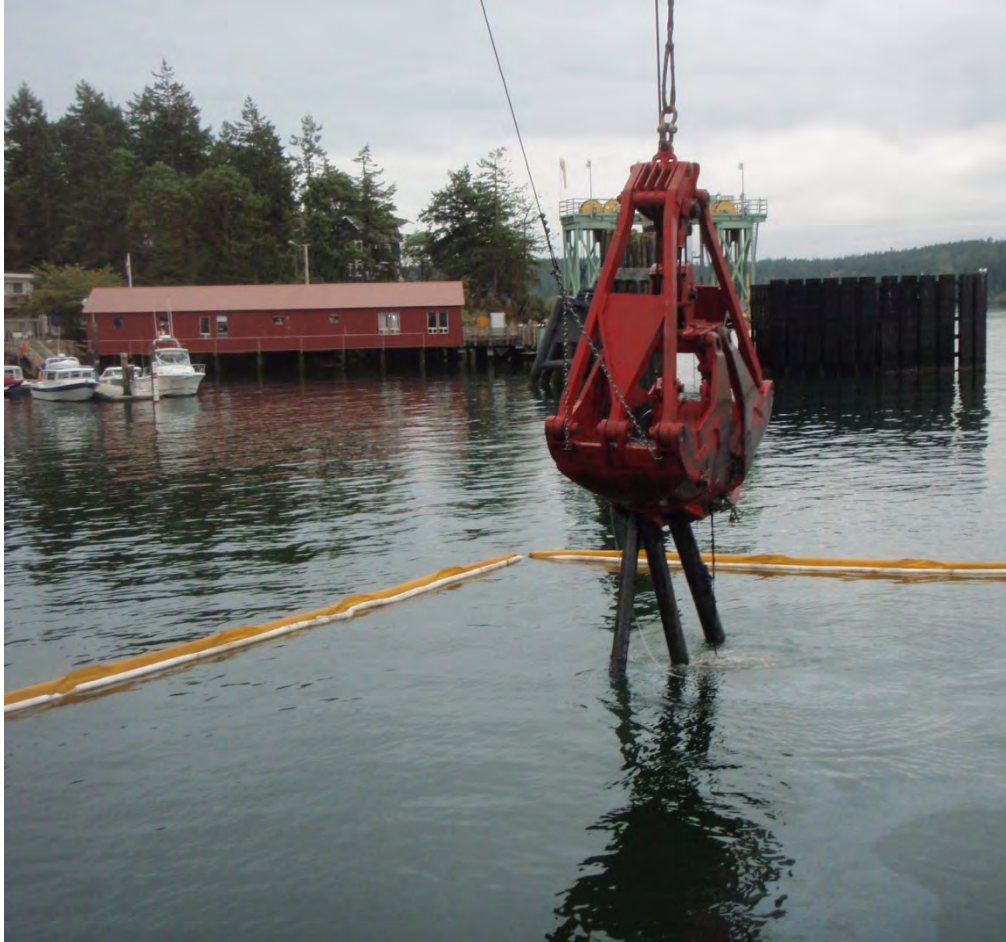
Figure 2-3
Removal of a Broken Pile with a Clamshell Bucket

If the piles break between the waterline and the mudline, pile stubs are then removed with a clamshell bucket. A clamshell bucket is a hinged steel apparatus that operates like a set of steel jaws. The bucket is lowered from a crane and the jaws grasp the pile stub as the crane pulls up (Figure 2-3). The broken piling and stubs are loaded onto the barge for off-site disposal.

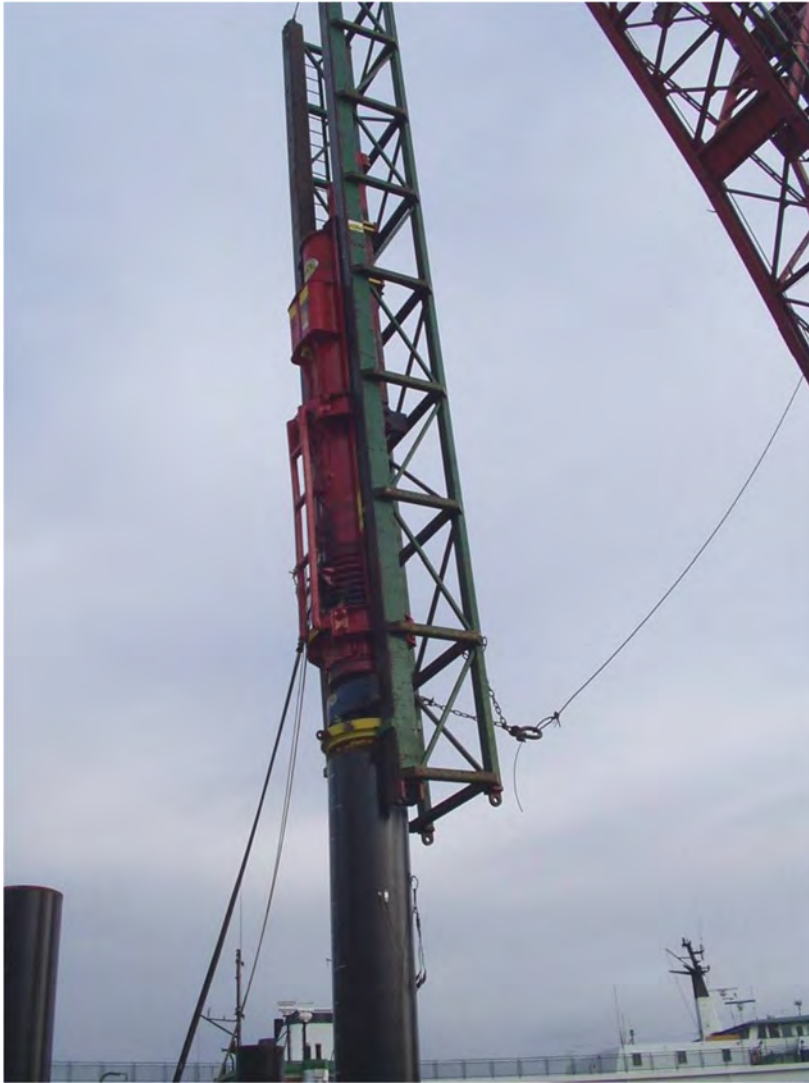
Figure 2-4
Impact Hammer Driving a Steel Pile

conditions, to over an hour under poor conditions (such as glacial till and bedrock, or exceptionally loose material in which the pile repeatedly moves out of position). Figure 2-4 shows a pile being driven with an impact hammer.

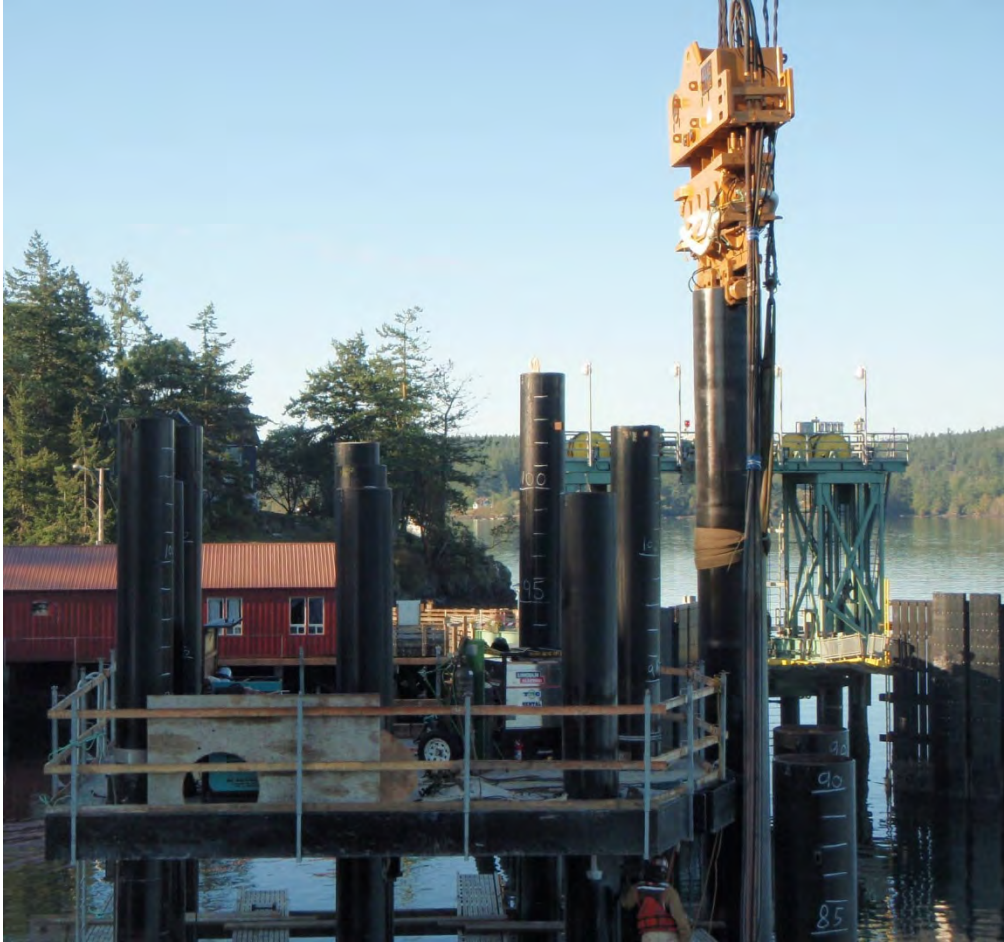
The vibratory hammer method is a common technique used in steel pile installation where the type of sediment allows this method to be used. This process begins by placing a choker around the pile and lifting it into vertical position with the crane. The pile will then be lowered into position and set in place at the mudline. The pile will be held steady while the vibratory hammer installs the pile to the required tip elevation (Figure 2-5). For some load-bearing structures such as towers, wingwalls, and trestles, the vibratory hammer can only install piles until they reach a certain level of resistance. To meet certain design criteria and ensure proper functioning of the structure, piles (steel, timber, and concrete) sometimes must be “proofed” by striking them with an impact hammer. During the proofing process, an observer records the distance the pile is embedded with each impact hammer blow. Data collected during this process is then sent to the Project Engineer for review to ensure the pile will meet the load-bearing design criteria.

Figure 2-5
Vibratory Hammer Installing a Steel Pile

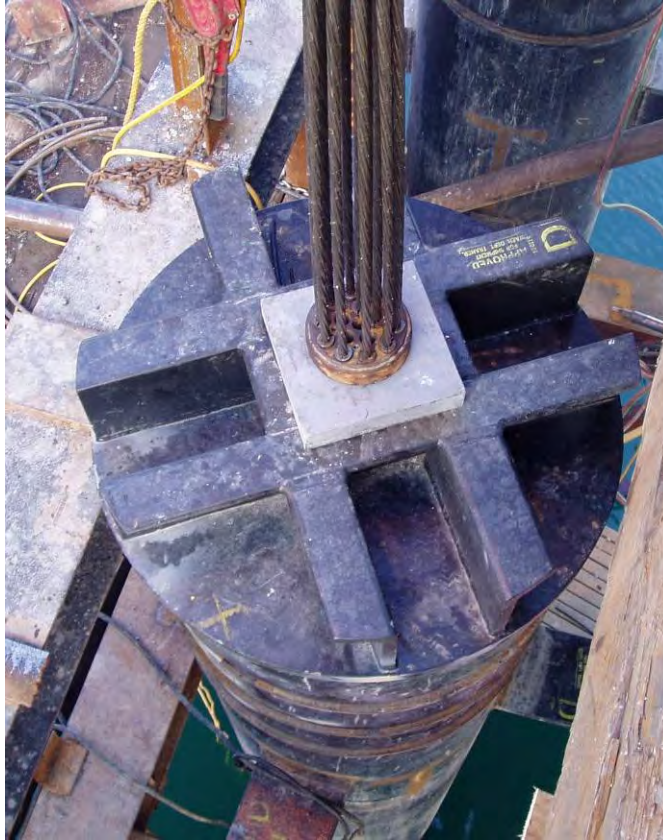
Figure 2-6
Steel Strand Cluster Method of Rock Anchor Installation

- The steel strands are tensioned to the required load and locked off. The casing is then filled with grout (for both dowel and strand methods).
- If site conditions allow, sandbags are placed around the base of the pile to prevent grout from leaking and coming into contact with surface water.

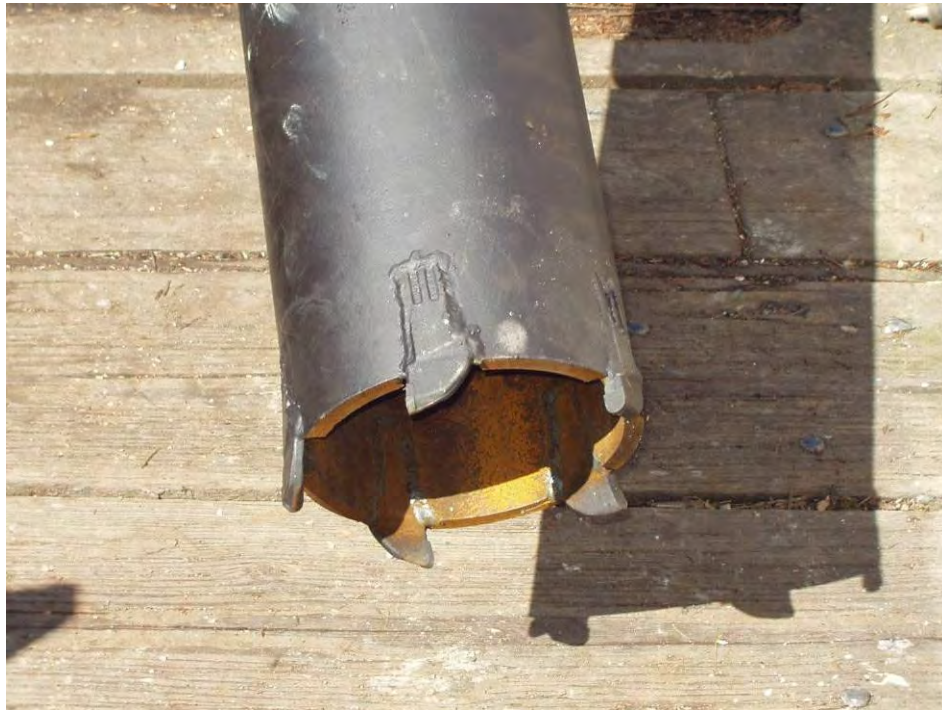
In some situations, micropiles can also be used at facilities located on bedrock as an alternative to rock anchors. Micropiles are relatively small in diameter (8 to 12 inches) and are not as strong as piles installed with rock anchors; therefore, their use is limited to situations with lower structural capacity requirements. Micropiles are steel piling with a serrated edge (Figure 2-8) that are drilled 2 to 3 feet into the rock rather than being installed with hammer. The pile is drilled from small equipment located on the trestle. The resulting soil and rock fragments are flushed out to the center of the pile with compressed air and contained for upland disposal. After the pile is cleaned of drill cuttings, the center of the pile is filled with grout. The micropile is then attached to the deck above with bolts and other fasteners.

Figure 2-8
Serrated Edge of a Micropile

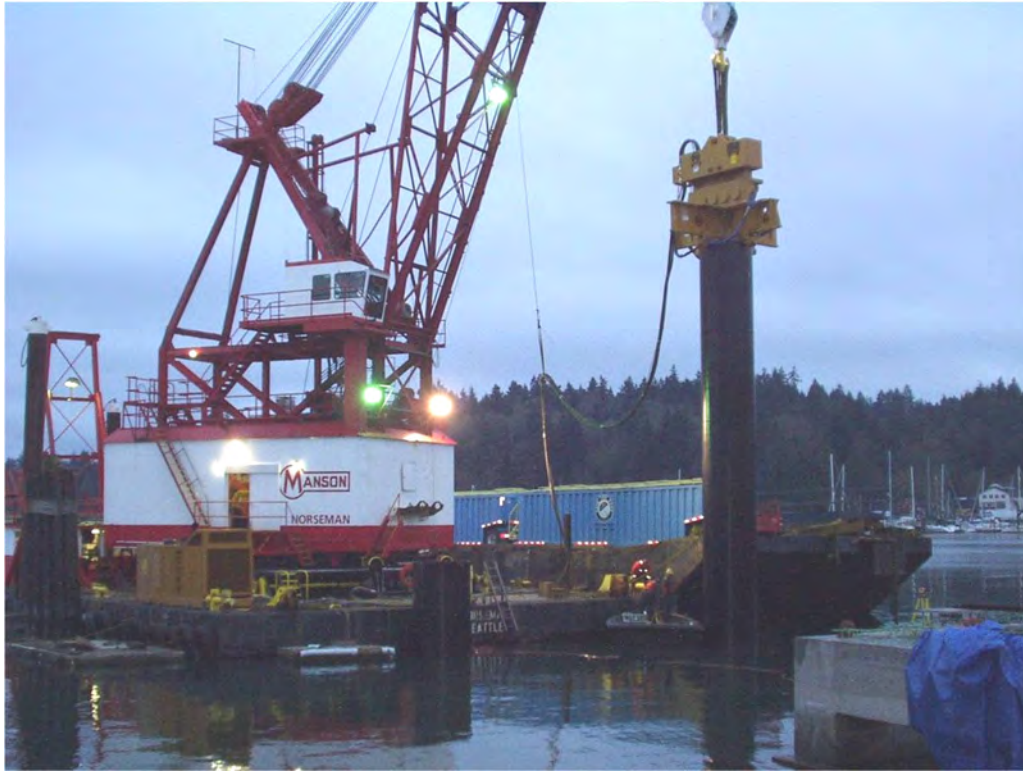
2-9), and the material inside the casing is excavated using an auger or a clamshell dredge (Figure 2-10). Augering is done within the casing such that no suspended sediments are released to the surface waters. Auger tailings are removed from the hole by mechanical means and disposed of upland.

Figure 2-9
Vibratory Installation of Drilled Shaft Casing

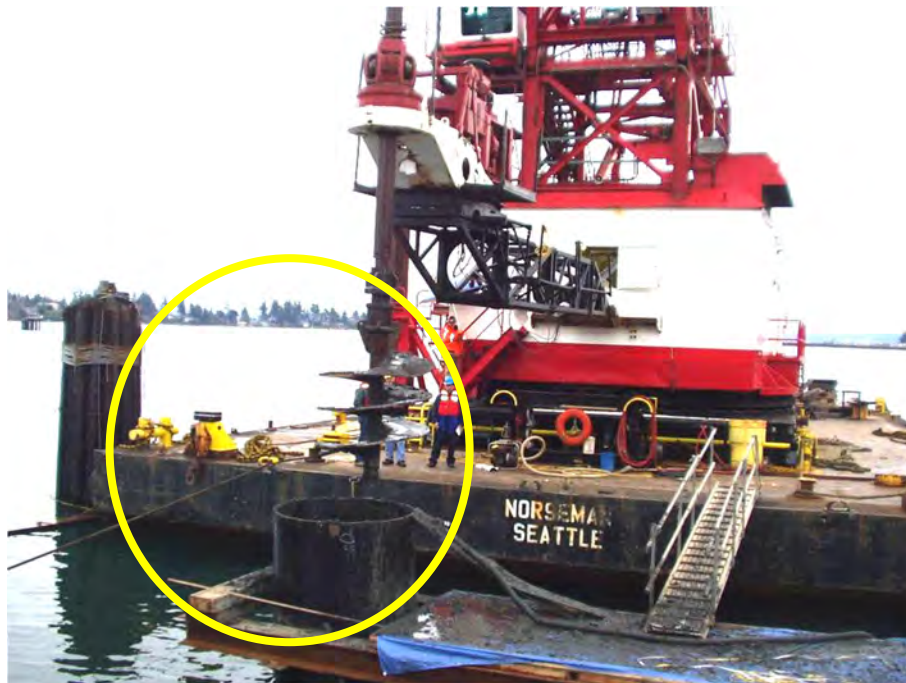
Figure 2-10
Auger Excavation of Drilled Shaft

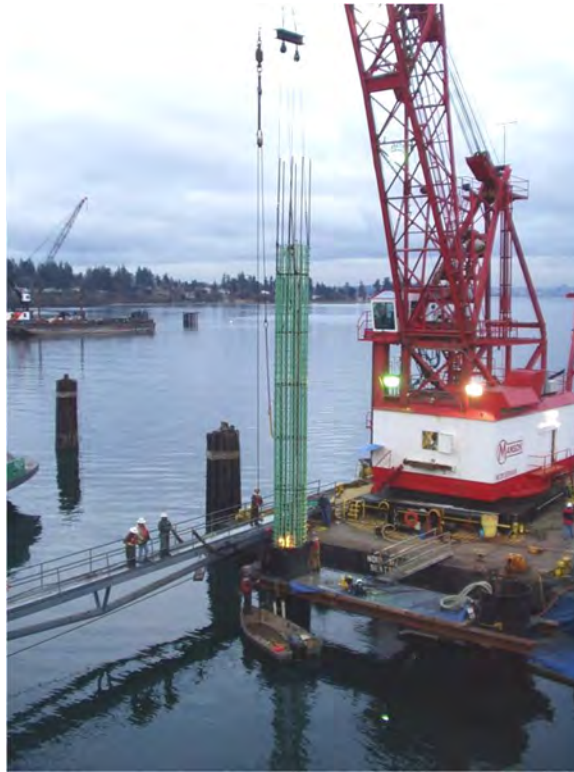
During excavation, a bentonite or synthetic polymer slurry is sometimes added to stabilize the walls of the shaft. When the shaft is of the desired depth, rebar reinforcement is placed in the shaft (Figure 2-11) and concrete is poured with a small-diameter flexible hose called a tremie. The concrete displaces any slurry that was previously added and a vacuum hose is used to remove the slurry from the top of the concrete (Figure 2-12).

Figure 2-11
Rebar Reinforcement of Drilled Shaft

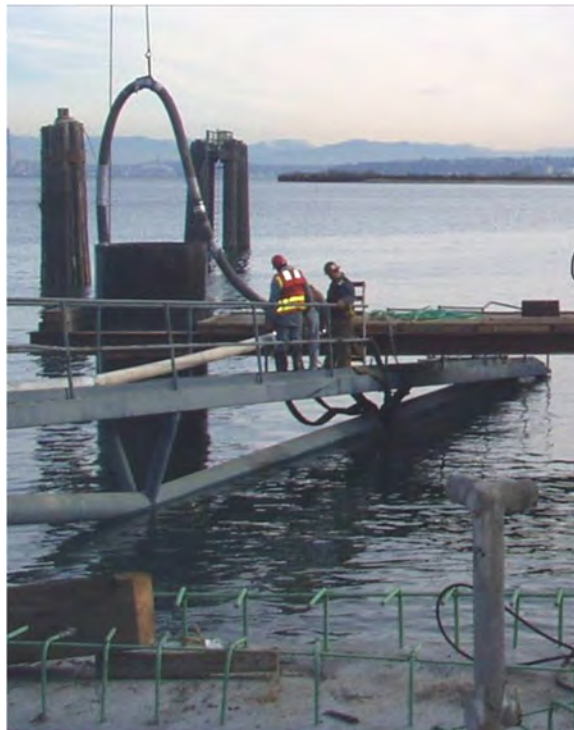
Figure 2-12
Vacuuming of Slurry from Drilled Shaft

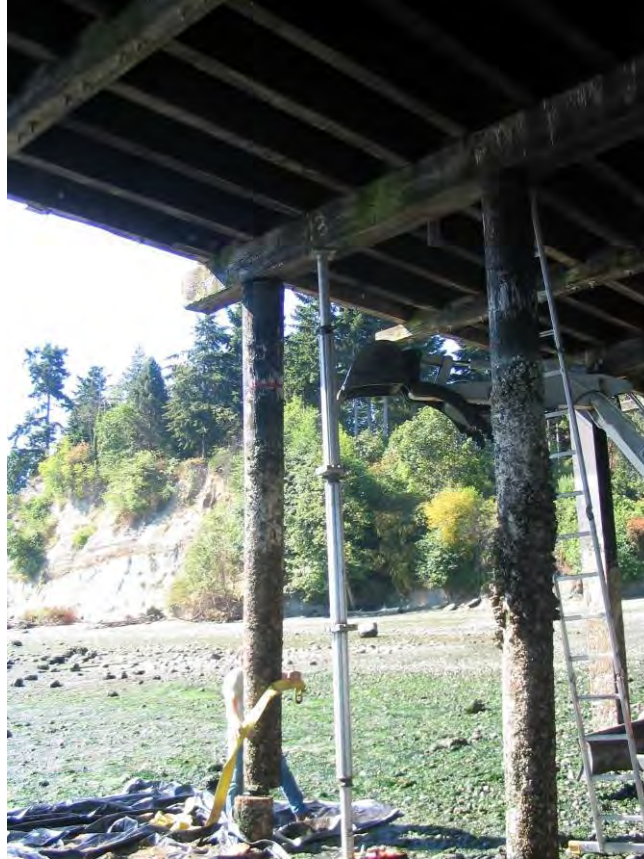
Figure 2-13
Pile Stubbing: Removing a Damaged Section of Pile

Pile stubbing is a process in which an existing, damaged length of pile above the ground line is removed and replaced with a new length of ACZA-treated timber pile. This process does not involve pile driving. Pile stubbing is often done at elevations that are exposed at low tide. The process for pile stub repairs in the dry involves cutting and removing a damaged timber pile between the ground line and the underside of the pile cap (Figure 2-13). The remaining portion of the pile is inspected for structural integrity. A 1-inch-diameter, 2-foot-long galvanized steel pin is installed in the center of the pile, extending 1 foot from each side of the joint. A new section of pile is then inserted between the cut section of pile that is still embedded in the sediments and the underside of the structure the pile is supporting (Figure 2-14). The pile surfaces are then cleaned of marine organisms. The form must extend 30 inches below and above the joint of the two timber piles, often requiring the excavation of small amounts of sediment around the base of the pile. The sediment can be excavated with a backhoe, hand tools, shovels, or a siphon. When the process is complete, the sand is returned to its original location and the form, which extends above the high tide elevation, is removed.

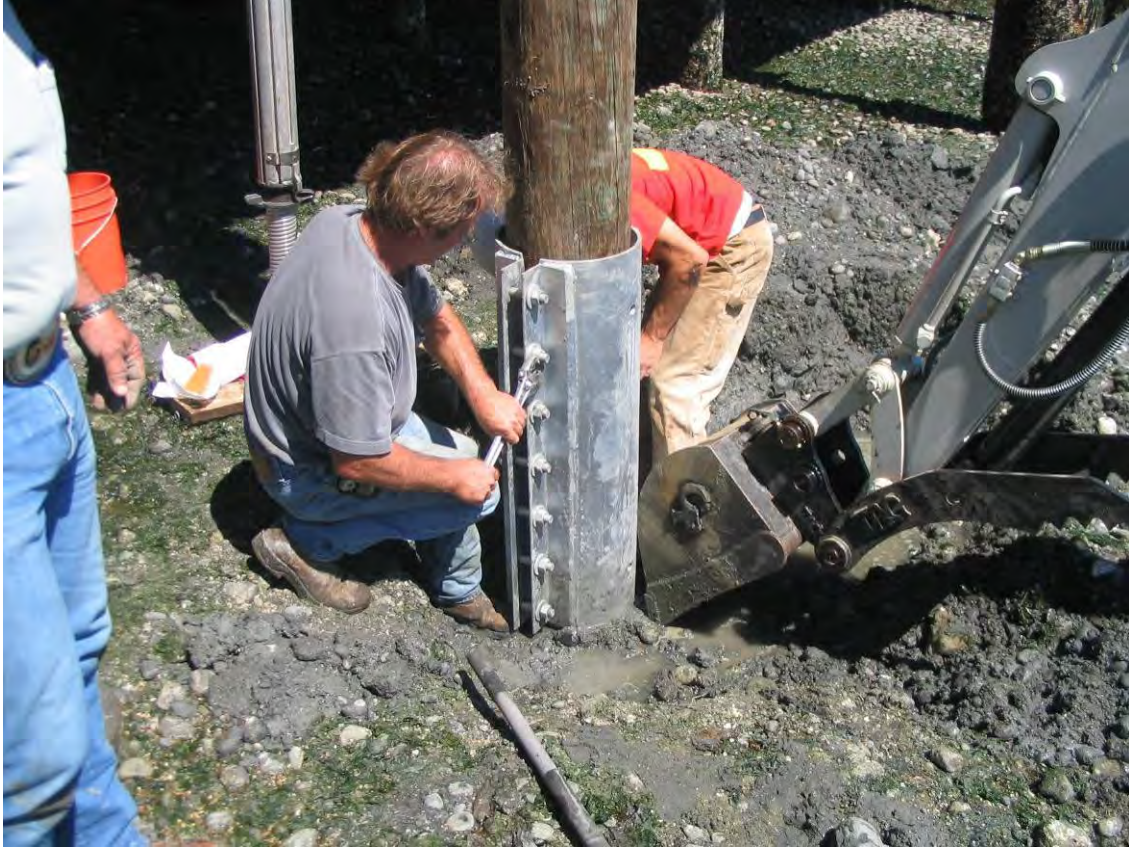
Figure 2-15
Pile Stubbing: Steel Collar Method

Another method of timber pile repair is a steel collar used in place of a cast concrete collar. The steel collar encases the pile and extends at least 1 foot beyond the joint in both directions. The collar is bolted together around the pile (Figure 2-15). As with the concrete collar, a galvanized steel pin is first installed inside the pile to reinforce the pile at the joint. The primary difference between this and pile stubbing is this method does not use concrete, rebar, or forms that require removal. However, use of the steel collar method is limited because it is difficult to achieve a tight, sealed connection between the old and new sections of pile if the old pile is warped or deteriorated. If the section of pile stub remaining in the ground is in poor condition, the cast concrete collar must be used.

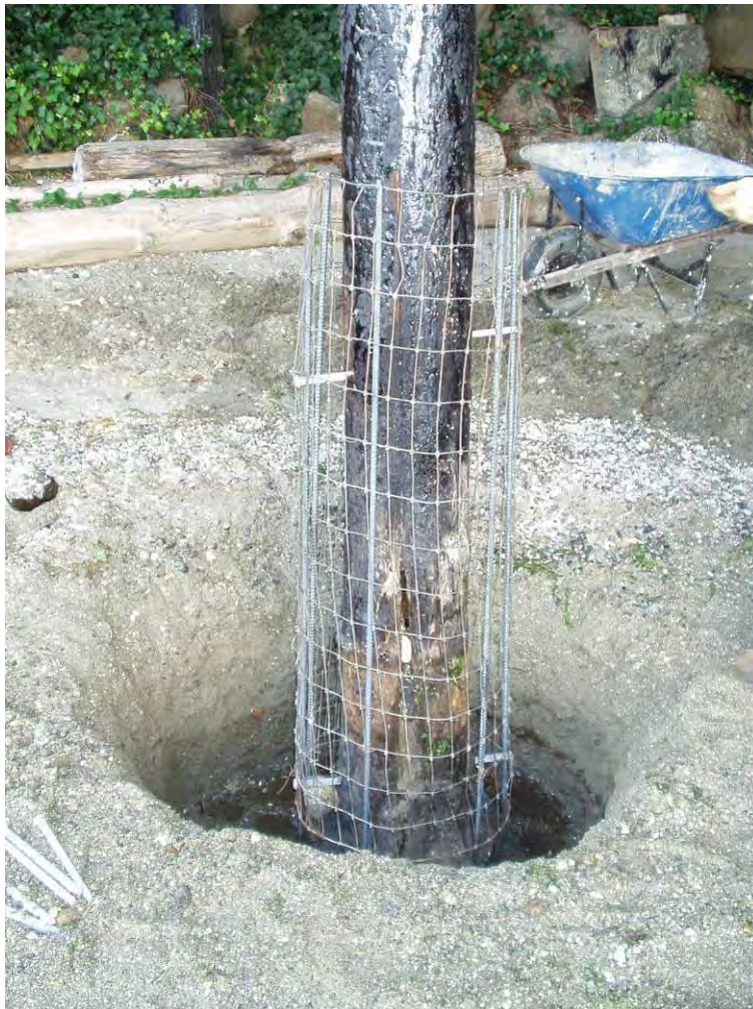
Pile encapsulation with a steel form works much like the pile stubbing method described above. A concrete plug is poured in the bottom of the form and allowed to cure. Once cured, seawater is pumped from the pile and contained so as not to enter surface waters. Concrete is then poured inside the form. The concrete pouring is stopped once the concrete reaches a level below the top of the pile to prevent concrete spillage. Encapsulation with a steel form is shown in Figures 2-17 through 2-19. In these figures, the encapsulation is being done in the dry. When done in water, work is performed from a skiff by commercial divers.

Figure 2-17
Pile Prepared for Encapsulation

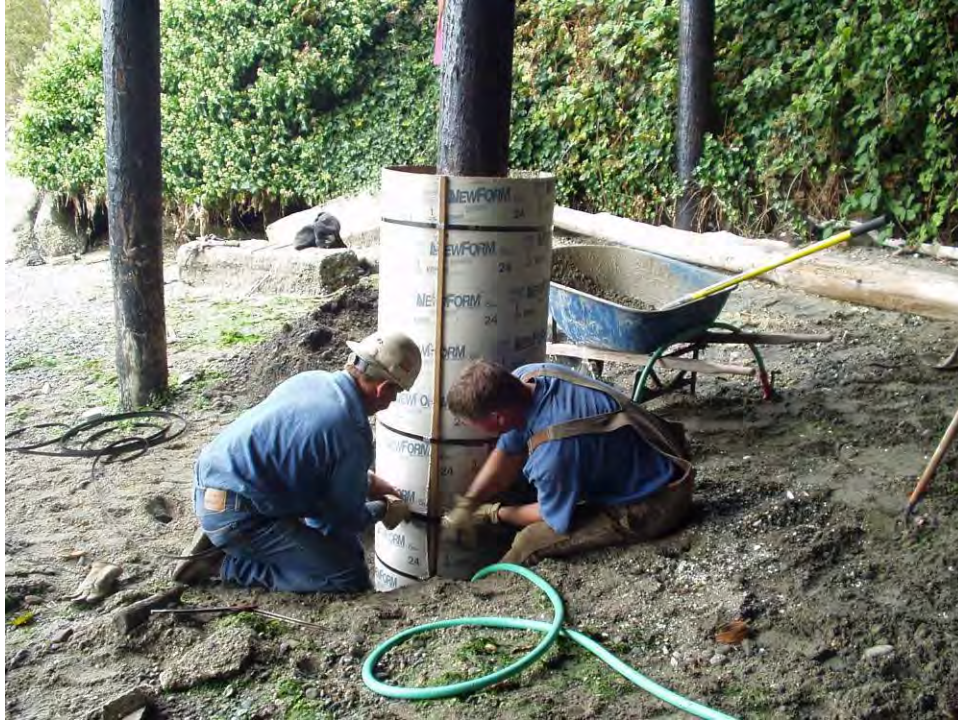
Figure 2-18
Installing the Form

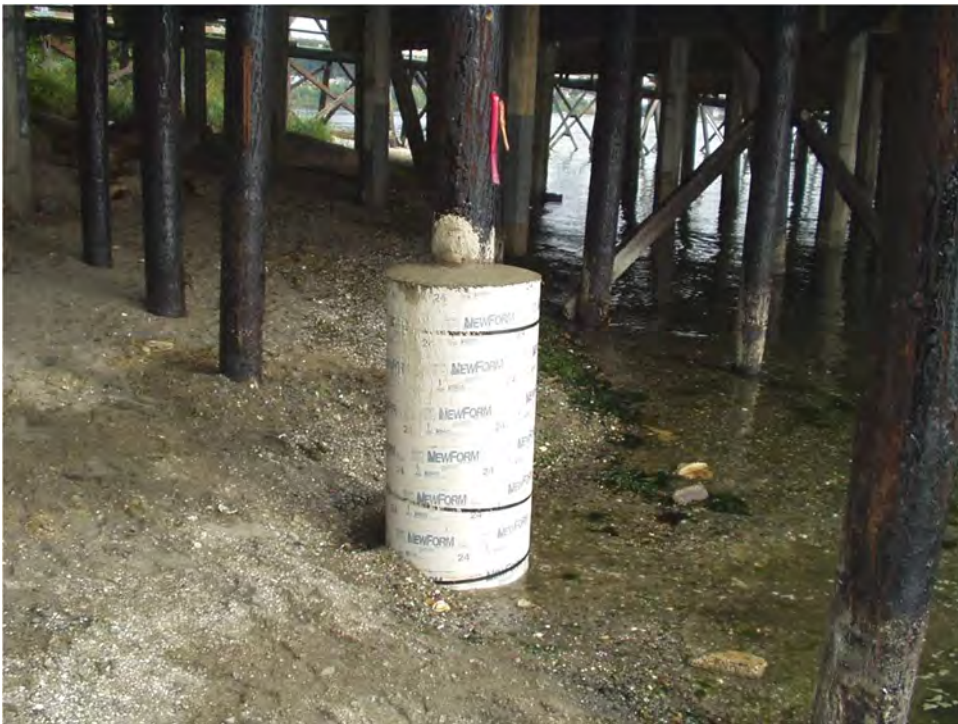
Figure 2-19
Completed Pile Encapsulation

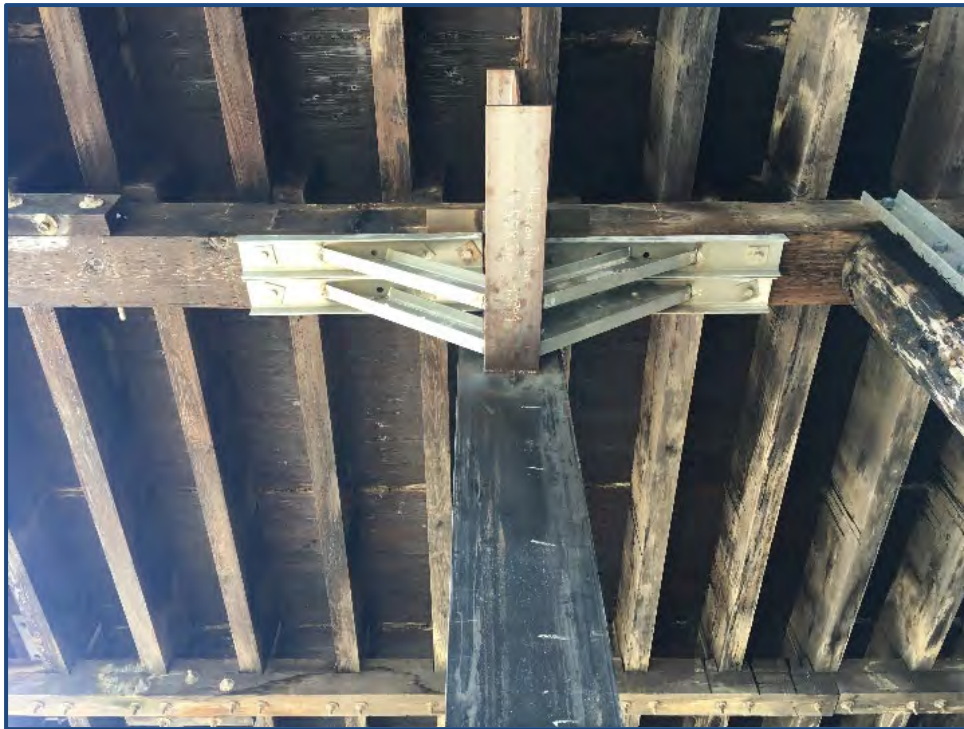
Figure 2-20
Completed H-Pile

In some cases where a timber pile is failing, it may be very difficult to remove and directly replace that pile (e.g. under a trestle with many piles close together). In this case, repair will occur by driving an H-pile through the deck of the trestle, in the approximate location of the failing timber pile. A cap will then be placed over the H-pile and timber pile, effectively connecting the two and providing support for the structure (Figure 2-20).

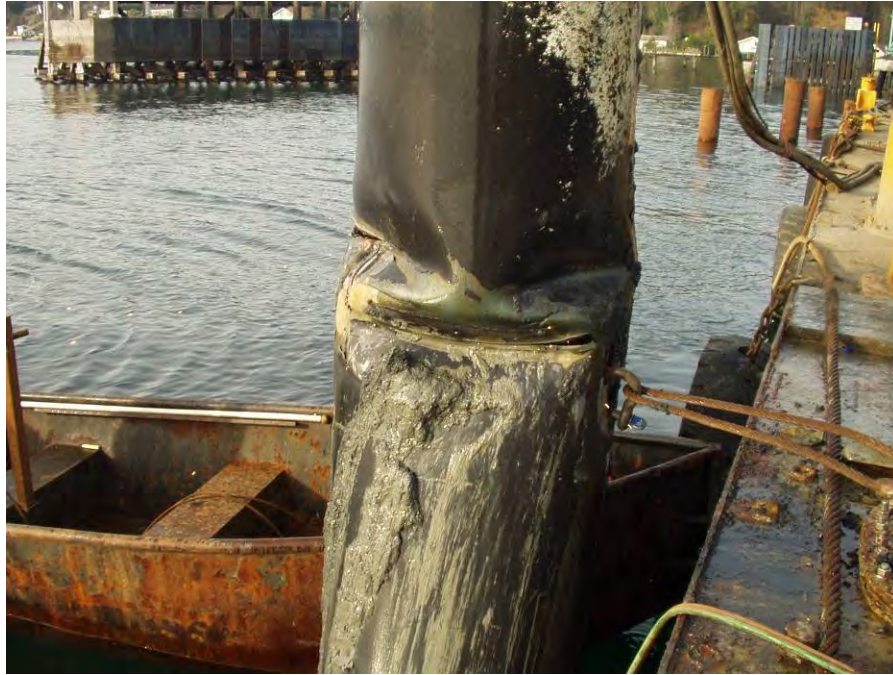
Figure 2-21
Bent Steel Pile in Need of Repair

because the vibratory hammer may break the pile during removal. In this rare case, the pile will be cut off at the mudline and abandoned. The approximate location of the abandoned pile can be documented in as-built drawings.

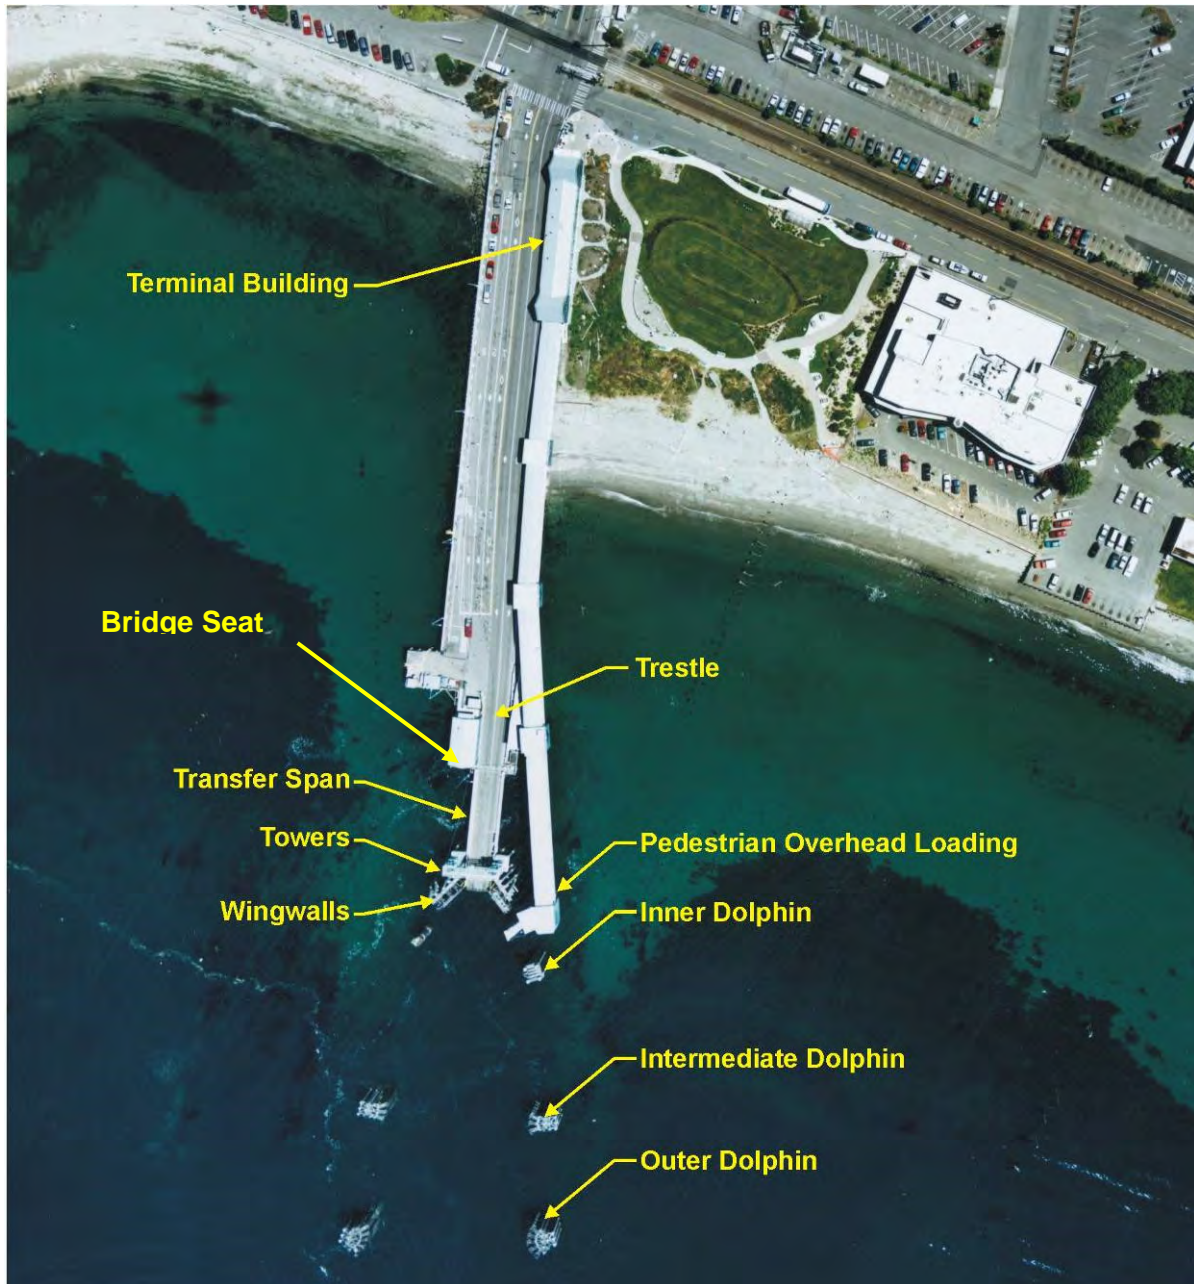
Figure 2-23
Typical Ferry Terminal, Aerial View

The components of a typical ferry terminal, from offshore to onshore, include dolphins, wingwalls, towers and headframe, transfer span with apron, bridge seat, trestle, pedestrian overhead loading, and bulkhead and terminal building (Figures 2-23 and 2-24).

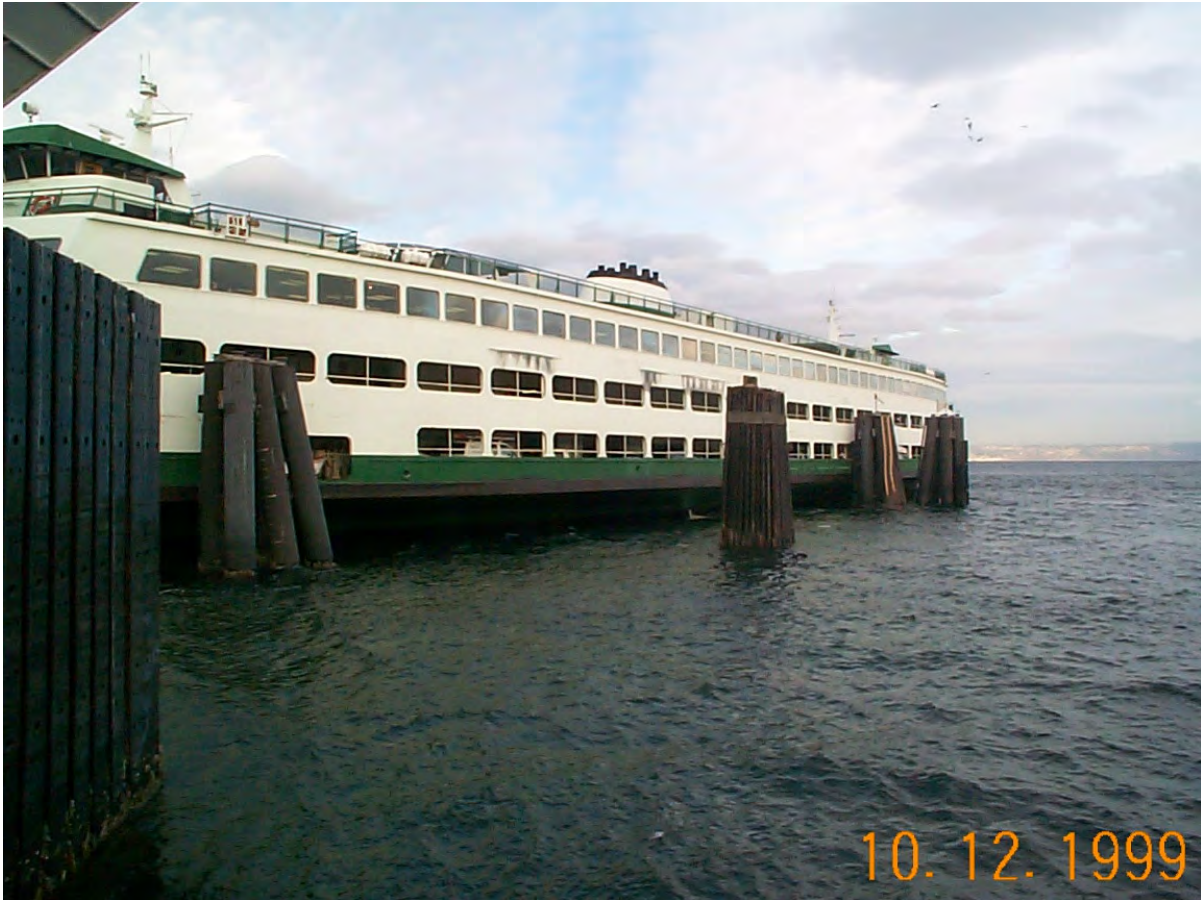
Dolphins are structures located offshore used to guide the ferry into the terminal and hold it in place while docked or berthed (Figure 2-25). Ferry captains use the dolphins to deflect misaligned vessels back into position during arrival and departure. Newly constructed dolphins have a life expectancy of 50 years. Existing timber dolphins have a life expectancy of 25 to 30 years.

Figure 2-25
Vessel in Berth Using Dolphins to Maintain Position

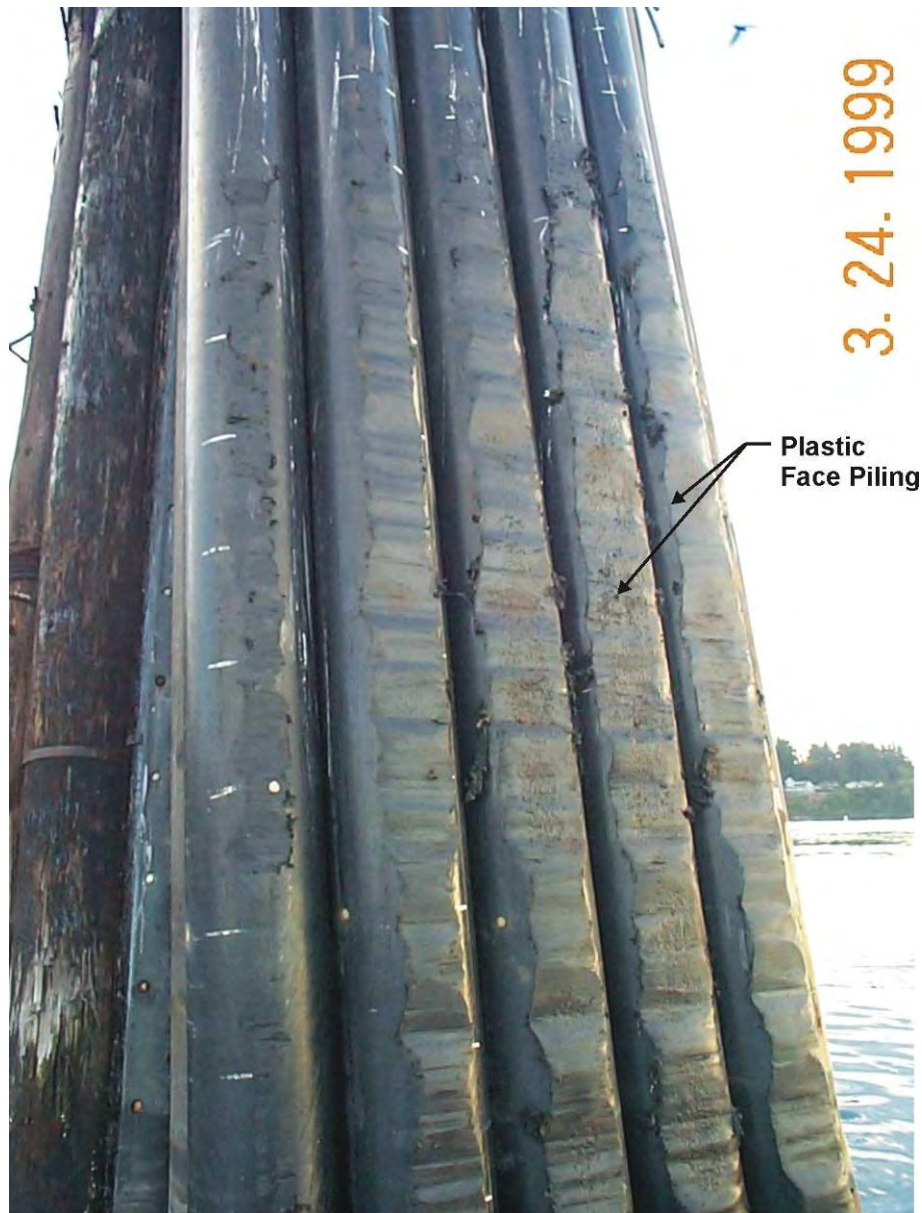
Figure 2-27
Plastic Face Piling on a Fixed Timber Dolphin

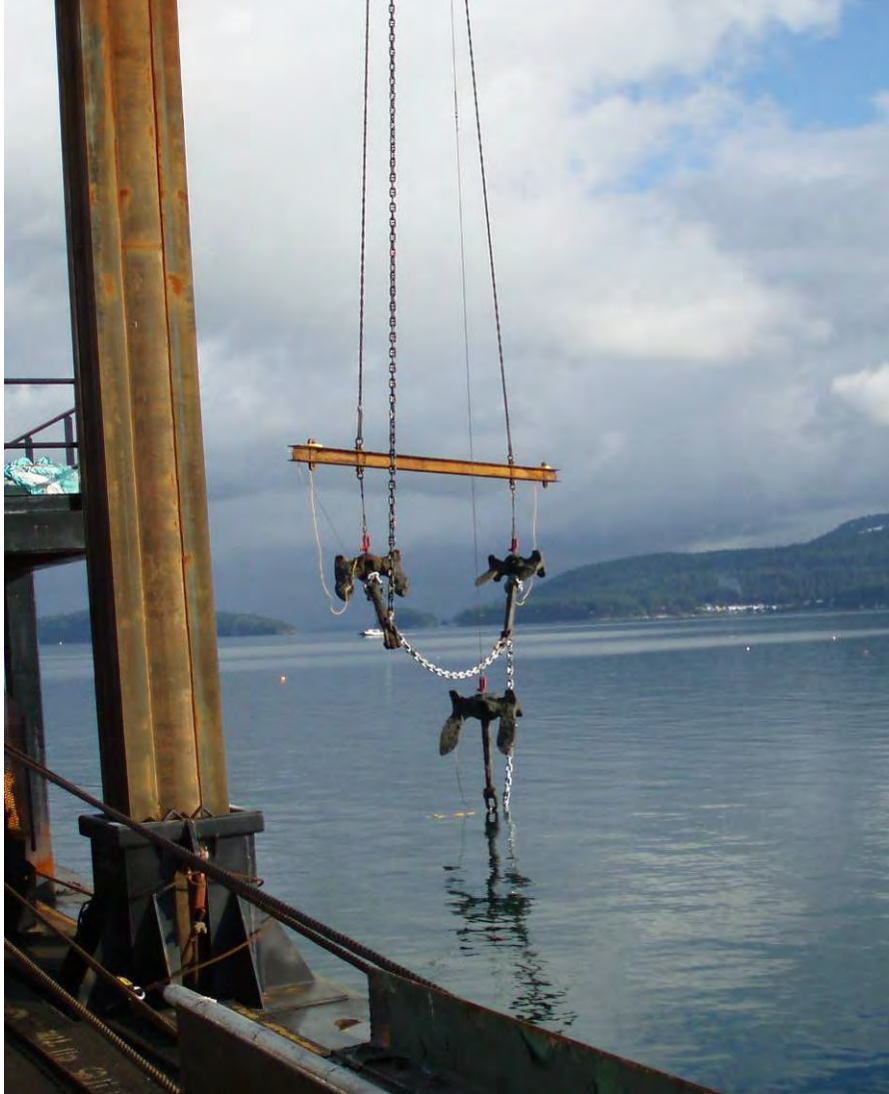
Anchors are installed by lowering them to the seafloor, from a workboat or tug, and dragging them until the anchor fluke penetrates the seafloor and develops the required holding capacity. The drag distance is a function of the soil type, factors of safety, and the length of the anchor fluke, and it may take one or two runs to set each anchor (see Figure 2-29).

Figure 2-29
Installation of Floating Dolphin Anchors

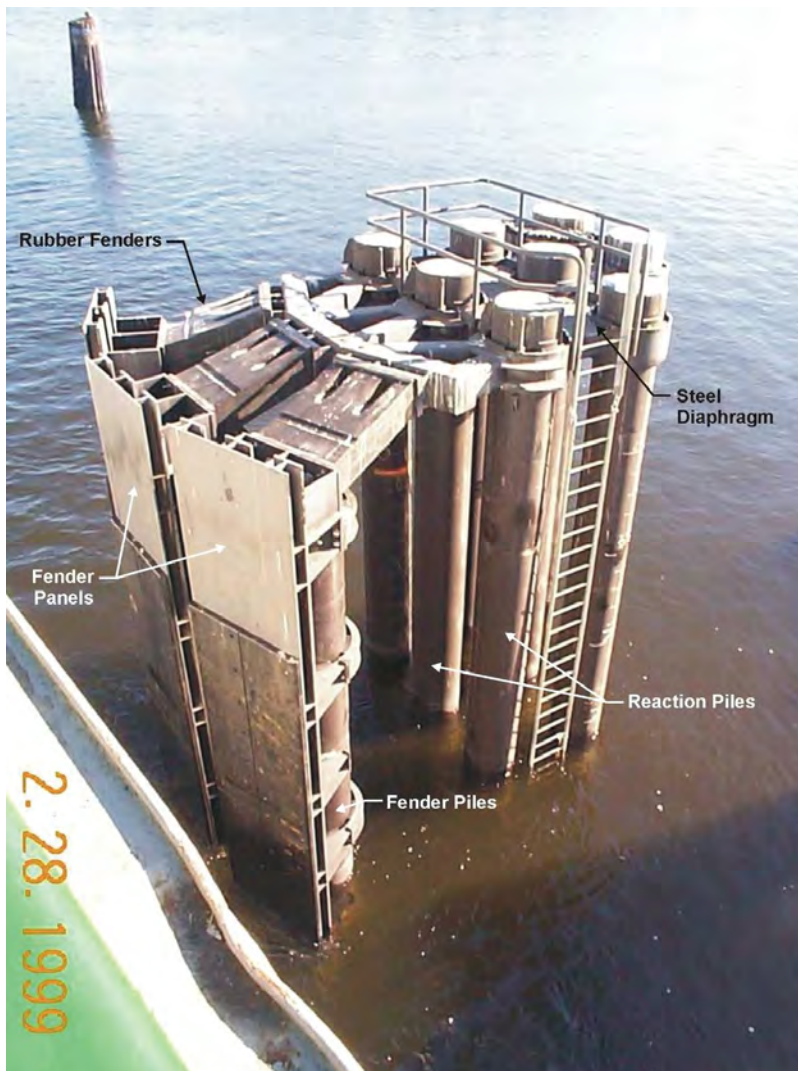
The size of steel dolphins varies with their distance from shore, depth, location, intended energy demand, and class of vessel service provided. Figure 2-31 shows a typical steel dolphin design. Outer dolphins are subject to the greatest demands, and typically contain up to 15 to 25 steel piling, although double-sided dolphins (serving two slips) contain about 30 piling (Figure 2-32). Intermediate dolphins typically contain about 12 to 15 piling, and inner dolphins generally contain about seven to 10 piling.

Though there are varieties of steel dolphin configurations in use, the materials and general design have evolved into the structure shown in Figures 2-31 and 2-32.

Figure 2-31
Typical Steel Dolphin

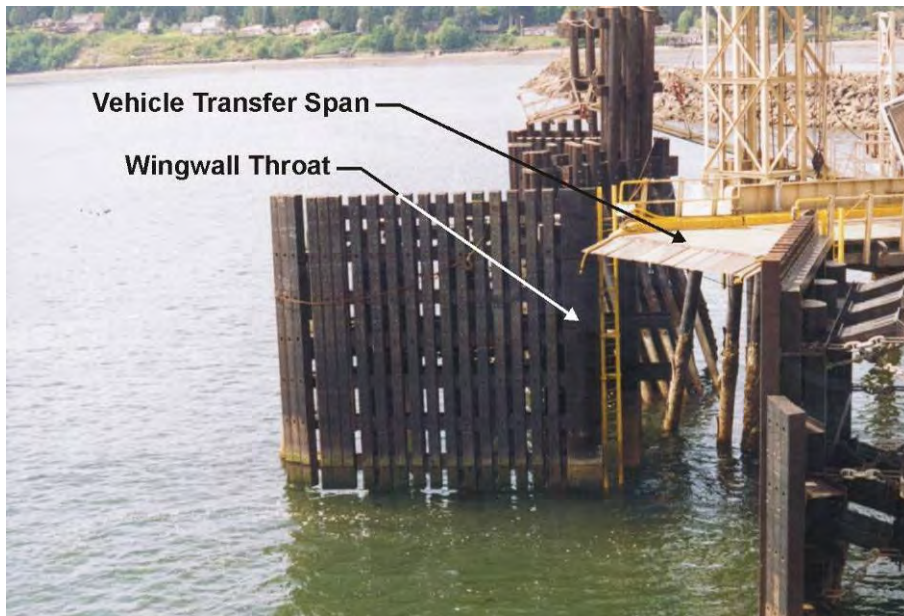
Figure 2-34
Wingwall Face

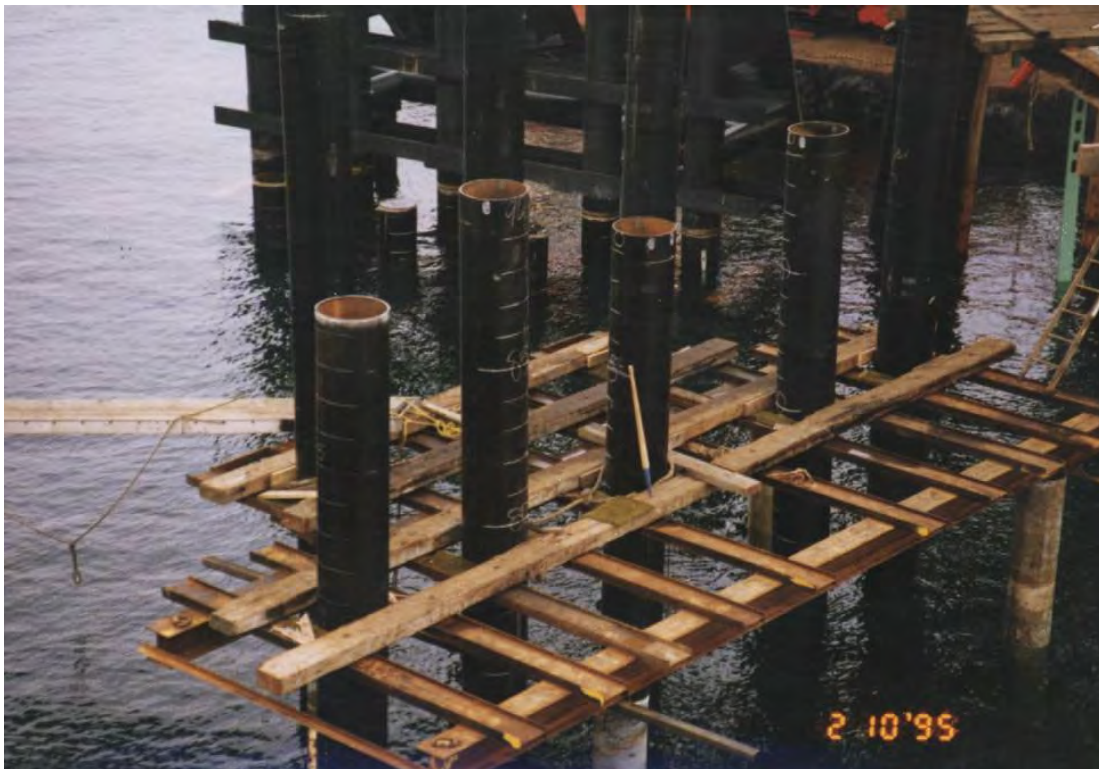
Figure 2-36
Template Used During Steel Wingwall Installation

Each replacement steel wingwall is installed by driving steel piling to the required depth, then cutting it off at the desired length. To ensure that the piling are installed in the correct position, a temporary template is often used to guide the piling into place (Figure 2-36).
