BIOLOGICAL ASSESSMENT REFERENCE

WASHINGTON STATE FERRIES CAPITAL, REPAIR, AND MAINTENANCE PROJECTS

May 2022

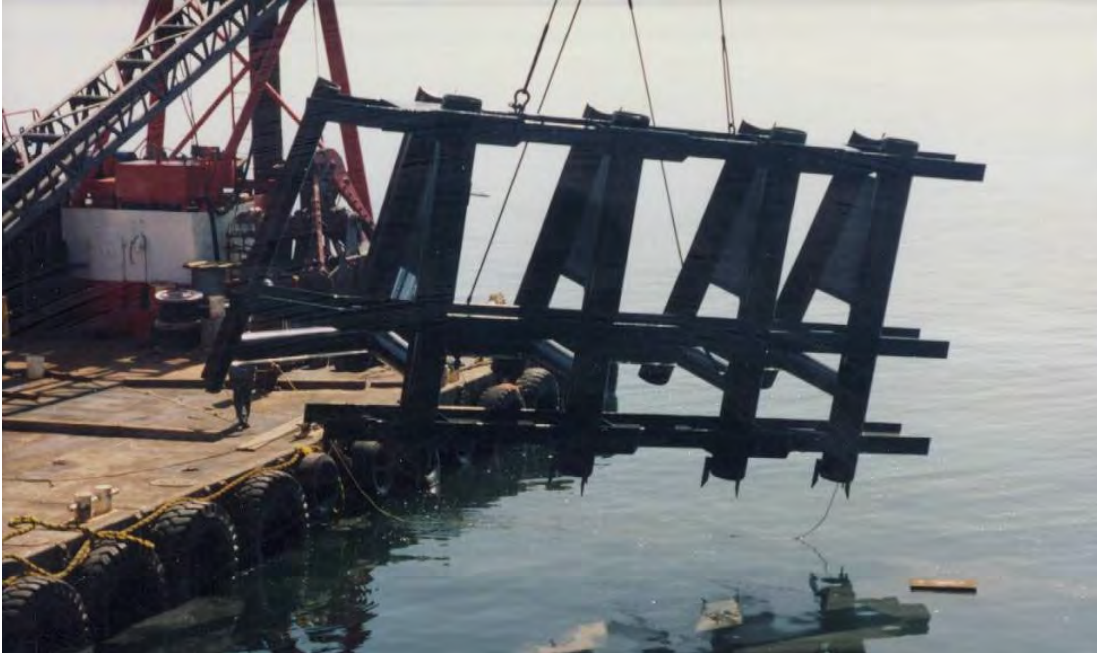
Figure 2-37
Crane Installing Steel Wingwall Frame

conducted while the slip is in operation. Once the piling are driven through the template, a prefabricated wingwall frame is set on top of the piling and fastened (Figure 2-37).

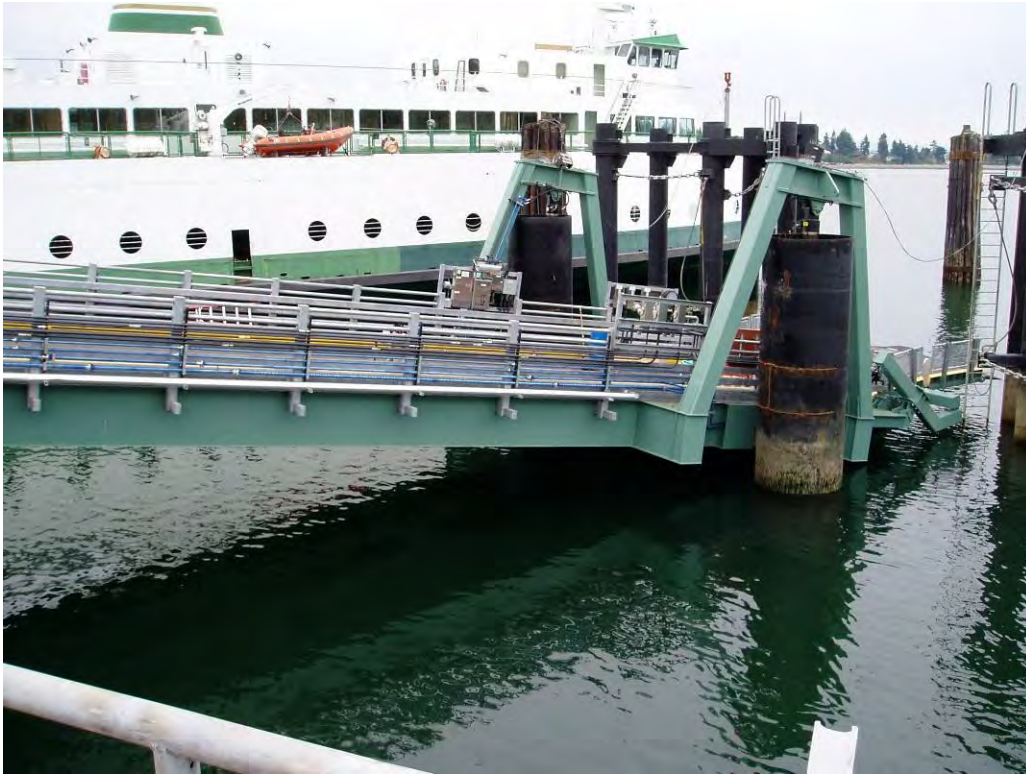
WSF is currently installing an alternate tower design as a new standard for all WSF facilities. The design is a system called an H-span, which uses hydraulic cylinders to move the transfer span up and down instead of the existing system of cables and counterweights (Figure 2-38).

Figure 2-38
Compression Cylinder Tower System

The hydraulic system (H-span) uses compression to raise and lower the transfer span. The cylinder hydraulic tower structure is primarily composed of two 5- to 6-foot-diameter steel casings mounted on a concrete plug installed with the drilled shaft method (see Section 2.1.1.6). Figure 2-38 shows a compression cylinder tower system.

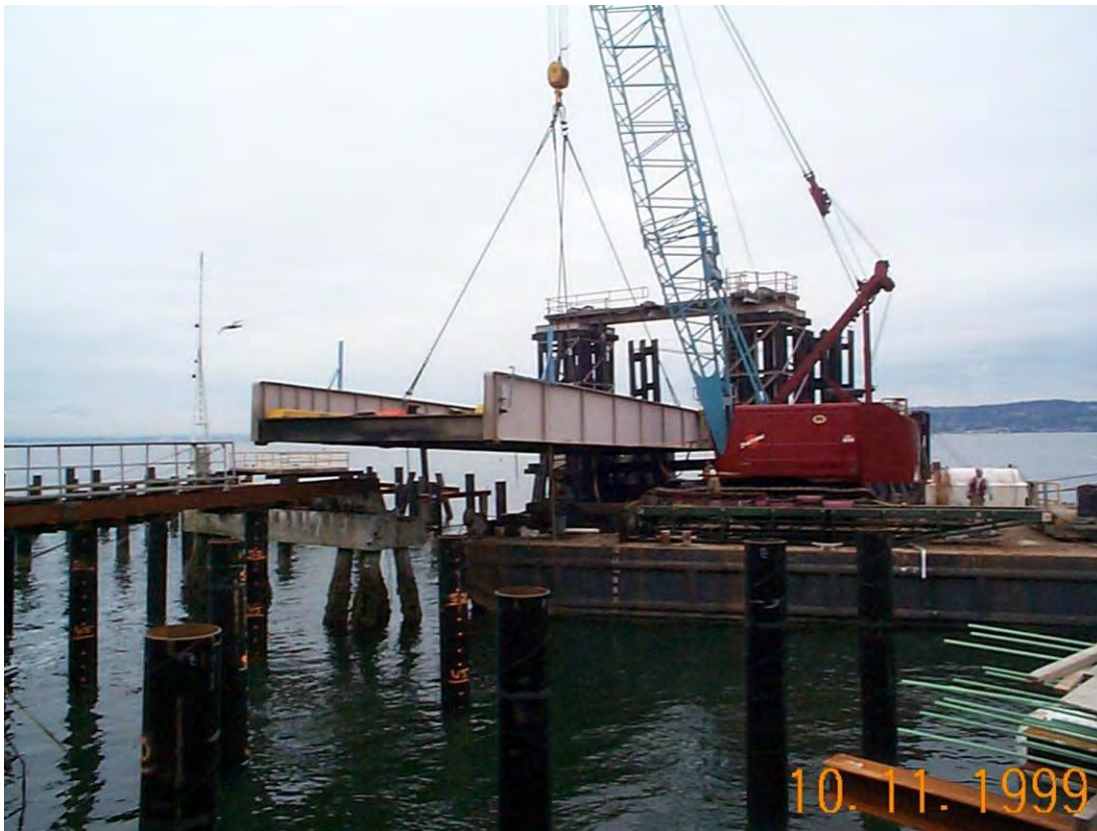
Figure 2-39
Removal of a Transfer Span

The transfer span and apron occur above mean higher high water (MHHW), but repair and replacement work typically occurs from a derrick on the water. The transfer span and apron are unsupported structures spanning between the bridge seat and the tower structures. The transfer span and apron are typically lifted off the supporting structures with a derrick and removed from the site (see Figure 2-39).

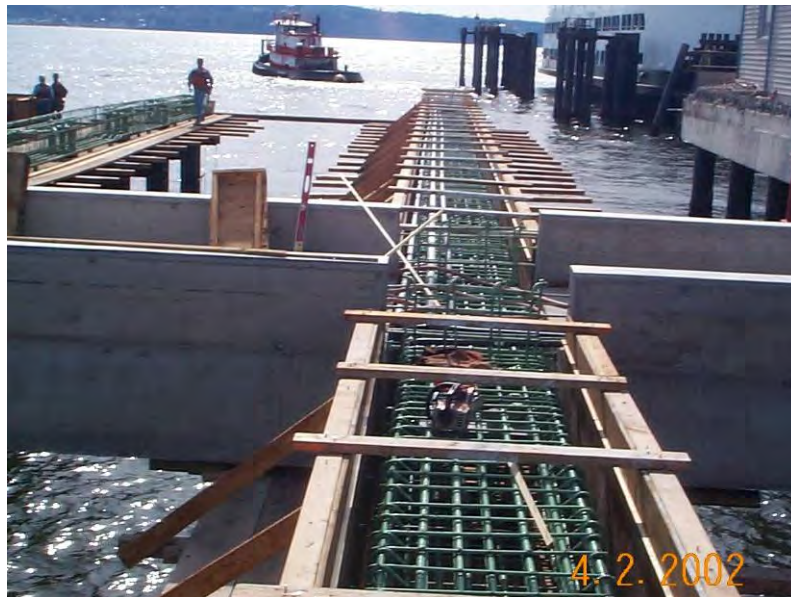
Figure 2-41
Forms Used for a Cast-in-place Concrete Pile Cap

Bridge seat piling can be repaired in several ways, depending on the severity of damage to the structure. The structure can be supported by driving additional piling beneath or next to the structure to stabilize it. Most bridge seats can be supported with as few as two to four additional steel piles. However, in rare cases where access is difficult or impossible, up to eight additional steel piles may be required to support a bridge seat. A more complex repair involves detaching the entire transfer span and removing it from the site, and removing the old piling and driving new piling. A cast-in-place or pre-cast concrete cap is installed to connect the steel piling. Cast in place structures require the use of forms to contain the concrete until it cures. Forms are sealed with rubber or foam to ensure no uncured concrete escapes (Figure 2-41).

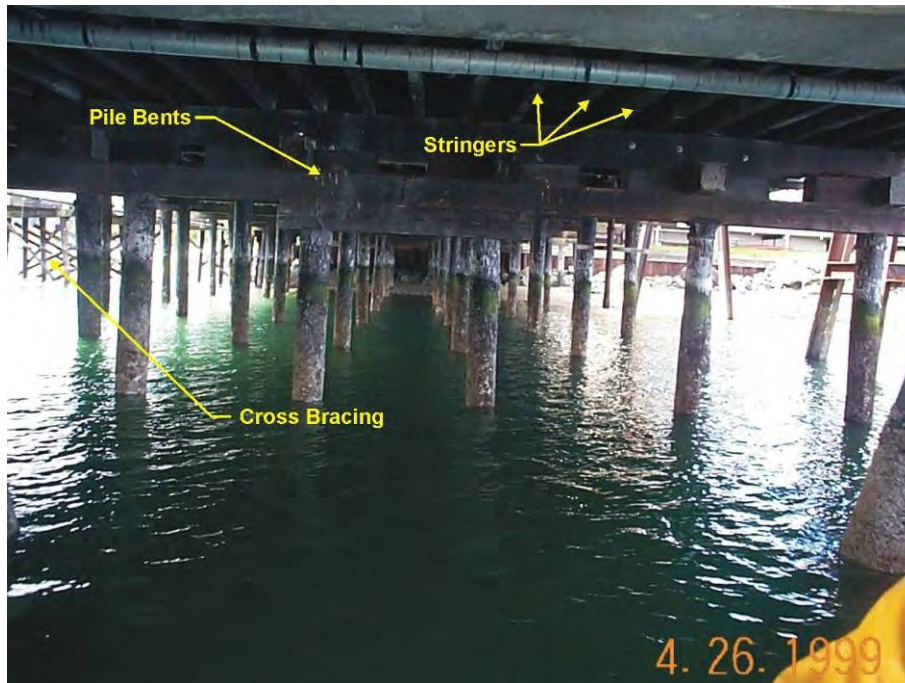
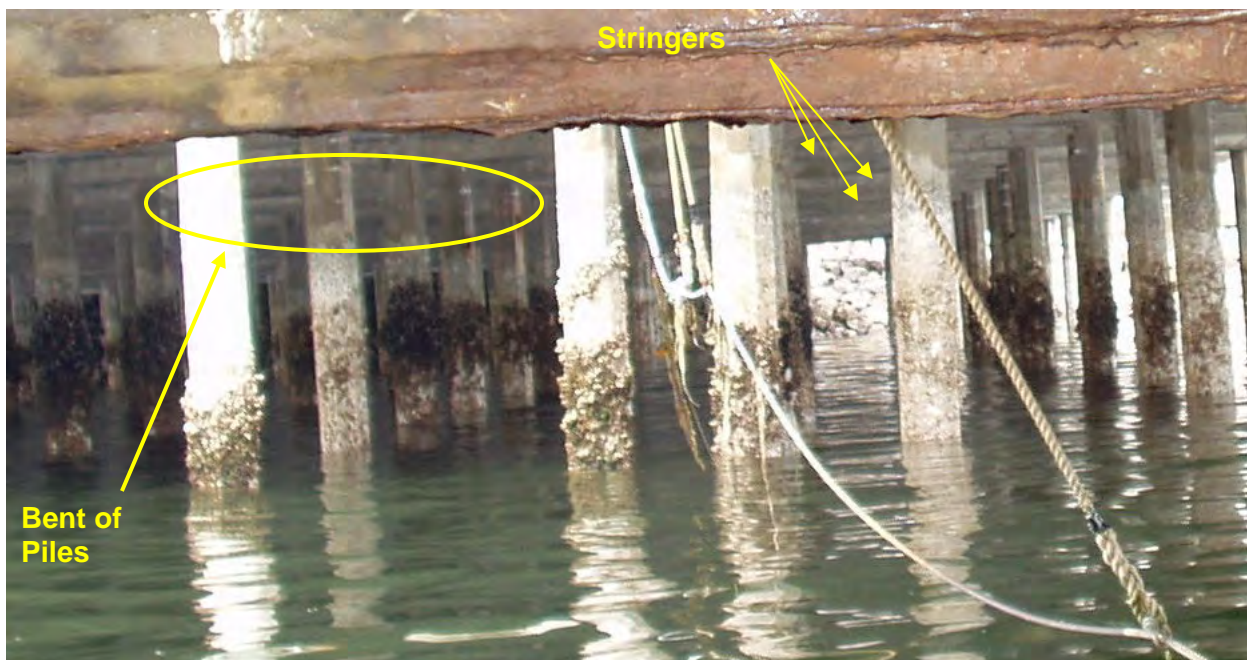
Figure 2-42
Under a Timber and Concrete Trestle

The trestle is constructed of a series of rows of piling that, when connected by a common cap, are called "bents" (see Figure 2-42). The bents provide support for the vertical load. The term "bent" includes the pile cap and all the piles that support it. Timber trestles are supported by the cross-bracing installed between the bents or by batter piling (Figure 2-42). The distance between the bents (and therefore the total number of piling required for the trestle) is determined by the load that the structure is expected to support, and the pile and pile cap capacity. The bents are linked at the top by stringers running from cap to cap for the length of the trestle. Older stringers are generally creosote-treated wood, and newer trestles are built with reinforced concrete stringers (Figure 2-42). The stringers are topped with one of a variety of decking materials; the decking is typically covered with asphalt.

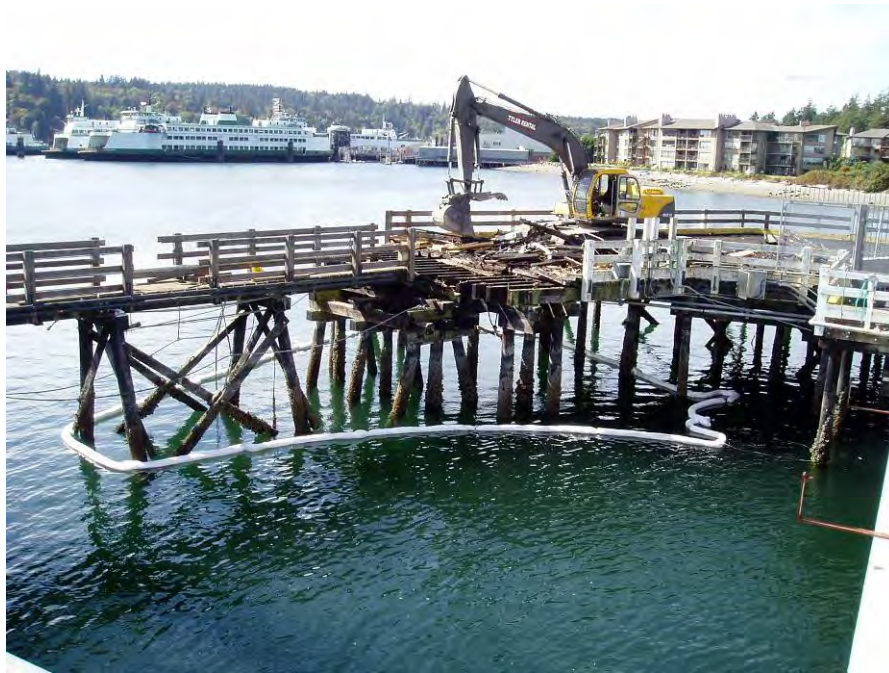
Figure 2-43
Removal of Timber Decking

Eventually timber trestles deteriorate to such a point that they can no longer be repaired and must be replaced. Trestle replacement starts with demolition of the old trestle including removal of the decking and old piles. This can be done from a derrick or sometimes with machinery working directly on the trestle or on shore (Figure 2-43).

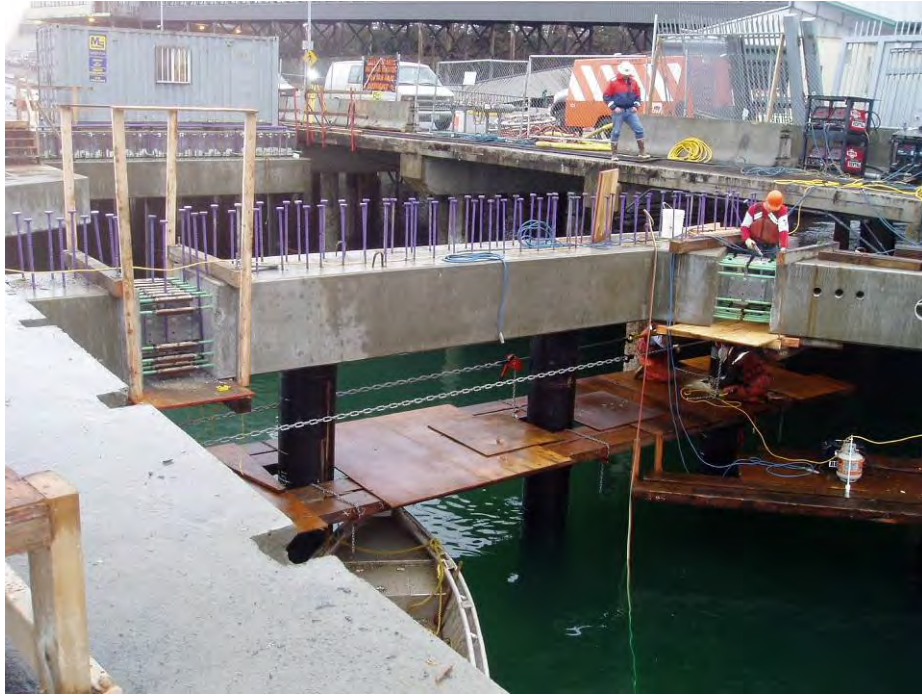
Old decking and piles are stored on a barge or in a truck and disposed of off site. Once demolition is complete, new piles are installed using the methods described in Section 2.1.1.2. The new piles are then fitted with concrete caps (Figure 2-44).

Figure 2-44
Concrete Pile Cap

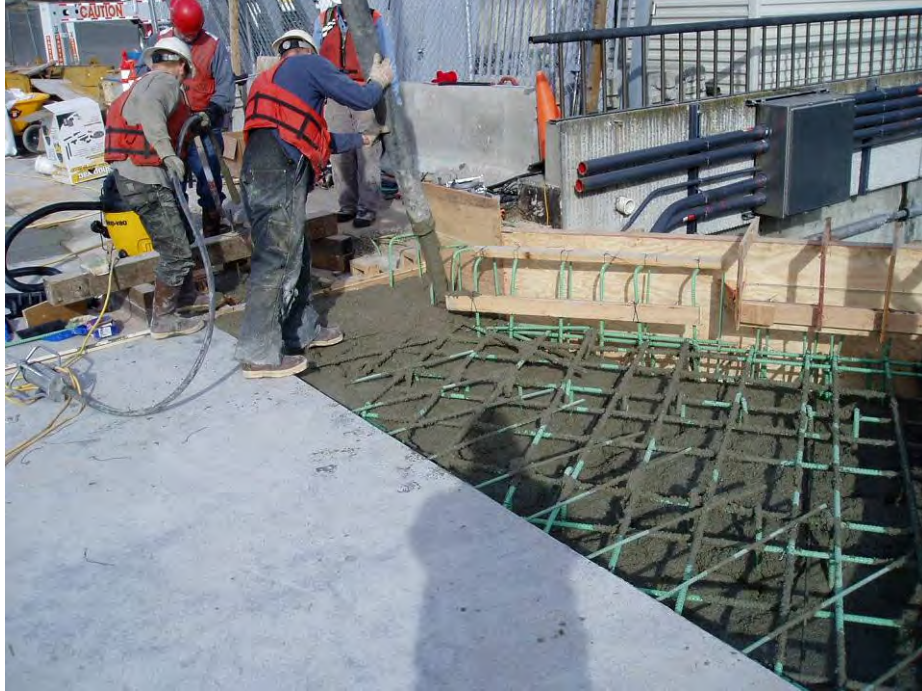
Deck panels are placed on top of the caps once the caps have cured. The concrete caps and deck panels may be cast in place (Figure 2-45) or pre cast (Figure 2-46).

Figure 2-45
Pouring Concrete for Cast-in-place Deck Panels

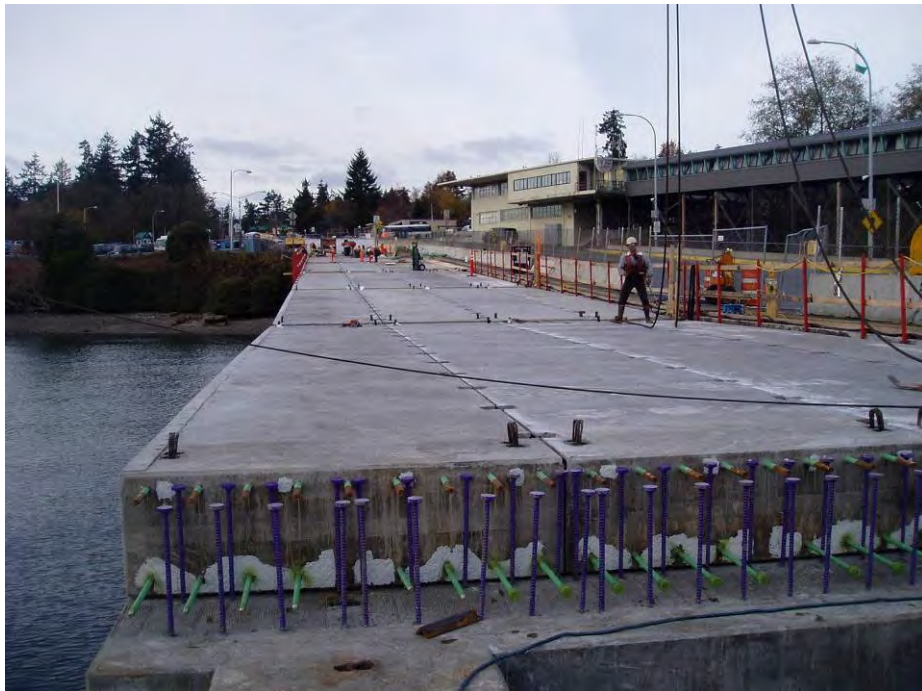
Figure 2-46
Pre-cast Concrete Deck Panels

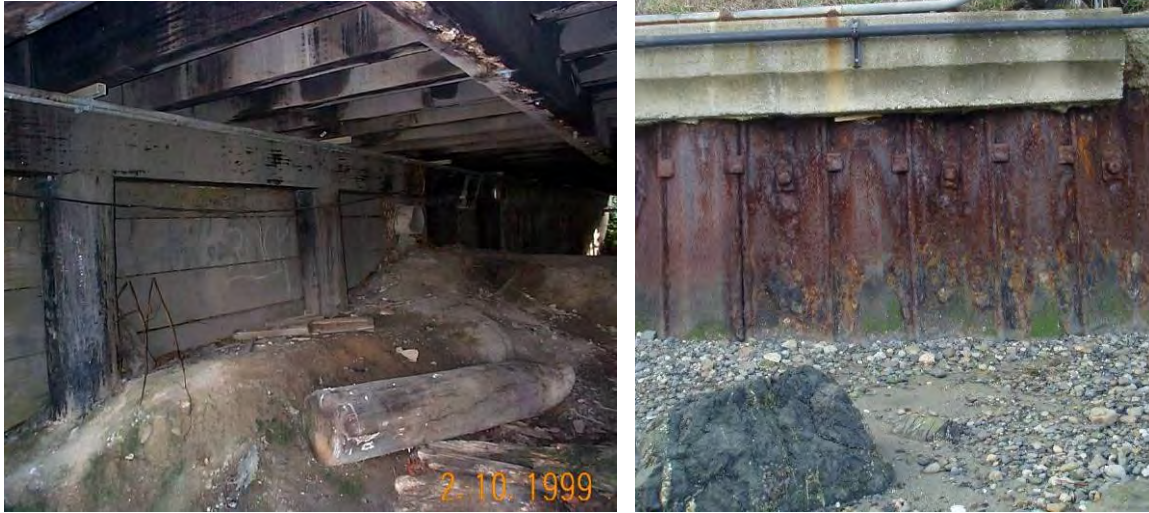
Figure 2-49
Timber and Steel Bulkheads

Bulkheads are designed in a number of ways. Bulkheads commonly consist of sheet piling driven into the ground or H-beam piling driven into the ground with either timber or pre-cast concrete in between the piling, riprap, or lagging (horizontal timber members in between vertical supports) (Figure 2-49). Large bulkheads or those constructed in poor soil conditions may require installation of piles or small diameter (36-inch) drilled shafts. Some bulkheads require support components, referred to as tie-backs, which extend shoreward from the bulkhead to provide additional support to the structure. Construction of concrete bulkheads usually requires trenching to install either pre-cast concrete panels (constructed off site and brought in for installation) or cast-in-place concrete lagging (concrete poured on site). To prevent erosion, riprap has been installed in front of many WSF bulkheads.

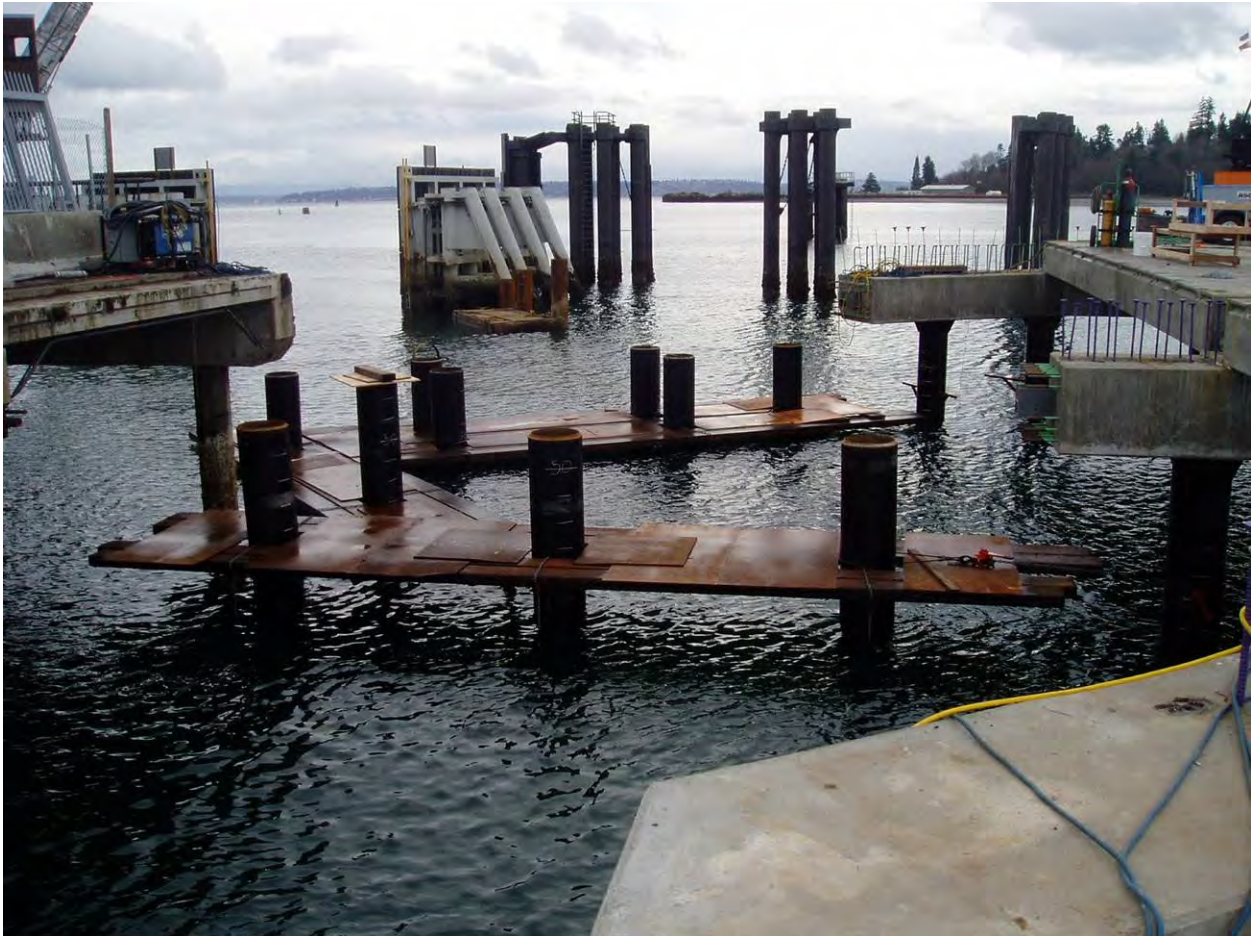
Figure 2-50
Temporary Work Platform

The installation of work platforms often requires placement of temporary piles for support (Figure 2-51).

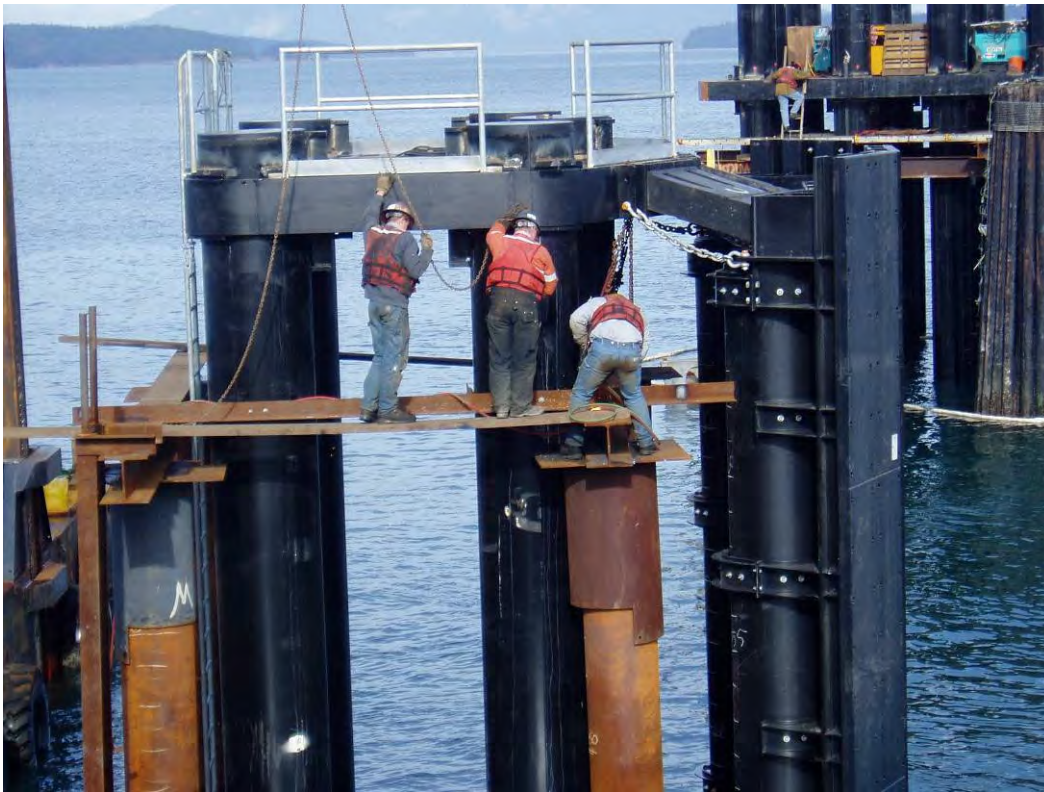
Figure 2-51
Work Platform Supported by Temporary Steel Piles

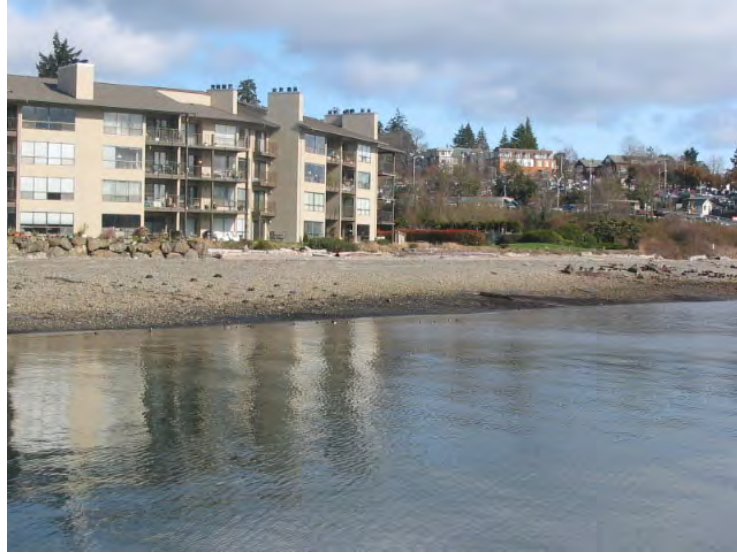
Figure EH-3
Shoreline Area East of the Eagle Harbor Maintenance Facility

Substrate beneath the facility is sandy silt, gravel, and shell. Propeller scour has removed most fine material leaving coarse sand, gravel, and shell debris. The depth/slope in the area is relatively flat with shallow depths (especially in the western portion of the harbor) and shoaling near the outlet to Puget Sound on the east side of the harbor. Offshore depths of maintenance facility structures are: head of Pier 1 (-35.8 feet MLLW), Pier 2 (-30.0 feet MLLW), and Slip E (-25.4 feet MLLW). Maximum depth for fixed dolphins is -37.0 feet MLLW.

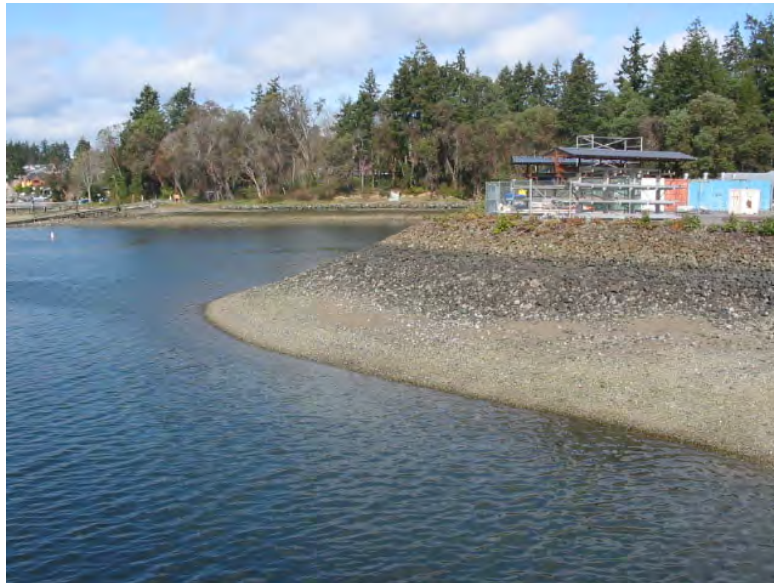
Figure EH-4
Shoreline Area West of the Eagle Harbor Maintenance Facility

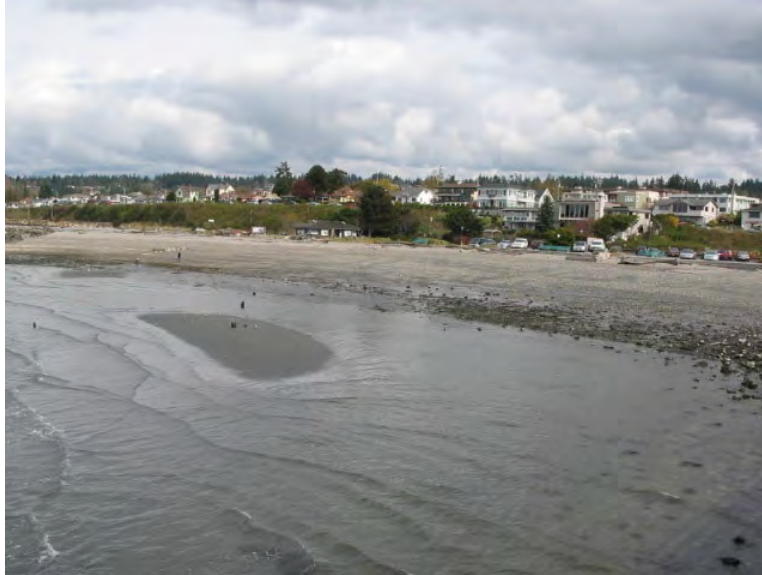
Figure ED-3
Shoreline Area East of the Edmonds Ferry Terminal

The shoreline is gently sloping low-bank beachfront (see Figures ED-3 and ED-4). Between -7 feet and -15 feet MLLW, substrate consists of 95 percent sand, 4 percent fines, and 0.4 percent gravel. At -25 feet MLLW, the substrate changes to 61 percent sand, 27.4 percent fines, and 11.6 percent gravel, with sand composition increasing to 91 percent at -40 feet MLLW. Offshore depths of terminal structures are: head of main slip (-36.5 feet MLLW). Maximum depth for fixed dolphins is -39.2 feet MLLW.

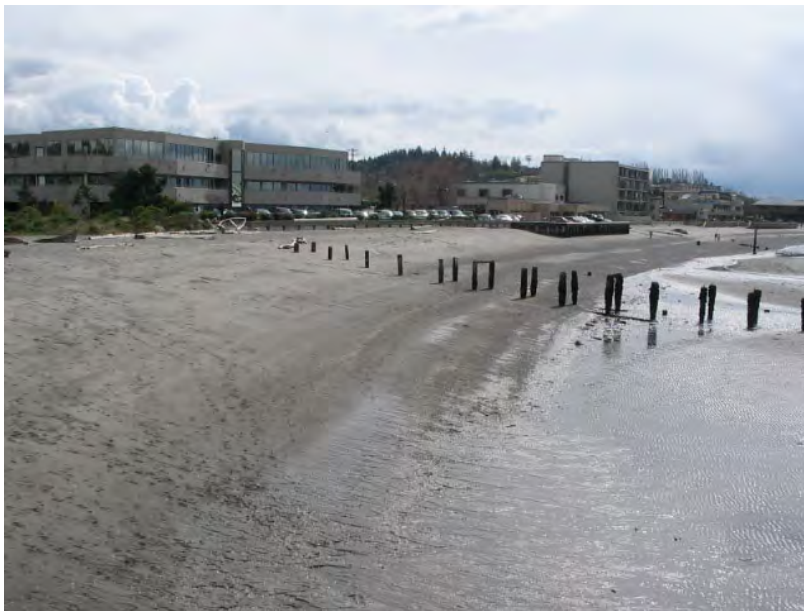
Figure ED-4
Shoreline Area West of the Edmonds Ferry Terminal

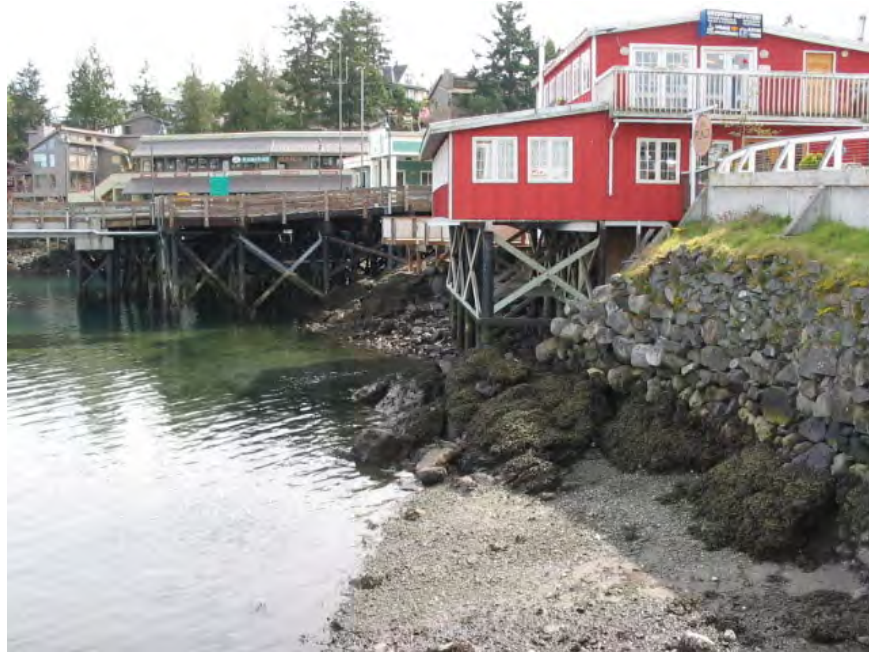
Figure FH-3
Shoreline Area on the Northwest Side of the Friday Harbor Ferry Terminal

Substrate conditions adjacent to the terminal are highly variable. Coarser grained sediments and gravel are more prevalent along the offshore areas of the facility and within the areas subject to operations. The shoreline is predominantly bedrock with some coarse sand and cobble (see Figures FH-3 and FH-4). Offshore depths of terminal structures are: head of main slip (-35.4 feet MLLW) and tie-up slip (-30.5 feet MLLW). Maximum depth for fixed dolphins is -46.5 feet MLLW.

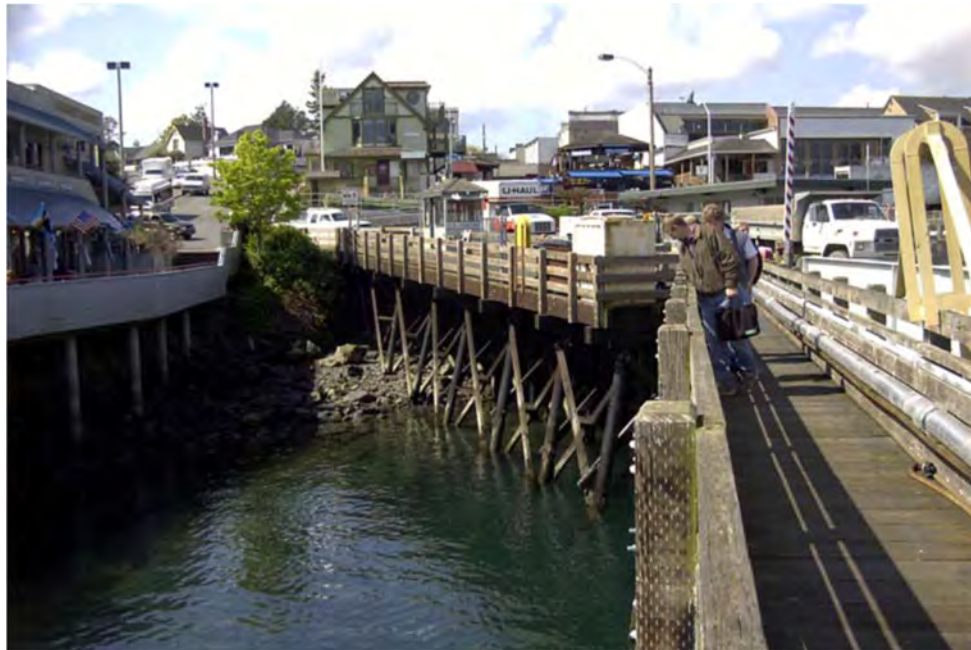
Figure FH-4
Shoreline Area on the Southeast Side of the Friday Harbor Ferry Terminal (the structure on the left houses private commercial businesses)

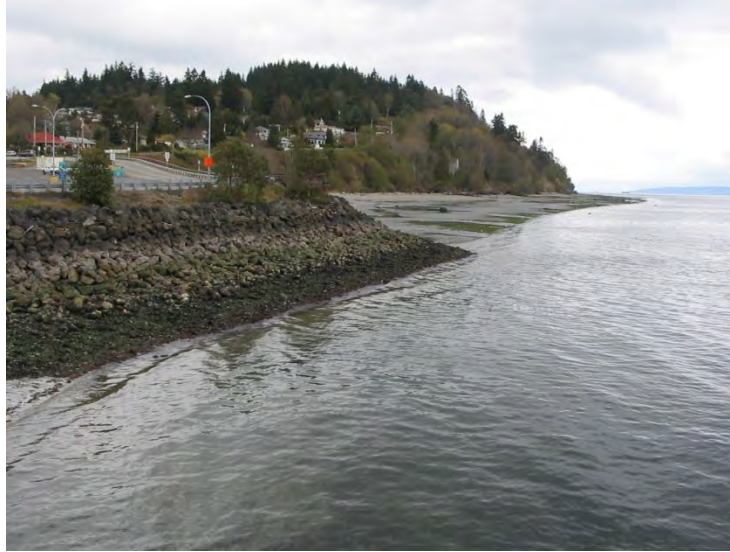
Figure KI-3
Shoreline Area North of the Kingston Ferry Terminal

The shoreline is heavily armored in the vicinity of the terminal (see Figures KI-3 and KI-4). Steep (2 horizontal to 1 vertical [2H:1V]) riprap slopes dominate from MHHW to about -8 feet MLLW. Beyond about -8 feet MLLW, there is a gentle slope to about -20 or -30 feet MLLW. Deeper intertidal and shallow subtidal substrates consist of gravel and sand, with occasional boulders. Offshore depths of terminal structures are: head of Slip 1 (-42.2 feet MLLW), Slip 2 (-33.5 feet MLLW), and tie-up slip (-26.0 feet MLLW). Maximum depth for fixed dolphins is -36.9 feet MLLW and for floating dolphins -35.7 feet MLLW.

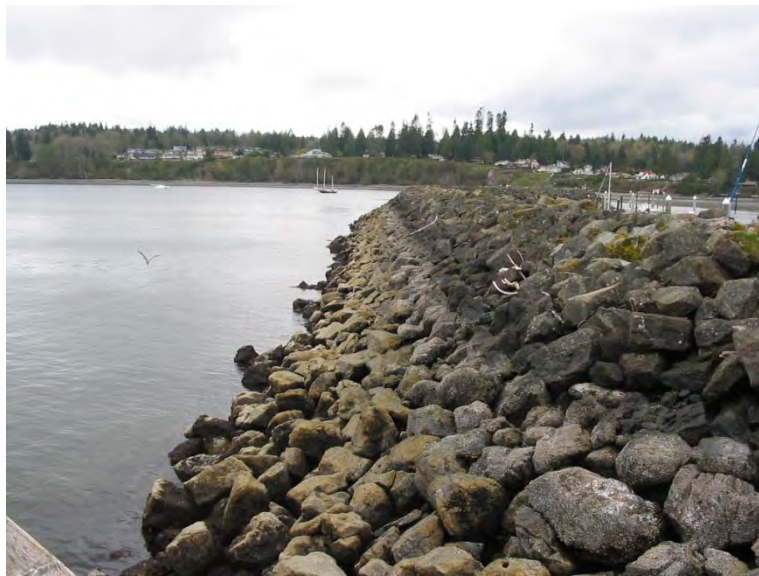
Figure KI-4
Shoreline Area South of the Kingston Ferry Terminal

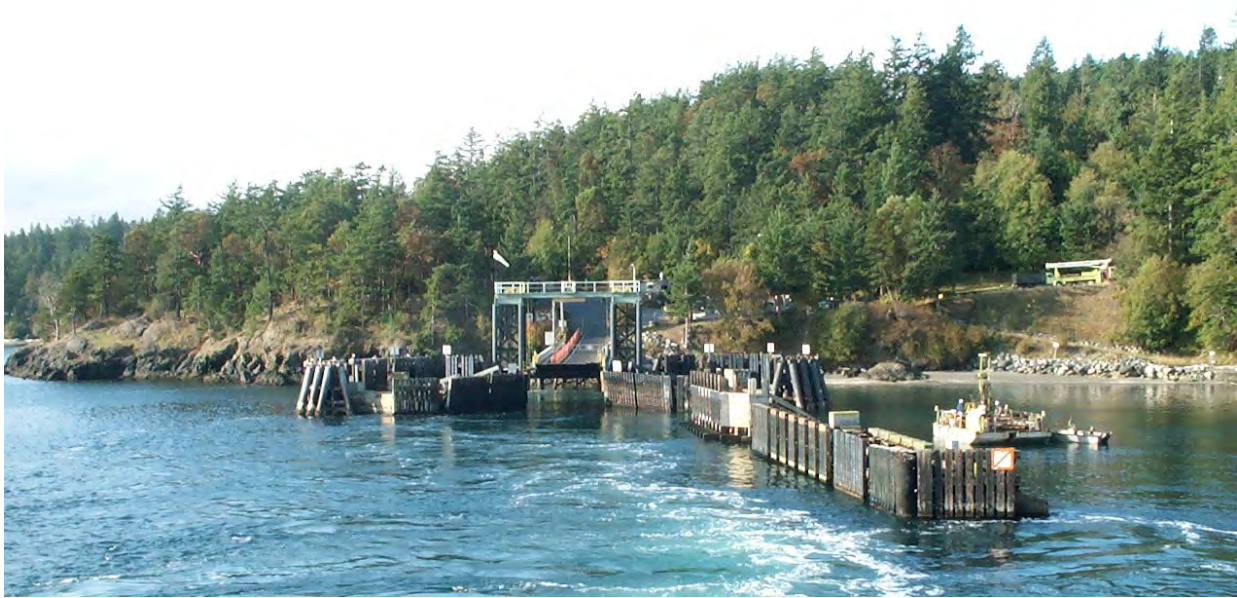
Figure LO-3
Shoreline Area at the Lopez Island Ferry Terminal

The substrate layer is thin and overlays a foundation of bedrock. Substrate consists of fine to coarse sand close to shore, giving way to mud overlying bare bedrock and boulders within the ferry slip. The bottom drops off quickly to deep water, with depths up to 90 feet at the outer dolphins. Offshore depths (feet MLLW) of terminal structures are: head of slip (-35.5). Maximum depth (feet MLLW) for fixed dolphins is -46.5 and for the floating dolphin -77.0. See Figure LO-3 for a picture of the shoreline area at the ferry terminal.

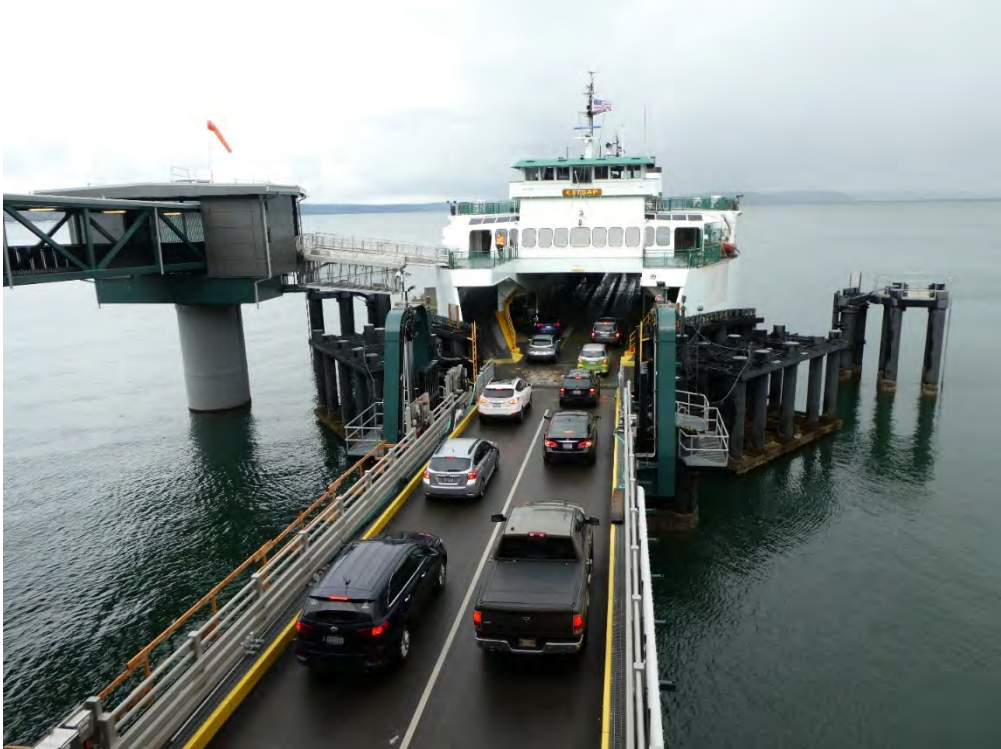
Figure MU-6 Hydraulic Transfer Span, Wingwalls, Fixed Dolphins, Overhead Loading

The terminal has one slip with a hydraulic transfer span, two steel wingwalls, and three dolphins: two fixed steel, and one floating concrete dolphin (Figures MU-6/7). The Mukilteo public fishing pier was relocated to the NE portion of the terminal shoreline (in far foreground of Figure MU-8).

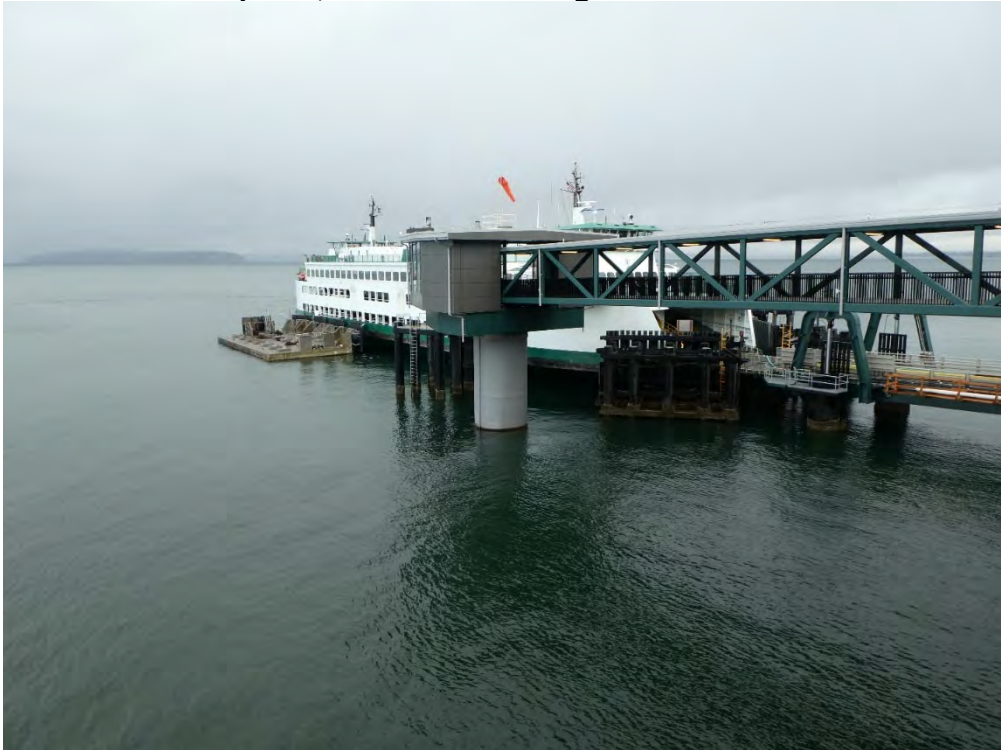
Figure MU-7 Hydraulic Transfer Span, Wingwall, Overhead Loading, Fixed Dolphin, Floating Dolphin

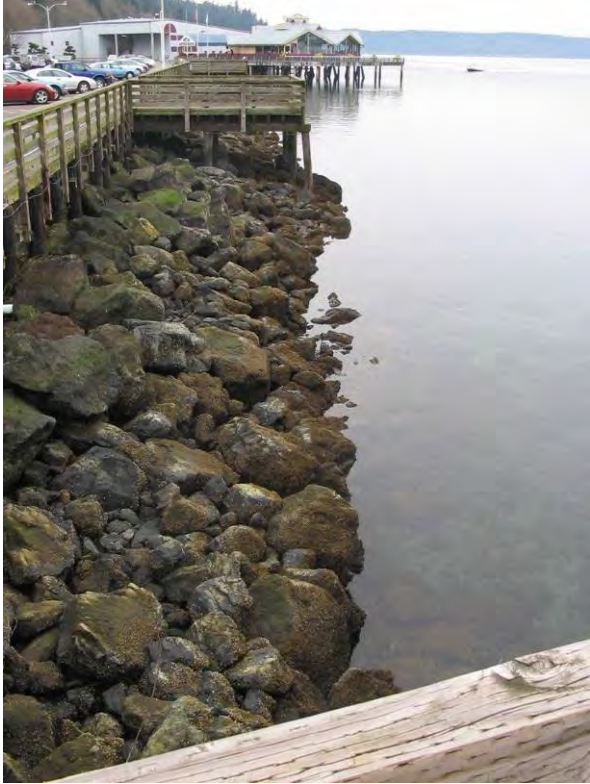
Figure PD-3
Shoreline South of the Point Defiance Ferry Terminal

The substrate is composed of medium dense silty fines to sand and gravel with riprap and bulkheads in the high intertidal. Based on aerial photographs, it appears that the aquatic bed slopes off steeply a short distance from the riprap bulkhead. Offshore depths of terminal structures are: head of slip (-18.5 feet MLLW). Maximum depth for fixed dolphin is -32.7 feet MLLW and for the floating dolphin -30.2 feet MLLW. See Figures PD-3 and PD-4 for pictures of the shoreline areas south and north of the ferry terminal.

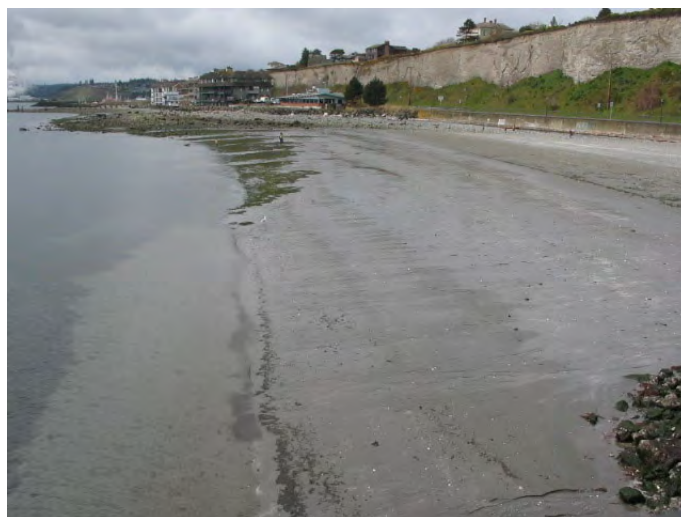
**Figure PT-4
Shoreline Area South of the Port Townsend Ferry
Terminal**

Substrate conditions in Port Townsend Bay are generally soft bottom types. The northern portion of the bay tends to be more coarse and the inner bay is more muddy. Littoral drift has an influence on the substrate character along shorelines. Within Port Townsend Bay, the pattern of littoral drift is north along the northwest shoreline, south along the southwest shoreline, and south along nearly the entire east shoreline of the bay. The drift cell along the city waterfront has been cut off from its feeder bluffs by fill and shoreline armoring.

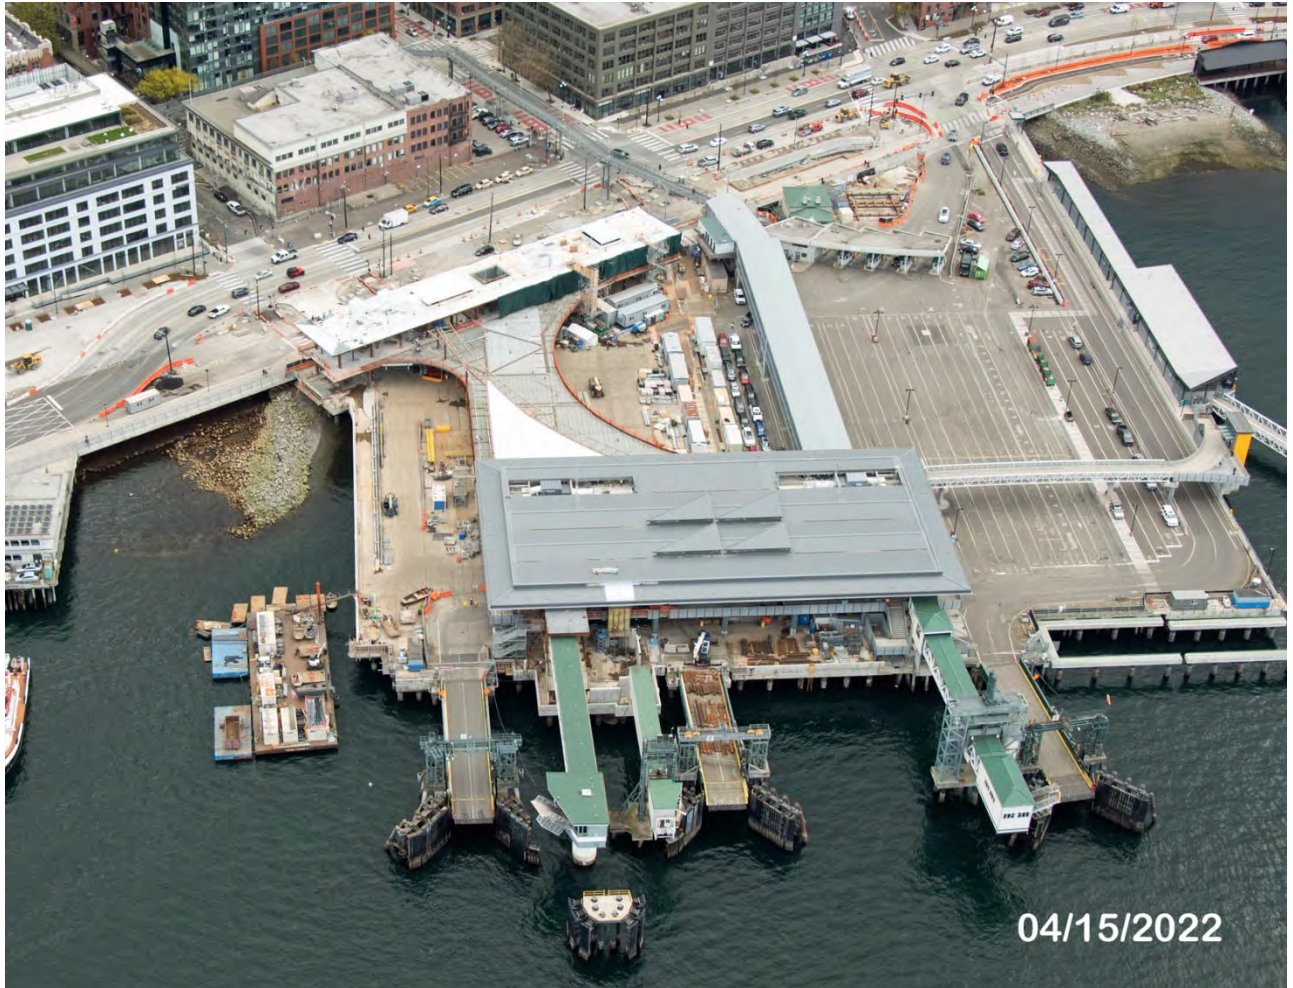
Figure SE-3
Shoreline Area at the Seattle Ferry Terminal

Much of the shoreline along the Seattle waterfront contains riprap and seawalls. Common shoreline features within the area include constructed bulkheads, with manmade structures such as piers, wharves, and buildings extending over the water, and steeply sloped banks armored with riprap or other fill materials (e.g., concrete slabs and miscellaneous debris). See Figures SE-3 for a view of shoreline areas near terminal. Newer features in the area include the Seattle seawall (that includes salmon passage and habitat structures), the Seattle habitat beach to the south of the terminal, and a habitat element of the project sediment cleanup to the north.

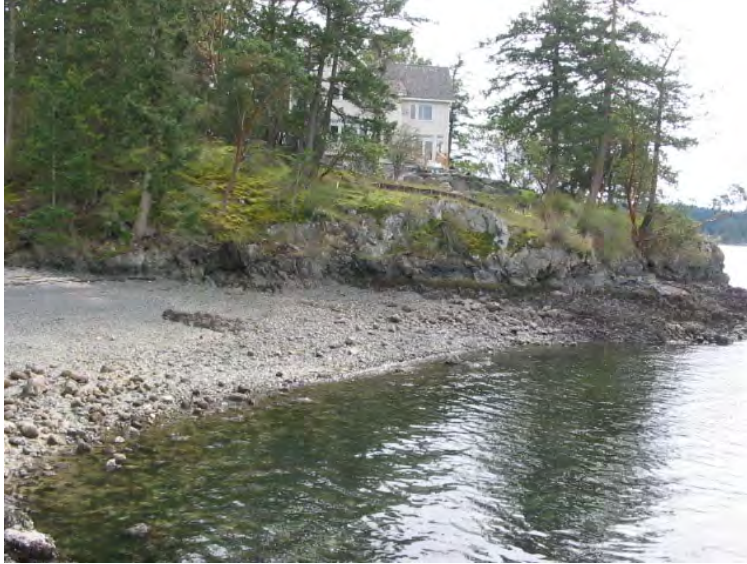
Figure SH-3
Shoreline Area West of the Shaw Island Ferry Terminal

With the exception of the Shaw Island Ferry Terminal, general store, chapel, music studio, and a private marina, the shoreline in the area is generally undeveloped. A small, gently sloping sandy beach exists to the southeast of the terminal, and another to the southwest. However, much of the shoreline area is steep and rocky (see Figures SH-3 and SH-4).

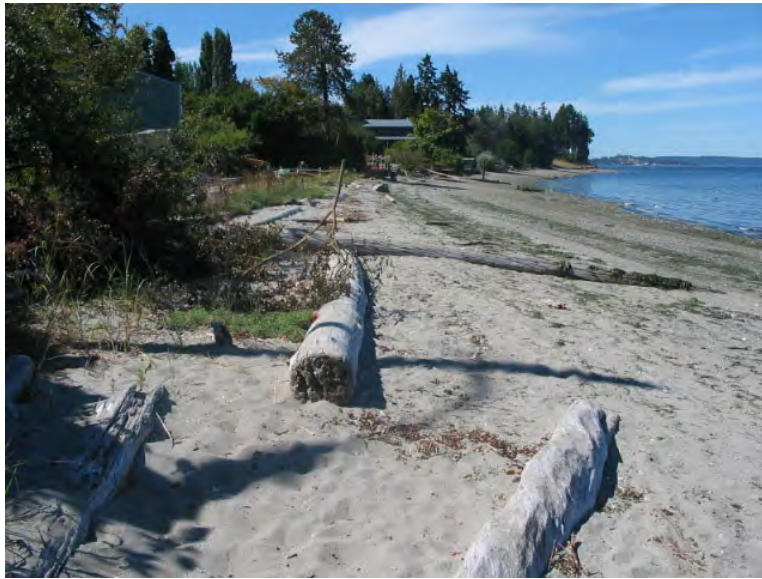
Figure SO-3
Beach and Intertidal Area North of the Southworth Ferry Terminal

Beach material to the south of the terminal is sand and clay; to the north is sand and cobble with sections of beach-stabilizing riprap or other constructed shore protection material (see Figures SO-3 and SO-4). Silt, sand, dense clay, and coarse sand are found in the intertidal and subtidal marine portions of the area.

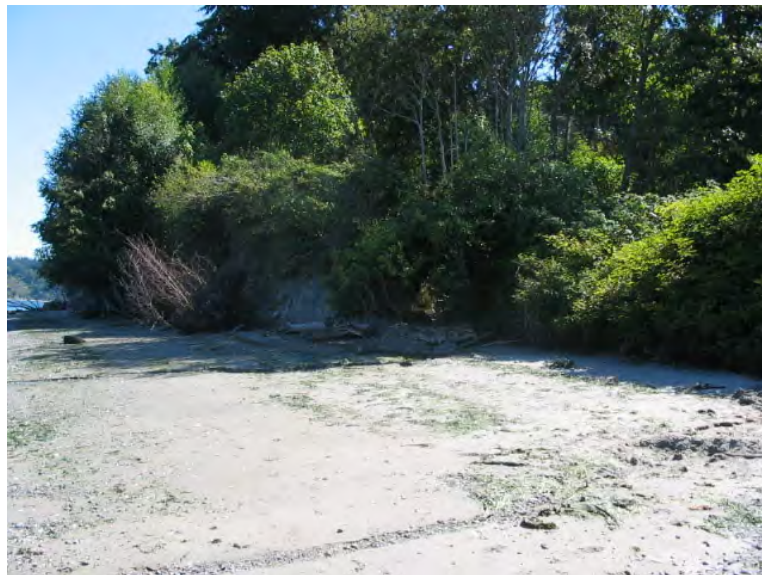
Figure SO-4
Beach and Bluff South of the Southworth Ferry Terminal

On the south side of the ferry terminal, there is a very steep bluff composed of clay and sands where sloughing is common (Figure SO-4). Erosion from the bluff ranges between 2 and 5 feet per year and is a significant source of sediments to the beach.

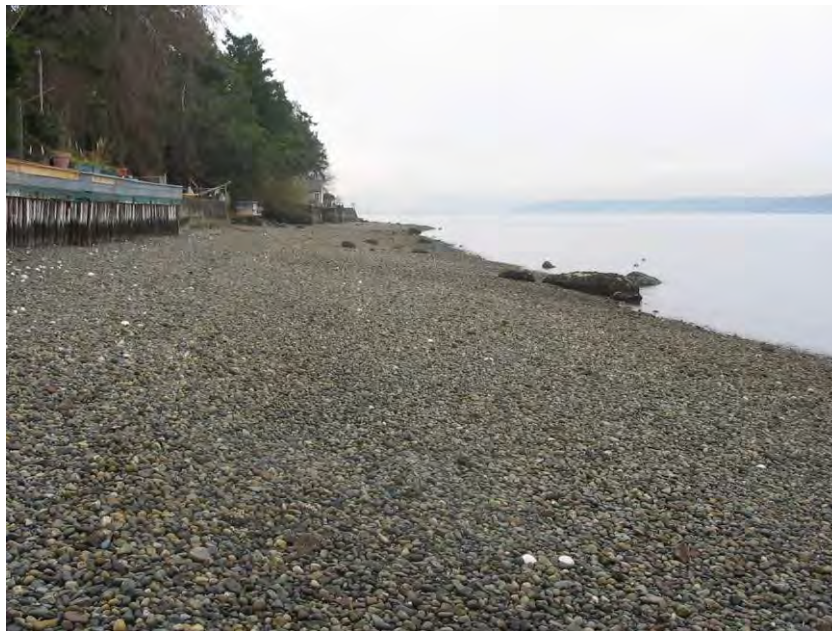
Figure TA-3
Shoreline East of the trestle

Beach substrate between MHHW and +2 feet MLLW is primarily gravel. A sand-gravel mix exists between +2 feet MLLW and MLLW, and from MLLW to -4 feet MLLW, the substrate is predominantly sand with some shell hash. On either side of the ferry terminal, there is extensive hardening of the shoreline to protect single-family homes. Figure TA-3 shows the shoreline east of the trestle (with residential bulkhead). Figures TA-4 to TA-5 show the shoreline west of the trestle, immediately post soft-shore project. Figure TA-6 shows the same area, after wood was recruited to the shoreline. Wood recruitment was expected post-project, though was accelerated by exceptional high tides and storms.
