BIOLOGICAL ASSESSMENT REFERENCE

WASHINGTON STATE FERRIES CAPITAL, REPAIR, AND MAINTENANCE PROJECTS

May 2022

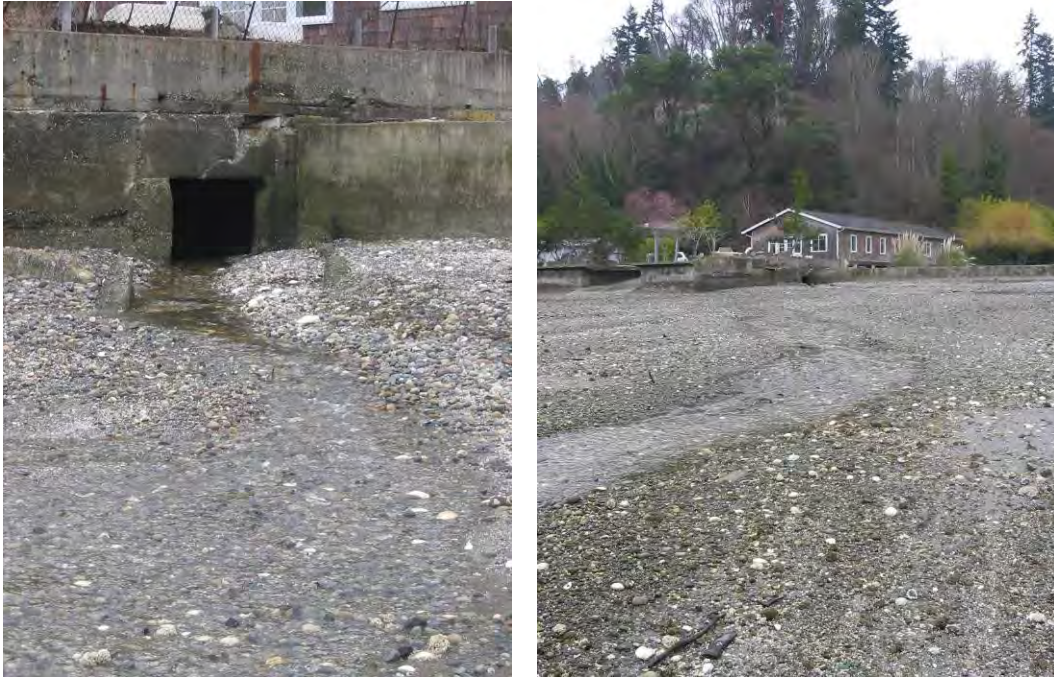
Tahlequah Creek and stormwater runoff from the surrounding area are the most significant sources of freshwater into the ferry terminal area. Tahlequah Creek enters Puget Sound about 500 feet west of the ferry terminal (see Figure TA-2). Approximately the last 300 feet of the creek is directed through private property via a concrete culvert (see Figure TA-5).

**Figure TA-5
Concrete Culvert Carrying Talequah Creek and the Creek as it Flows onto the Beach**

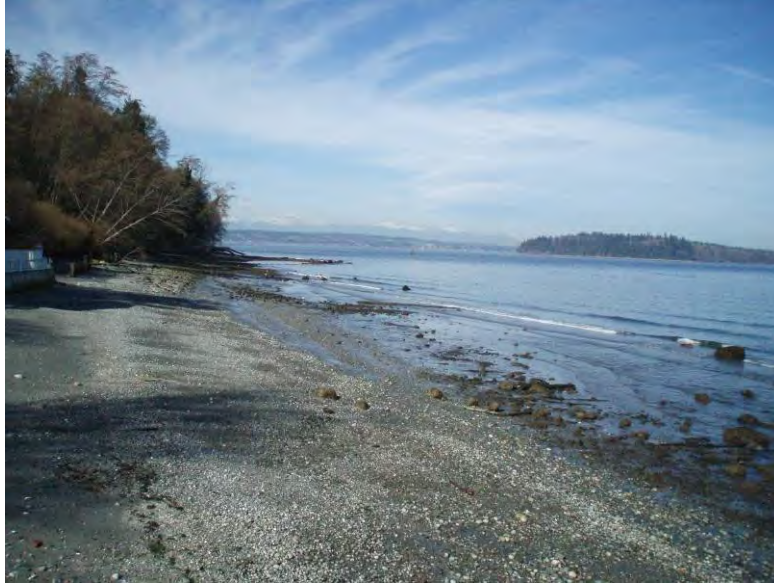
Figure VA-3
Beach and Intertidal Area West of the Vashon Island Ferry Terminal

Substrates on the beach are composed of fine sand, coarse sand, shell hash, gravel, and cobble with a rocky intertidal area (Figure VA-3). The beach has a gentle slope. Substrates in the off-shore area consist of loose sands underlain by glacial till.
