*FRIDAY HARBOR FERRY TERMINAL RESTORATION PROJECT*

**UNDERWATER SOUND LEVELS  
ASSOCIATED WITH RESTORATION OF  
THE FRIDAY HARBOR FERRY  
TERMINAL**

*Prepared by:  
Jim Laughlin  
Washington State Department of Transportation  
Office of Air Quality and Noise  
15700 Dayton Avenue North, P.O. Box 330310  
Seattle, WA 98133-9710*

**May 2005**

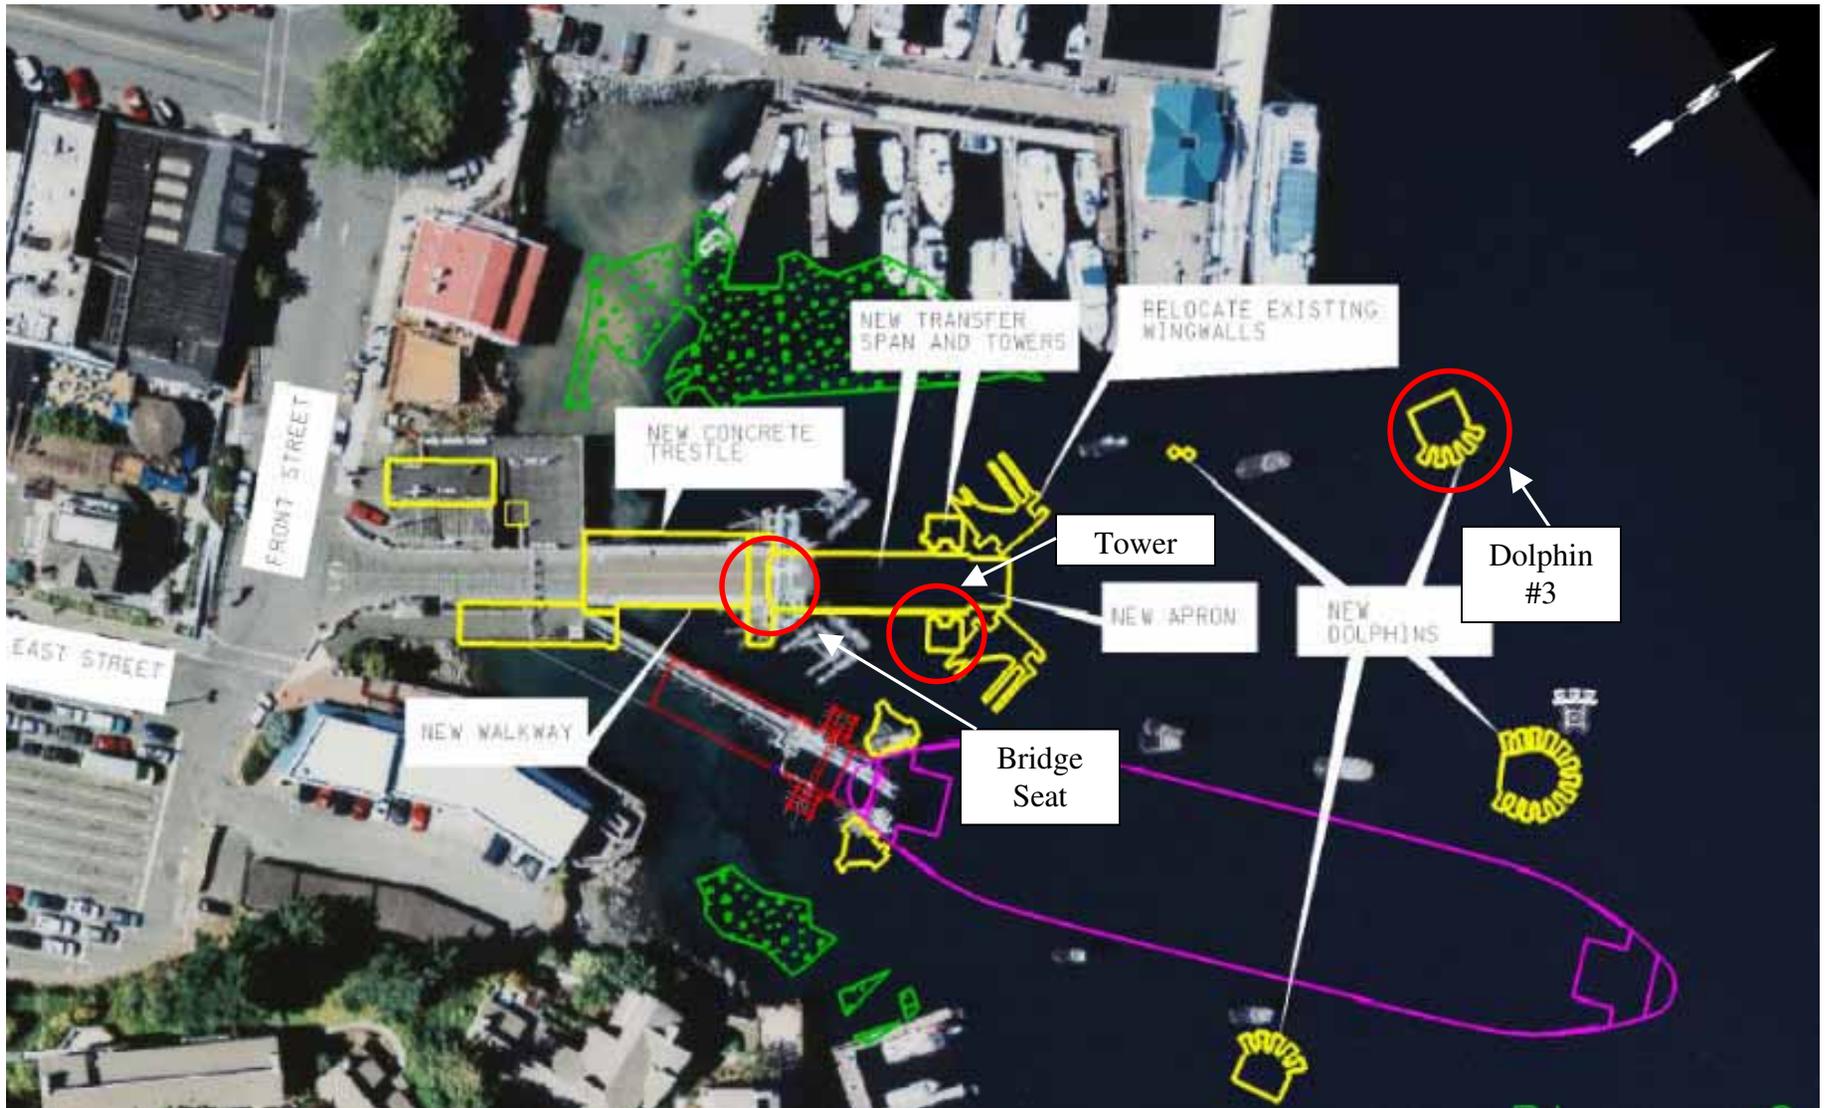
**Figure 1: Location of Underwater Noise Monitoring at Friday Harbor. There were three 24-inch piles monitored at Dolphin #3, three 24-inch piles monitored at the Bridge Seat, and two 30-inch piles monitored at the Tower.**

This technical report presents results of underwater sound levels measured during the driving of 10 piles at the Friday Harbor ferry terminal during February 2005 and March 2005 at the Friday Harbor Ferry Terminal project (Contract number: C6737). The data presented here correspond to the piles driven during September 17 through 22, 2004; between February 10<sup>th</sup> through 12<sup>th</sup>, 2005; February 23<sup>rd</sup> through 24<sup>th</sup>, 2005; and March 4<sup>th</sup>, 2005. Five 24-inch piles were monitored to test the effectiveness of the bubble curtain at two wing walls in September 2004 using a diesel hammer only. Three 24-inch diameter piles were monitored at dolphin #3 using three different hammer types (diesel, air, and hydraulic) (Figure 1). Three 24-inch diameter piles were monitored at the slip bridge seat using a diesel hammer on two piles and a hydraulic hammer on the third. Two 30-inch diameter piles were monitored at the towers with a diesel hammer only. The bubble curtain was tested during the second testing phase in different scenarios. First by turning the rings on in succession starting at the bottom ring and then turning all rings off. Then the bottom ring was first turned on full and then all the rings on and all rings off.. The driving of 24- and 30-inch diameter steel piles was conducted as part of the restoration of the ferry terminal at Friday Harbor. Figure 1 shows the locations of monitored piles.

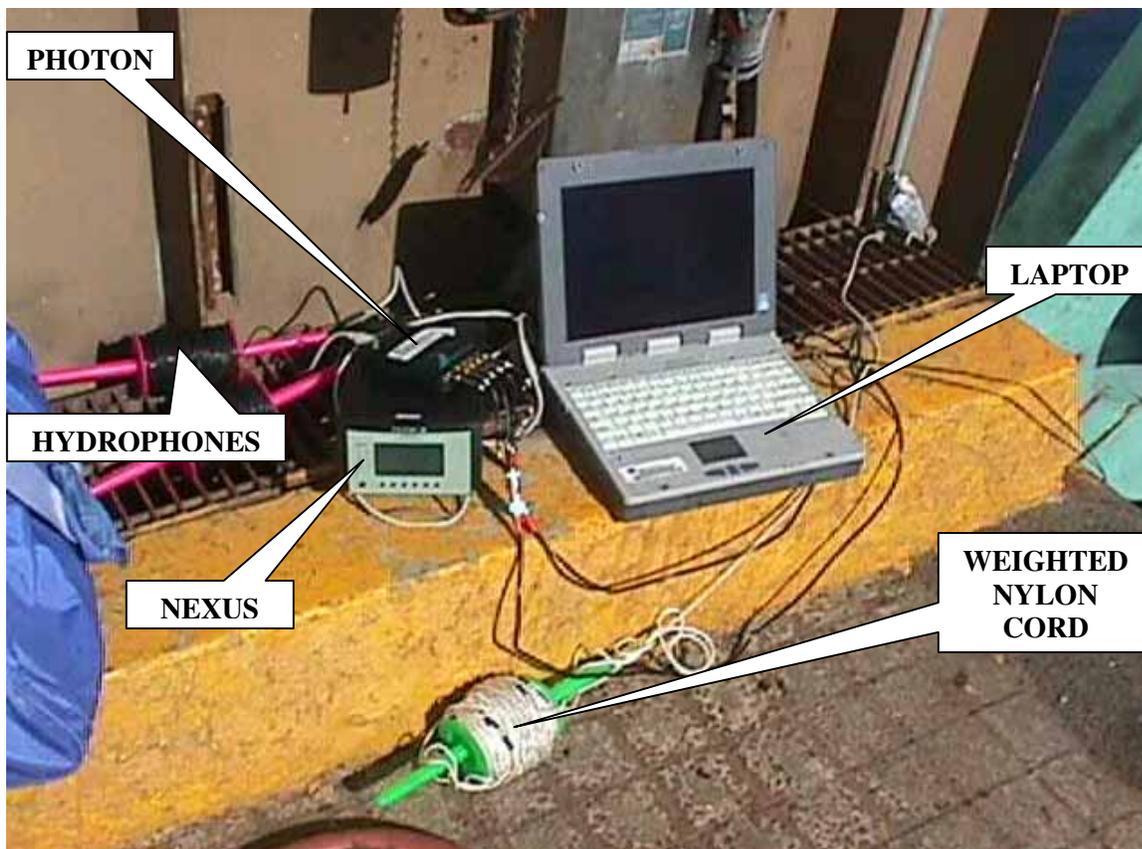
Figure 2: Underwater Sound Level Measurement Equipment

Underwater sound levels were measured using two Reson TC 4013 hydrophones. One hydrophone was positioned approximately one foot above the bottom and the other at a mid-water level. Both hydrophones were located at a distance of 30 feet from the pile and inshore of the pile being monitored. The measurement system includes a Brüel and Kjær Nexus type 2692 4-channel signal conditioner, which kept the high underwater sound levels within the dynamic range of the signal analyzer (Figure 2). The output of the Nexus signal conditioner was received by a Dactron Photon 4-channel signal spectrum analyzer that was attached to an Itronix GoBook II laptop computer. The waveform of the pile strikes along with the number of strikes, overpressure minimum and maximum, absolute peak values, and RMS sound levels, integrated over 90% of the duration of the pulse, were captured and stored on the laptop hard drive for subsequent signal analysis. The system and software calibration is checked annually against a NIST traceable standard. The operation of the hydrophone was checked in the field using a GRAS type 42AC high-level pistonphone with a hydrophone adaptor. The pistonphone signal was 146 dB re: 1  $\mu$ Pa. The pistonphone signal levels produced by the pistonphone and measured by the measurement system were within 1 dB and the operation of the system was judged to be acceptable over the study period. A photograph of the system and its components are shown in Figure 2.

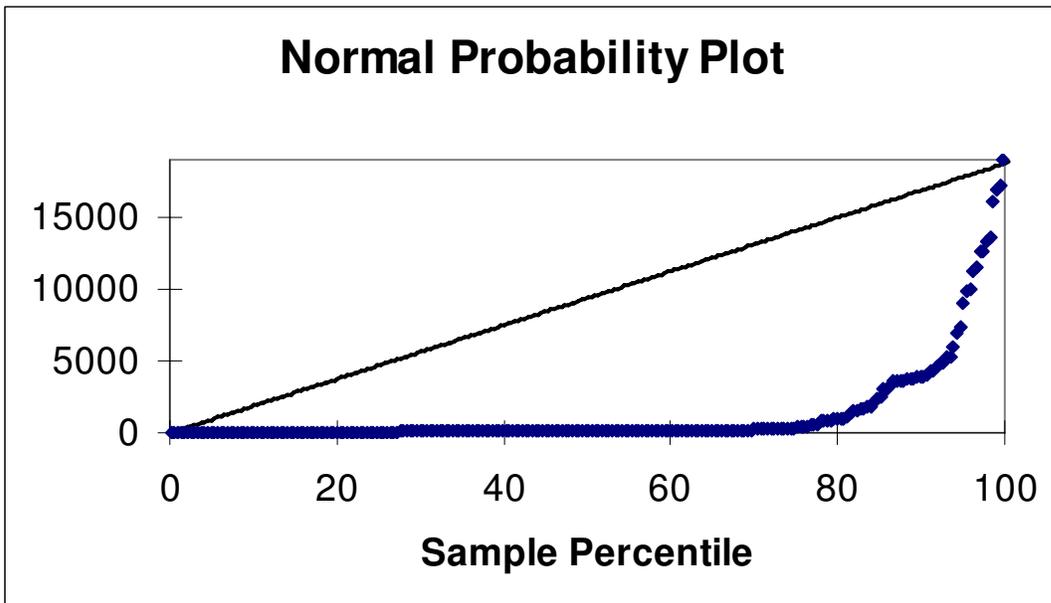
homogeneity of variances using normal probability plots such as the one above and the variance ratio test for equal variances (Zar, 1984). The example above is typical of all the normal probability plots for all data sets. The diagonal line is normal and the diamond symbols represent our data which is skewed from normality. In all cases due to the high degree of variability within each category but also between categories the data were found to be non-normal and have non-equal variances. Therefore, the Mann-Whitney U test was used for the comparisons (Zar, 1974).

Statistical comparisons were performed comparing the initial bubbles off peak values with the peak values of the various bubble ring on conditions to determine whether additional rings and additional air flow make a difference in sound reduction. The data were first tested for normality and

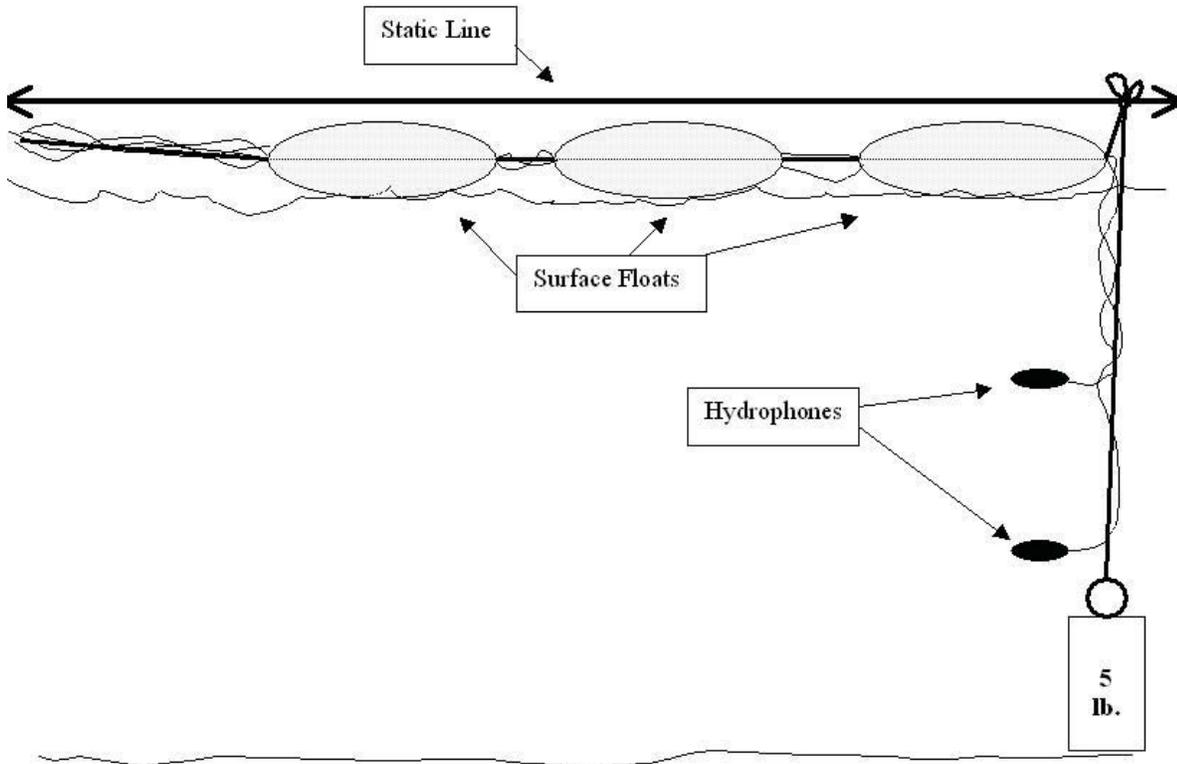
**Figure 3: Hydrophone Weight and Float System**

The location of the hydrophones is determined by allowing a clear line of sight between the pile and the hydrophones with no other structures nearby. The distance from the pile to the hydrophone location was measured using a Bushnell Yardage Pro rangefinder. The hydrophones were attached to a weighted nylon cord anchored with a five-pound weight. The cord and hydrophone cables were tied to a static line at the surface 33 feet (10 meters) from the pile. The cord and cables are supported at the surface by plastic floats until they were attached to the equipment.

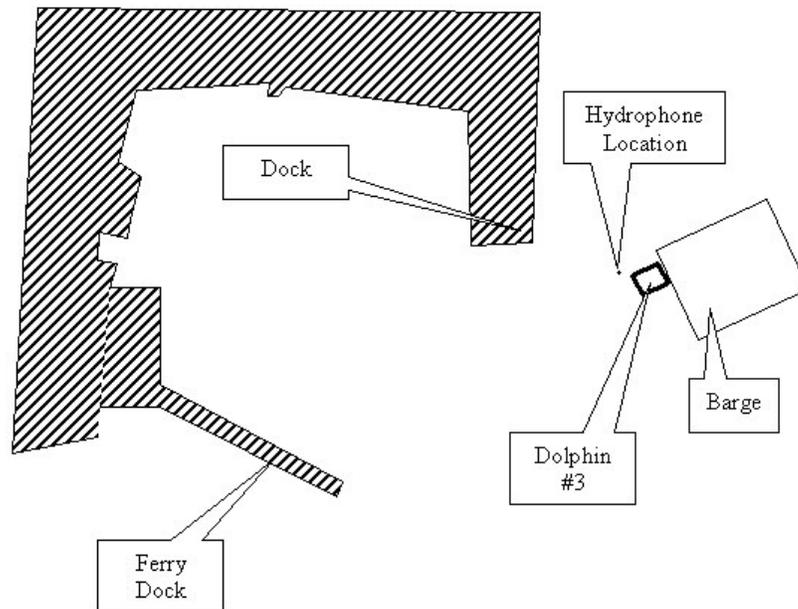
**Figure 4: Diagram of Monitoring Location in Relation to the Shoreline and Other Nearby Structures.**

Figure 6 is a diagrammatic drawing of the hydrophone monitoring location in relation to the shoreline and other structures in the water for piles 1, 2 and 3. The drawing is not to scale.

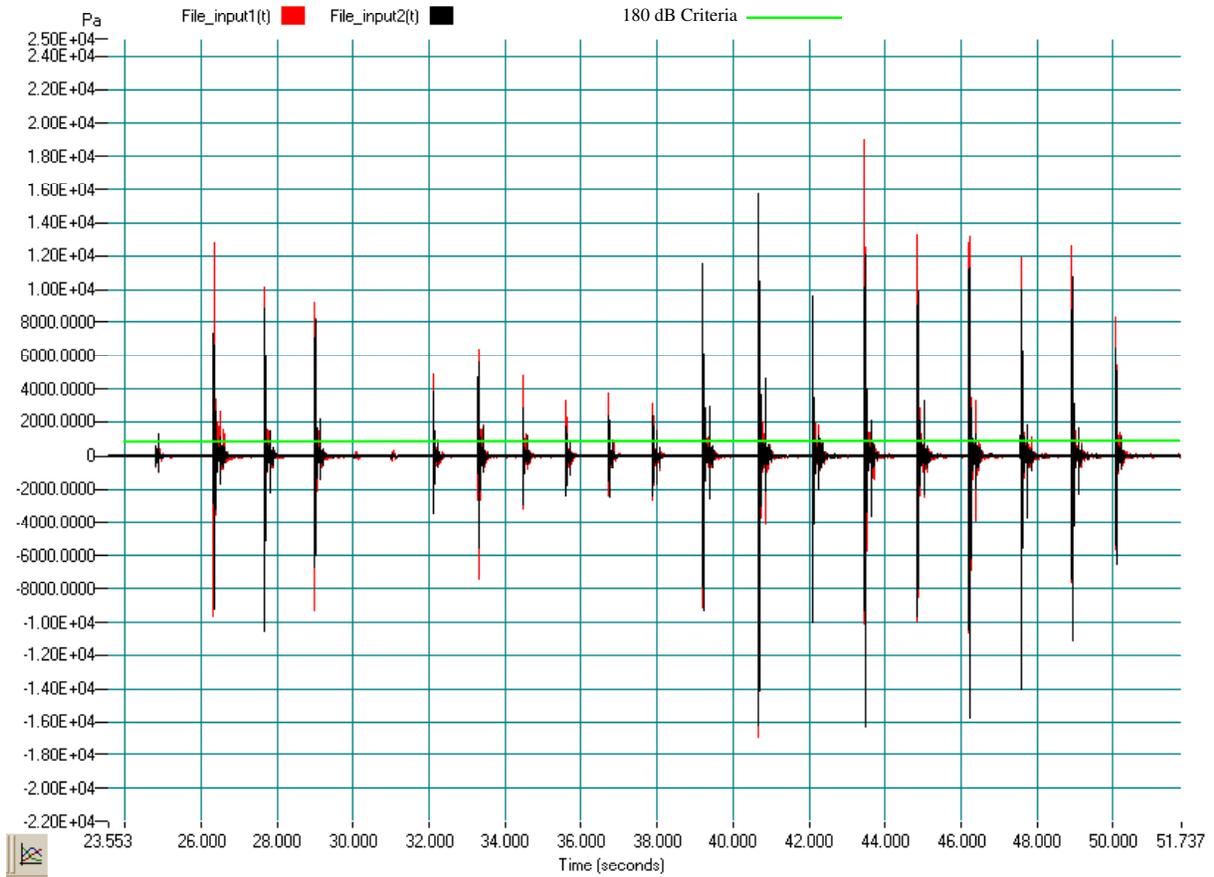
**Figure 5: Pile 1 Initial Pile Strikes with Bubble Curtain Off. (File\_input1(t) = bottom; File\_input2(t) = midwater)**

Peak values for sound levels at the bottom with all rings off (Figure 4) ranged from 183 dB<sub>peak</sub> to 206 dB<sub>peak</sub> 10 meters from the pile. The midwater peaks ranged from 182 dB<sub>peak</sub> to 204 dB<sub>peak</sub> 10 meters from the pile. Figure 4 gives some indication of the variability between pile strikes.

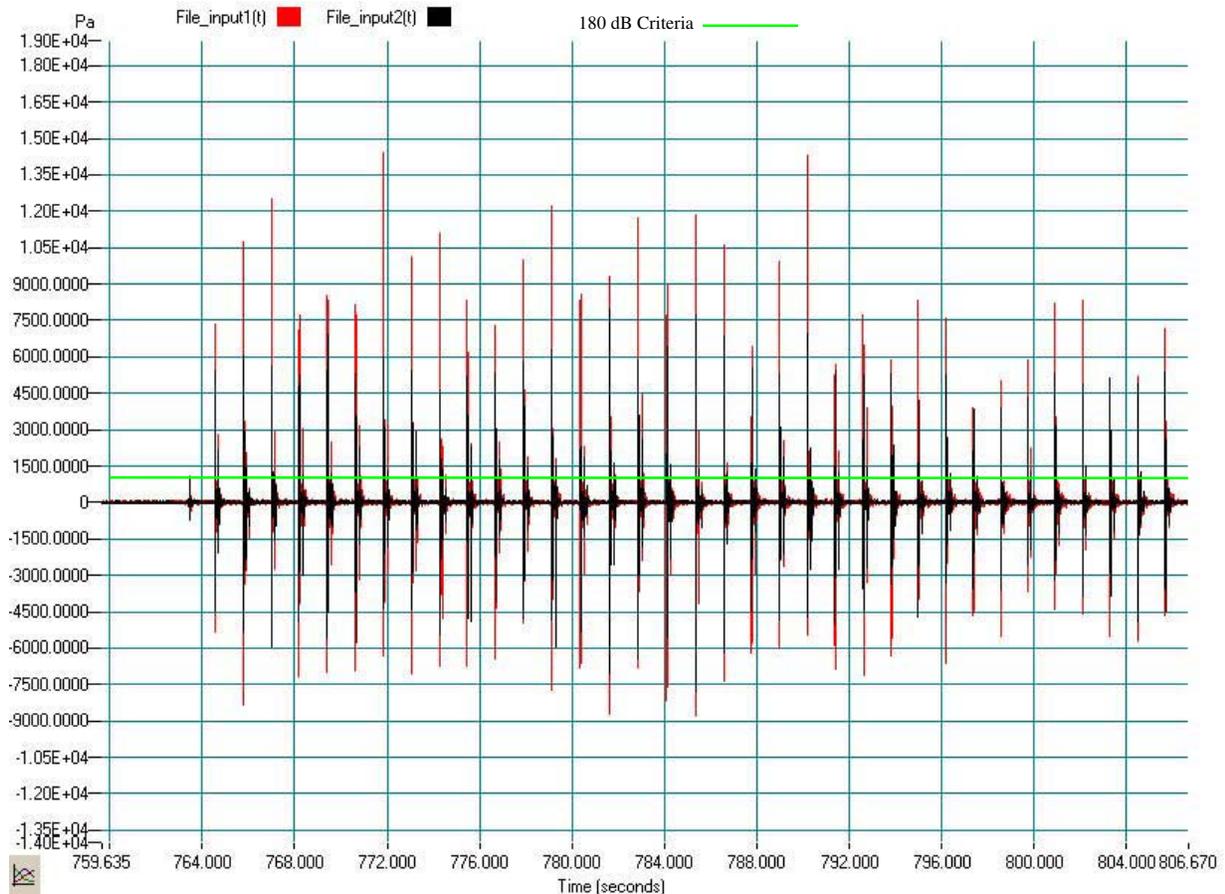
**Figure 6: Pile 1 Initial Pile Strikes with Bubble Curtain On Full. (File\_input1(t) = bottom; File\_input2(t) = midwater)**

Peak values for sound levels at the bottom with all rings on (Figure 5) ranged from 180 dB<sub>peak</sub> to 204 dB<sub>peak</sub> ten meters from the pile. The midwater peaks ranged from 180 dB<sub>peak</sub> to 206 dB<sub>peak</sub> ten meters from the pile. The peak values for the bottom and midwater recordings did not occur at the same strike. Figure 5 indicates the somewhat lessened variability with the bubble curtain in operation.

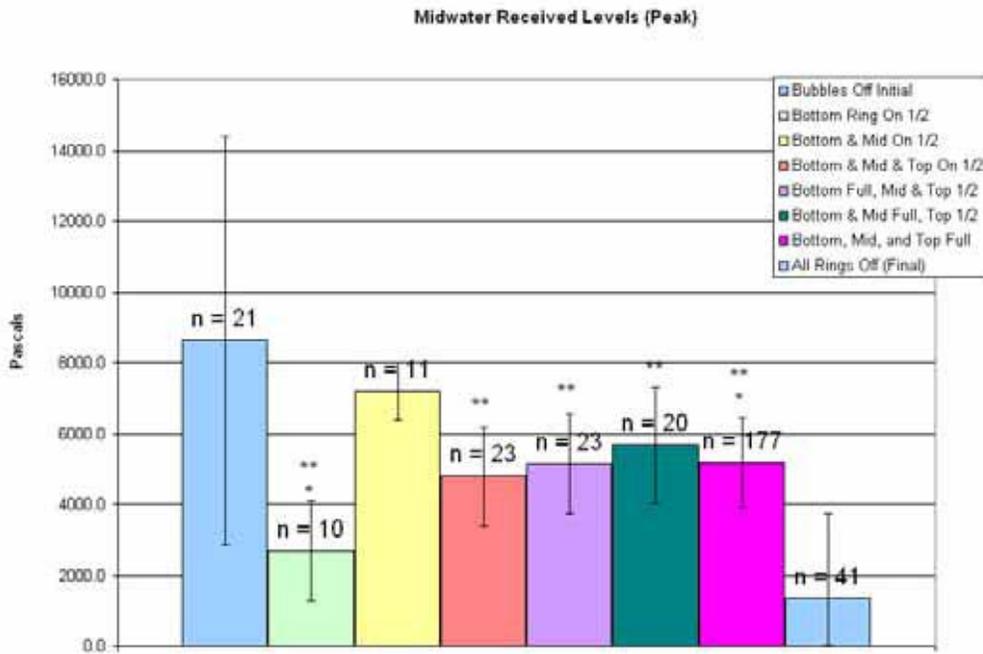
**Figure 7: Pile 1, midwater average peak received levels. Error bars represent one standard deviation. \* = Significant compared to bubbles off initial ( $p < 0.05$ ). \*\* Significant compared to bubbles off final ( $p < 0.05$ ).**

Figure 7 shows the average peak underwater sound pressure levels ( $\pm$  one standard deviation). Midwater received peak level statistical comparisons made to the initial bubbles off condition indicated that only the bottom ring at  $\frac{1}{2}$  flow and the all rings on full conditions were significantly less (Figure 7). When compared to the final bubbles off condition all were significantly greater except the bottom and mid rings at half flow.

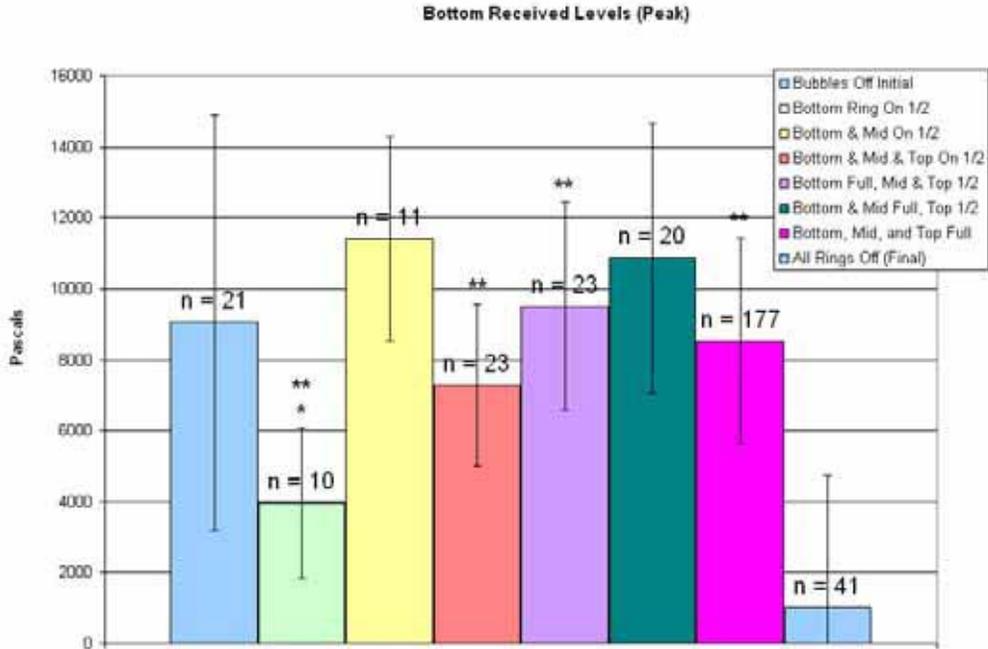
**Figure 8: Pile 1, bottom average peak received levels. Error bars represent one standard deviation. \* = Significant compared to bubbles off initial ( $p < 0.05$ ). \*\* Significant compared to bubbles off final ( $p < 0.05$ ).**

Bottom received peak level comparisons (Figure 8) indicated similar associations as the midwater peak levels. However, when the comparisons were made to the initial bubbles off condition only the bottom ring at  $\frac{1}{2}$  flow was significantly less. When compared to the final bubbles off condition the bottom ring at  $\frac{1}{2}$  flow, bottom and mid rings at  $\frac{1}{2}$  flow, bottom and mid rings on full and top ring  $\frac{1}{2}$  flow, and all rings at  $\frac{1}{2}$  flow were significantly greater.

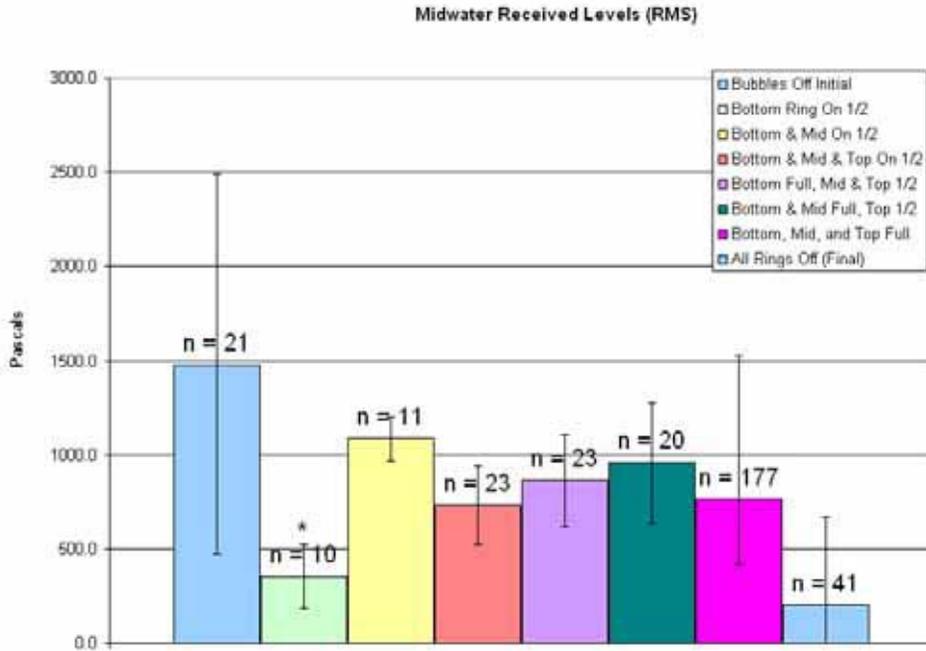
Figure 9: Pile 1, midwater average RMS received levels. Error bars represent one standard deviation. \* = Significant compared to bubbles off initial (p<0.05). \*\* Significant compared to bubbles off final (p<0.05).

RMS values are less variable than the peak values and excluding the bottom ring at 1/2 only indicate a slight trend towards a lower RMS value as more rings are turned on and air flow increases (Figure 9). The lowest RMS values occurred when the bottom bubble curtain ring was at half flow. The same pattern can be seen for SEL as well

Figure 9 shows the average RMS values ( $\pm$  one standard deviation). Midwater received RMS level statistical comparisons made to the initial bubbles off condition indicated that only the bottom ring at 1/2 flow was significantly less. When compared to the final bubbles off condition, none were significant.

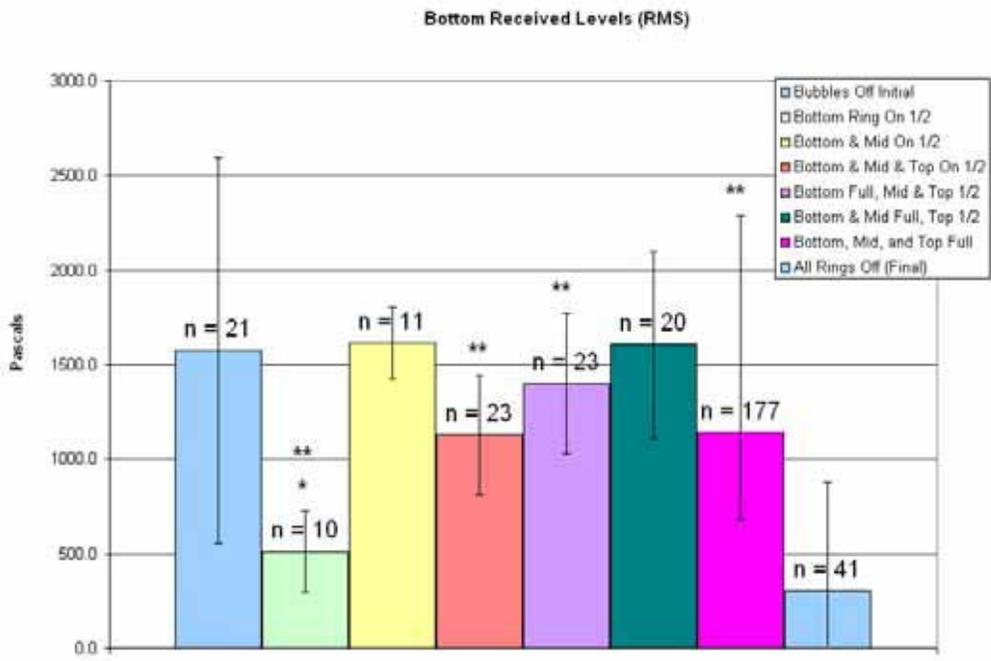
Figure 10: Pile 1, bottom average RMS received levels. Error bars represent one standard deviation. \* = Significant compared to bubbles off initial (p<0.05). \*\* Significant compared to bubbles off final (p<0.05).

Bottom received RMS level statistical comparisons indicated that only the bottom ring at 1/2 flow was significantly less than the initial bubbles of condition (Figure 10). When compared to the final bubbles off condition, all but the bottom and mid ring at 1/2 flow and the bottom and mid rings at full and the top at 1/2 flow were significantly greater.

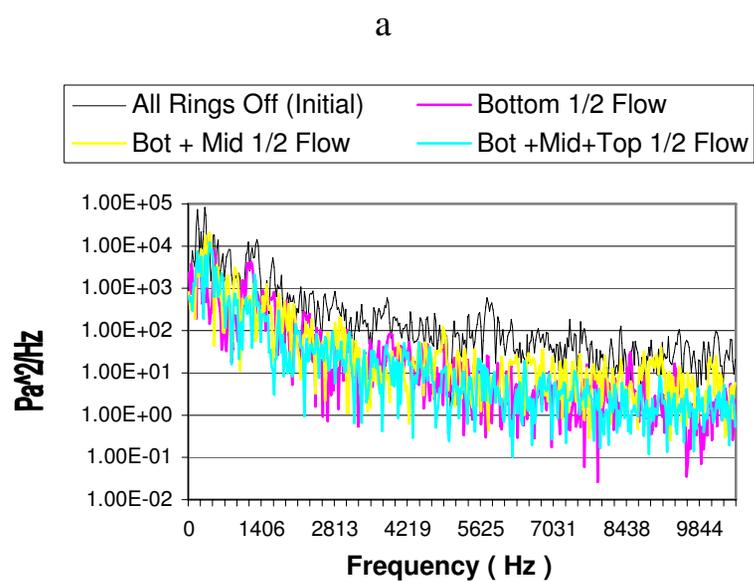
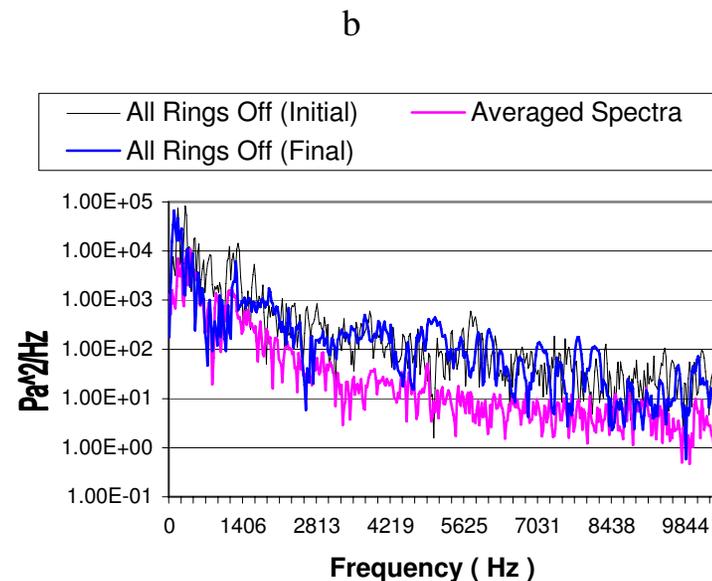
**Figure 11: Pile 1: a. Frequency Spectral Analysis Comparing All Rings Off with Various Rings at 1/2 Air Flow. b. Frequency Spectral Analysis Comparing All Rings Off with the Average of All Spectra with Rings at 1/2 Air Flow.**

Figures 11 and 12 below show the acoustical frequency content of the absolute peak pile strike for each bubble ring air flow condition. Figure 11a compares the differences between the acoustical frequency content with all rings off and with bottom, mid, and top rings sequentially at ½ air flow rate. As can be seen in the figure, the upper frequencies are reduced with the bubble curtain rings at ½ air flow. This indicates that the bubble curtain was effective in reducing the overall noise levels although not as much as during the initial bubble curtain testing phase. Figure 11b compares the bubble curtain off condition to the averaged spectrum for all rings at ½ flow rate again indicating that the bubble curtain was effective in reducing the overall noise levels.

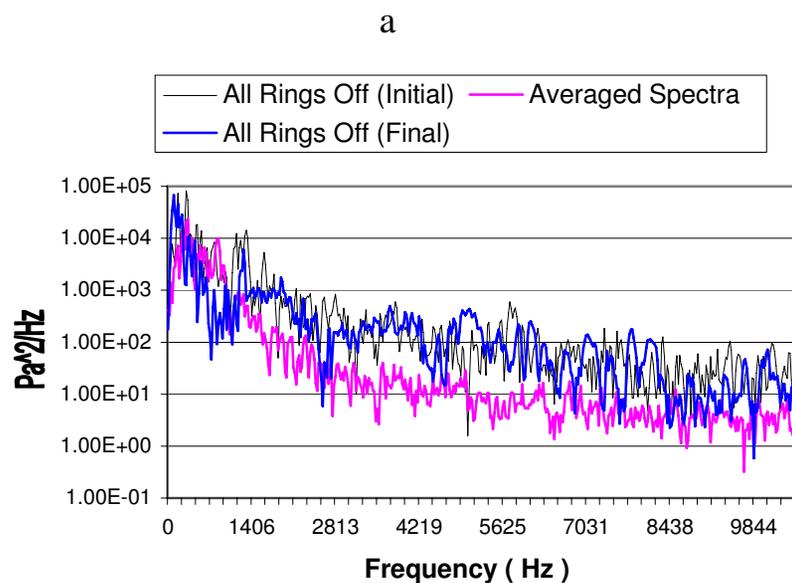
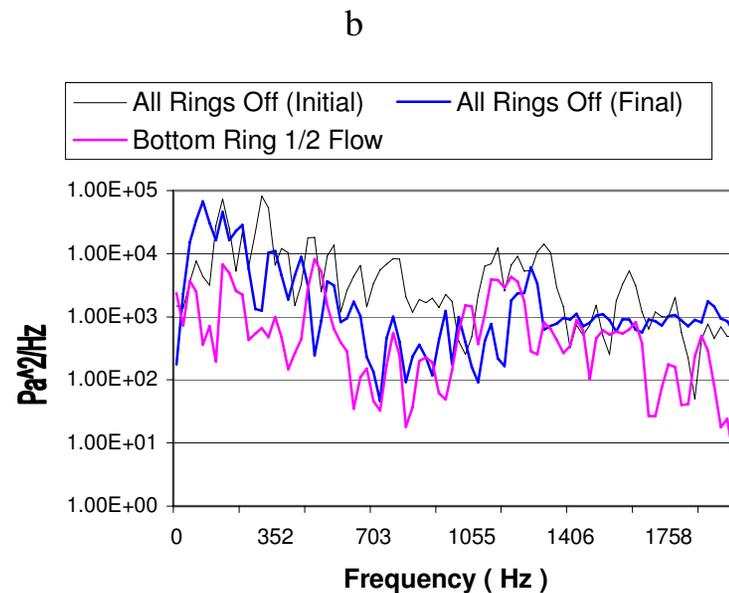
**Figure 12: Pile 1: a. Frequency Spectral Analysis Comparing All Rings Off with All Rings at Full Air Flow. b. Frequency Spectral Analysis between DC and 2 kHz Comparing All Rings Off with 1/2 Flow for All Rings.**

Figure 12a compares the bubble curtain off condition with the condition of all the bubble curtain rings at full air flow. As the figure indicates, there is not a substantial change in the overall noise levels when compared to the bubble curtain at ½ air flow rate (Figure 11b). This indicates that the bubble curtain did not perform better with increased air flow. Both figures show that the dominant energy in each pile strike is between about 50 and 600 Hz. This held true for all piles monitored.

Figure 12b compares the bubble curtain condition with the averaged spectra for peak strikes at ½ air flow rate between DC and 2 kHz (the range of fish hearing). As the figure indicates, there is some reduction at frequencies below about 1 kHz compared to the initial bubbles off condition.

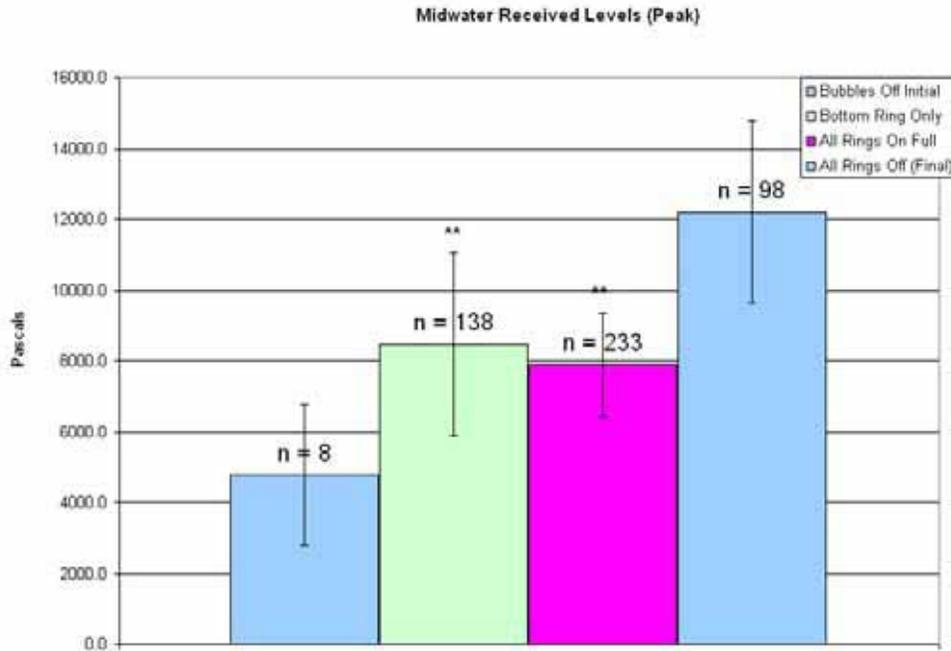
**Figure 13: Pile 2, midwater average peak received levels. Error bars represent one standard deviation. \* = Significant compared to bubbles off initial ( $p < 0.05$ ). \*\* Significant compared to bubbles off final ( $p < 0.05$ )**

Figure 13 shows the average peak underwater sound pressure levels for Pile 2 ( $\pm$  one standard deviation). Midwater received peak level statistical comparisons made to the initial bubbles off condition indicated that none were significant (Figure 13). When compared to the final bubbles off condition all were significantly less indicating little difference between the bottom ring on only and all rings on.

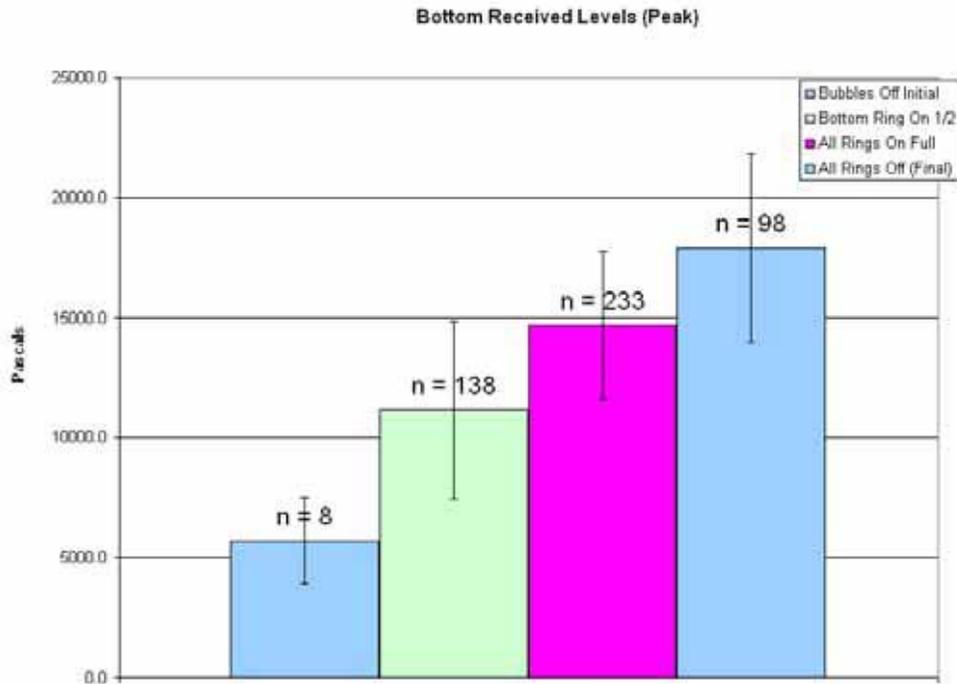
**Figure 14: Pile 2, bottom average peak received levels. Error bars represent one standard deviation. \* = Significant compared to bubbles off initial ( $p < 0.05$ ). \*\* Significant compared to bubbles off final ( $p < 0.05$ )**

Bottom received peak level comparisons (Figure 14) indicated progressively increasing peak values with none significant.

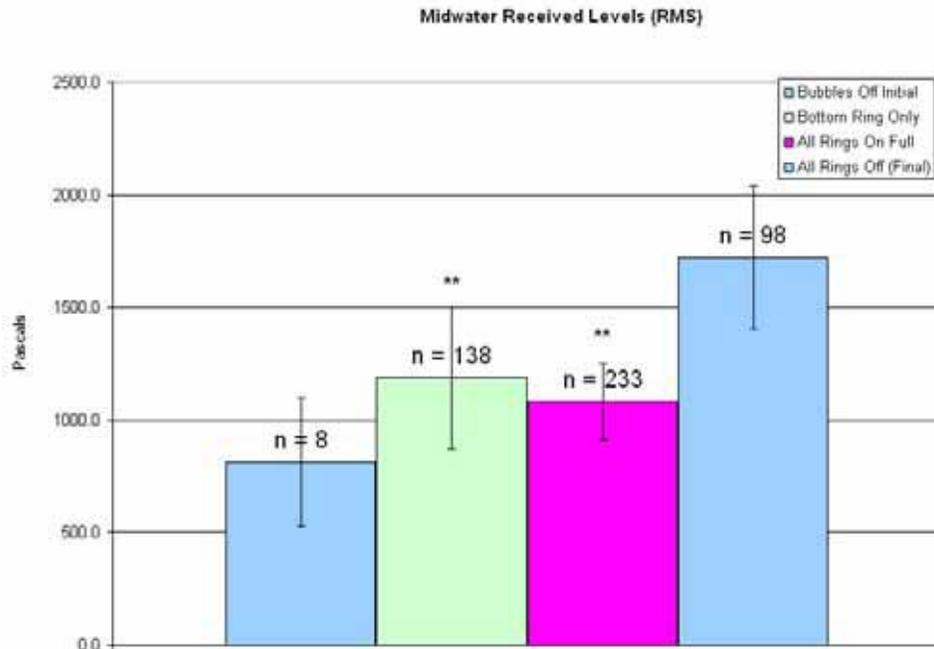
**Figure 15: Pile 2, midwater average RMS received levels. Error bars represent one standard deviation. \* = Significant compared to bubbles off initial ( $p < 0.05$ ). \*\* Significant compared to bubbles off final ( $p < 0.05$ )**

RMS values are less variable than the peak values and when compared statistically with the initial bubbles off condition none were significant. Figure 15 shows the average midwater RMS values ( $\pm$  one standard deviation). Midwater received RMS level statistical comparisons made to the initial bubbles off condition indicated that none were significant. However, when compared to the final bubbles off condition both bottom ring only and all rings on were significantly less.

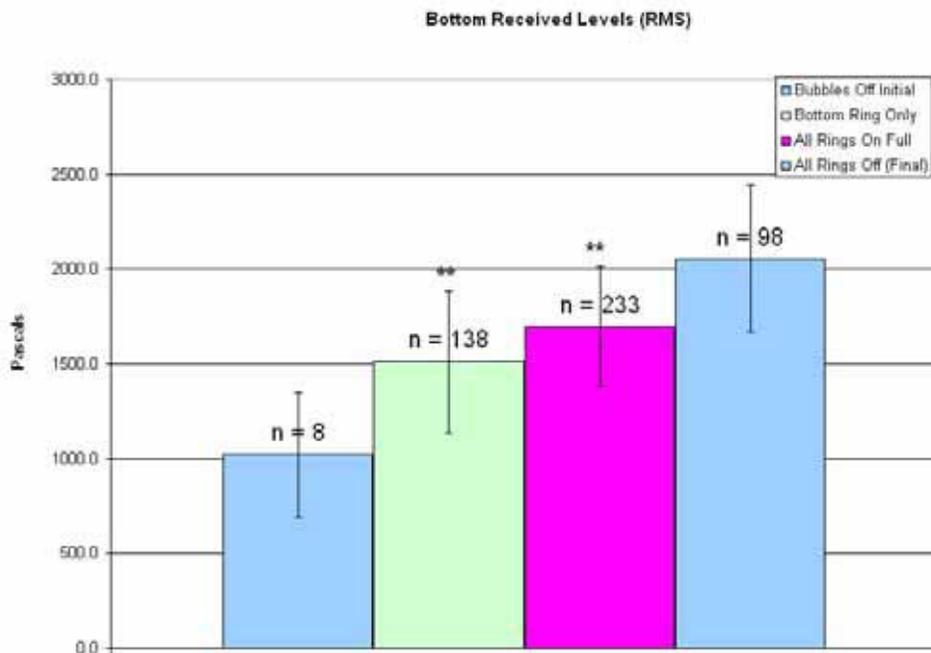
**Figure 16: Pile 2, bottom average RMS received levels. Error bars represent one standard deviation. \* = Significant compared to bubbles off initial ( $p < 0.05$ ). \*\* Significant compared to bubbles off final ( $p < 0.05$ )**

Bottom received RMS level statistical comparisons indicated that none were significantly different from the initial bubbles off condition (Figure 16). Both bottom ring only and all rings on were significantly less than the final bubbles of condition.

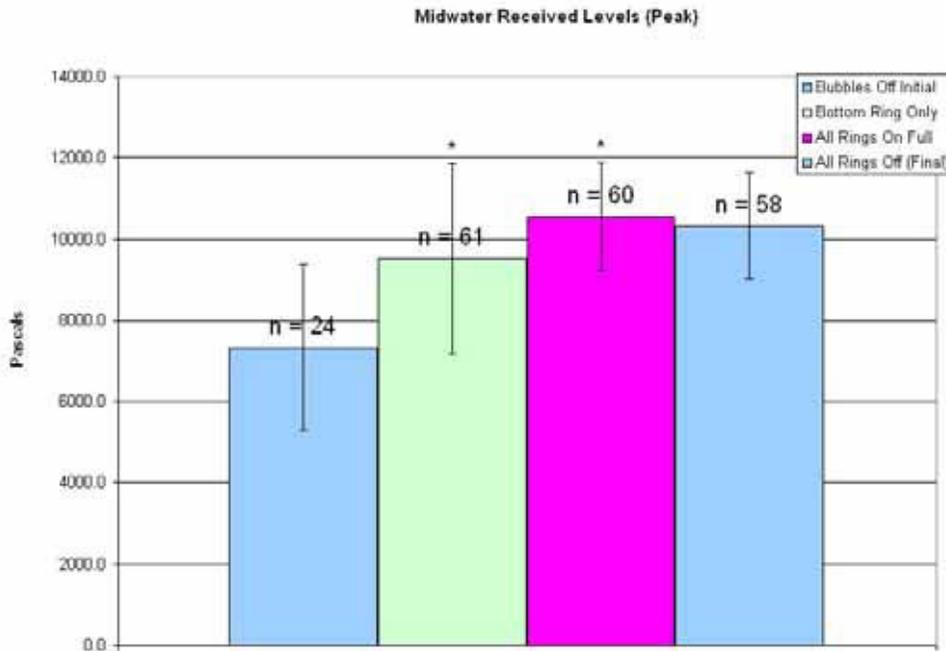
**Figure 17: Pile 3, midwater average peak received levels. Error bars represent one standard deviation. \* = Significant compared to bubbles off initial ( $p < 0.05$ ). \*\* Significant compared to bubbles off final ( $p < 0.05$ )**

Figure 17 shows the average peak underwater sound pressure levels for Pile 3 ( $\pm$  one standard deviation). Midwater received peak level statistical comparisons made to the initial bubbles off condition indicated that all with air flow on were significantly higher. When compared to the final bubbles off condition none were significant.

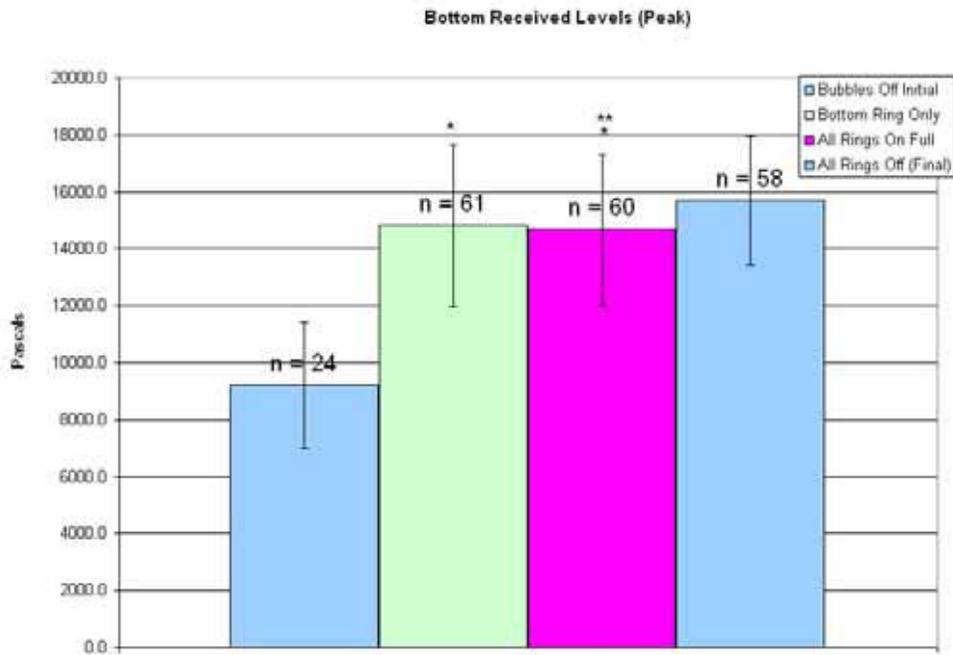
**Figure 18: Pile 3, bottom average peak received levels. Error bars represent one standard deviation. \* = Significant compared to bubbles off initial ( $p < 0.05$ ). \*\* Significant compared to bubbles off final ( $p < 0.05$ )**

Figure 18 indicates the average peak underwater sound pressure levels for Pile 3 ( $\pm$  one standard deviation). Bottom received peak level statistical comparisons made to the initial bubbles off condition indicated that all with air flow on were significantly higher. When compared to the final bubbles off condition only the all rings full on was significantly less.

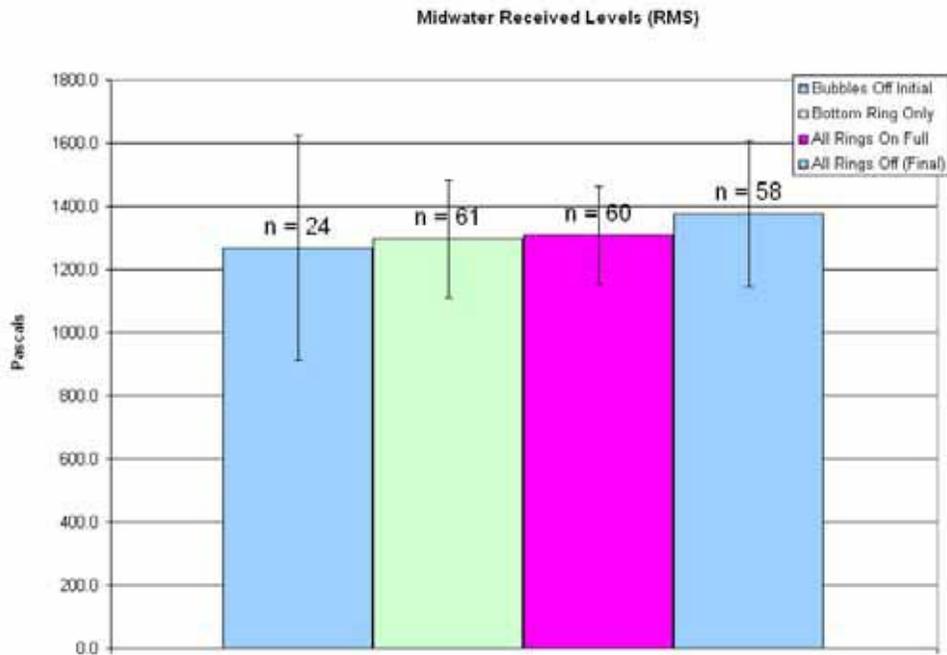
**Figure 19: Pile 3, midwater average RMS received levels. Error bars represent one standard deviation. \* = Significant compared to bubbles off initial ( $p < 0.05$ ). \*\* Significant compared to bubbles off final ( $p < 0.05$ )**

RMS values are less variable than the peak values and when the midwater received RMS levels were compared statistically with the initial bubbles off condition none were significant (Figure 19). When compared to the final bubbles off condition none were significant.

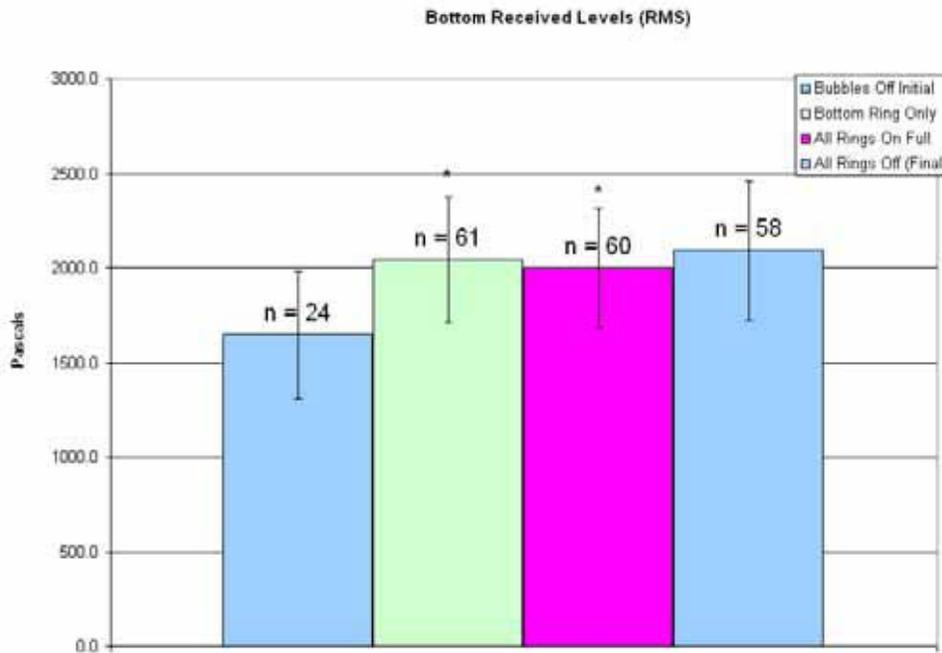
**Figure 20: Pile 3, bottom average RMS received levels. Error bars represent one standard deviation. \* = Significant compared to bubbles off initial ( $p < 0.05$ ). \*\* Significant compared to bubbles off final ( $p < 0.05$ )**

Bottom received RMS level statistical comparisons indicated that all were significantly higher than the initial bubbles off condition. When compared to the final bubbles off condition none were significant (Figure 20).

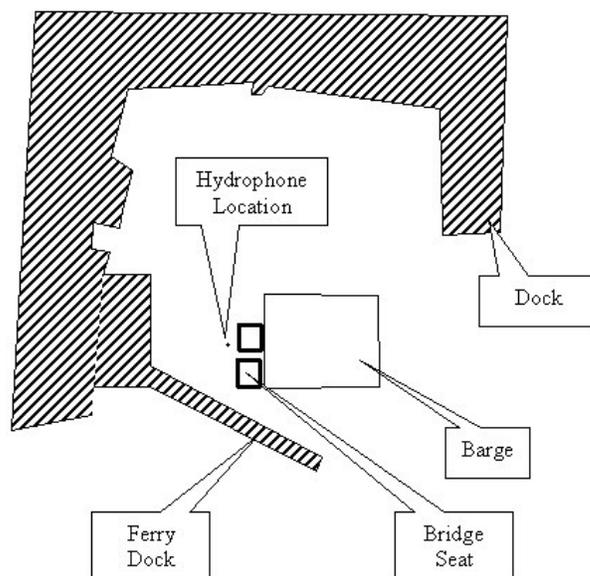
Figure 21 is a diagrammatic drawing of the hydrophone monitoring location in relation to the shoreline and other structures in the water for piles 4, 5 and 6. The drawing is not to scale.

**Figure 21. Diagram of Monitoring Location in Relation to the Shoreline and Other Nearby Structures.**

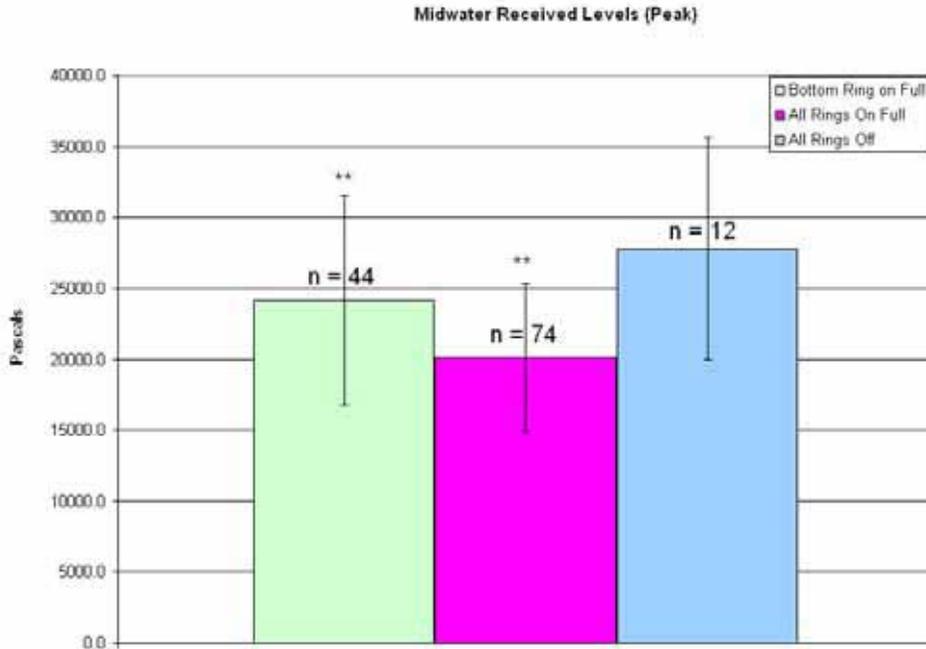
Figure 22 shows the average peak underwater sound pressure levels for Pile 4 ( $\pm$  one standard deviation). Midwater received peak level statistical comparisons made to the final bubbles off condition indicated that all with air flow on were significantly lower. The all rings on full condition was slightly lower than having just the bottom ring on full.

**Figure 22: Pile 4, midwater average peak received levels. Error bars represent one standard deviation. \* = Significant compared to bubbles off initial ( $p < 0.05$ ). \*\* Significant compared to bubbles off final ( $p < 0.05$ )**

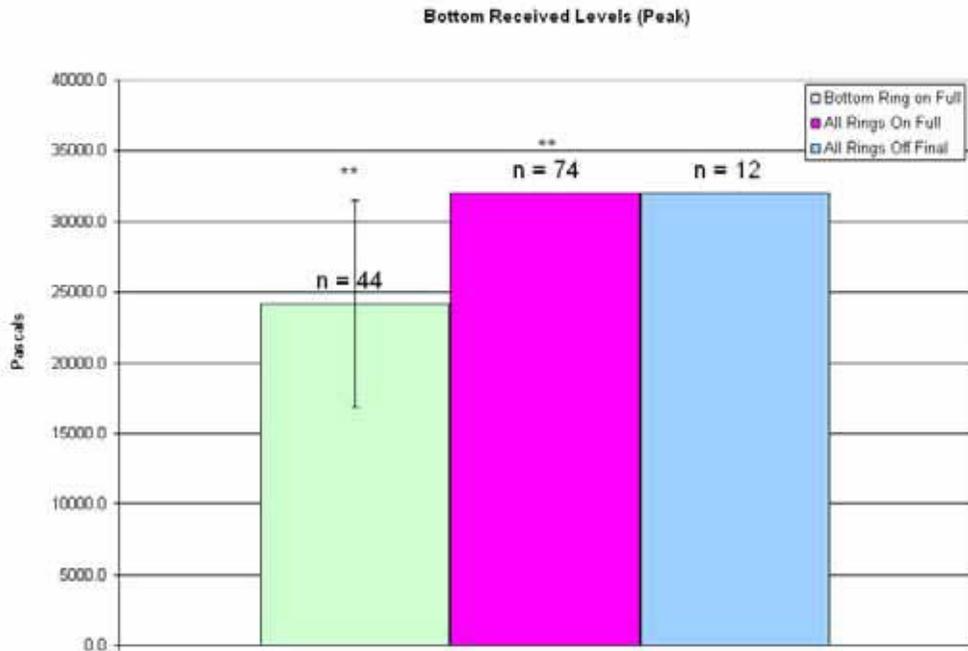
Figure 23 indicates the average peak underwater sound pressure levels for Pile 4 ( $\pm$  one standard deviation). Bottom received peak level statistical comparisons made to the final bubbles off condition indicated that all with air flow on were significantly lower. However, because the peaks were clipped at 210 dB the variability is artificially small, with the exception of the bottom ring on only condition. Therefore, the statistical significance is likely artificial as well.

**Figure 23: Pile 4, bottom average peak received levels. Error bars represent one standard deviation. \* = Significant compared to bubbles off initial ( $p < 0.05$ ). \*\* Significant compared to bubbles off final ( $p < 0.05$ )**
