*FRIDAY HARBOR FERRY TERMINAL RESTORATION PROJECT*

**UNDERWATER SOUND LEVELS  
ASSOCIATED WITH RESTORATION OF  
THE FRIDAY HARBOR FERRY  
TERMINAL**

*Prepared by:  
Jim Laughlin  
Washington State Department of Transportation  
Office of Air Quality and Noise  
15700 Dayton Avenue North, P.O. Box 330310  
Seattle, WA 98133-9710*

**May 2005**

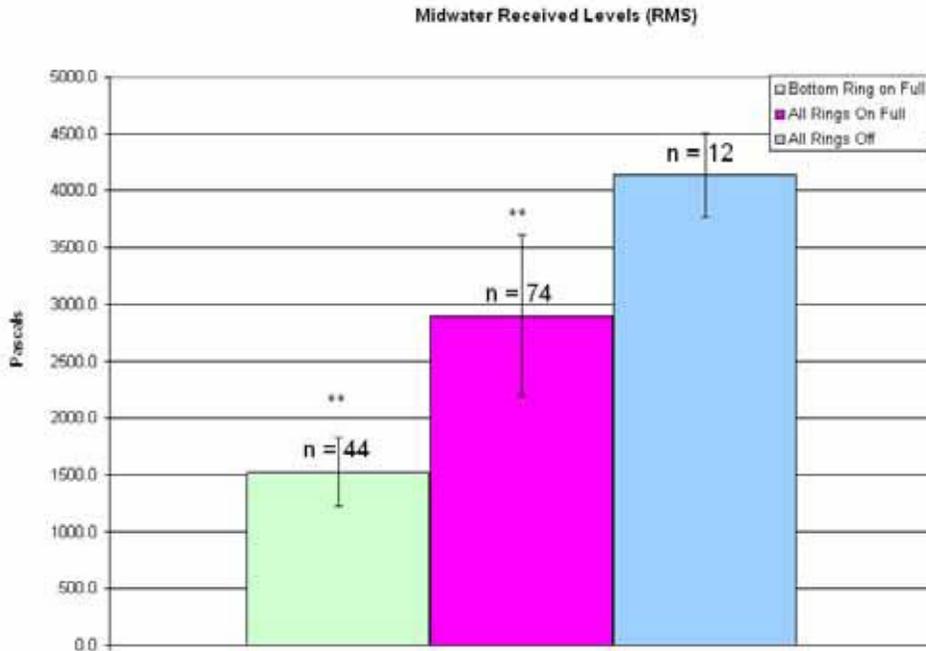
**Figure 24: Pile 4, midwater average RMS received levels. Error bars represent one standard deviation. \* = Significant compared to bubbles off initial ( $p < 0.05$ ). \*\* Significant compared to bubbles off final ( $p < 0.05$ )**

RMS and SEL values are less variable than peak values. Both hydrophones indicated an inverse reduction in sound levels with increasing air flow. Midwater received RMS levels were compared statistically with the final bubbles off condition and all were significant (Figure 24). Bottom received RMS levels were statistically compared with the final bubbles off condition and all were significant (Figure 25). In both cases the greatest reduction in RMS values occurred with the bottom ring only on full.

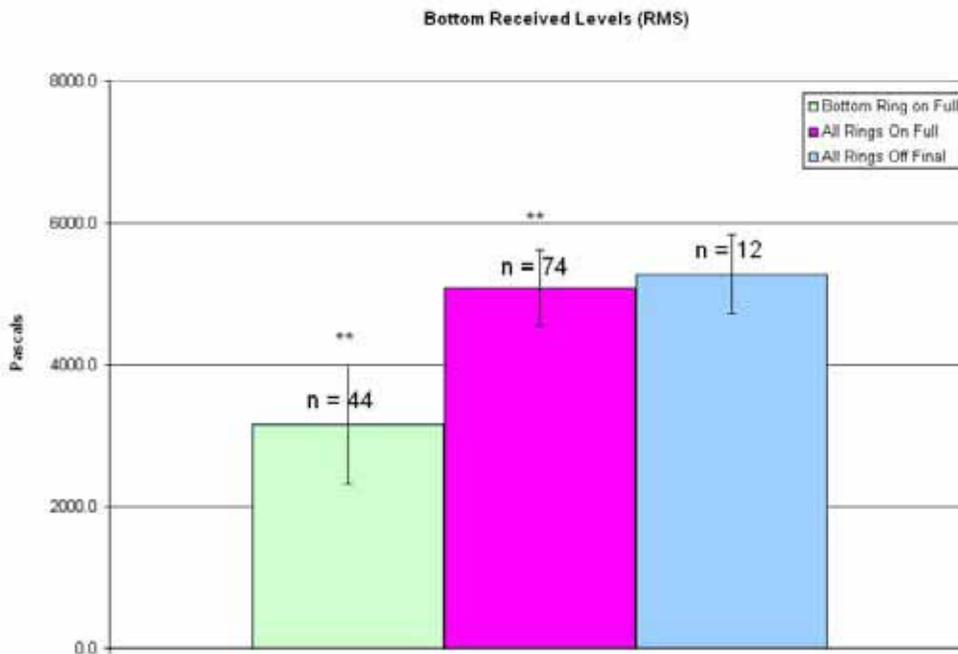
**Figure 25: Pile 4, bottom average RMS received levels. Error bars represent one standard deviation. \* = Significant compared to bubbles off initial ( $p < 0.05$ ). \*\* Significant compared to bubbles off final ( $p < 0.05$ )**

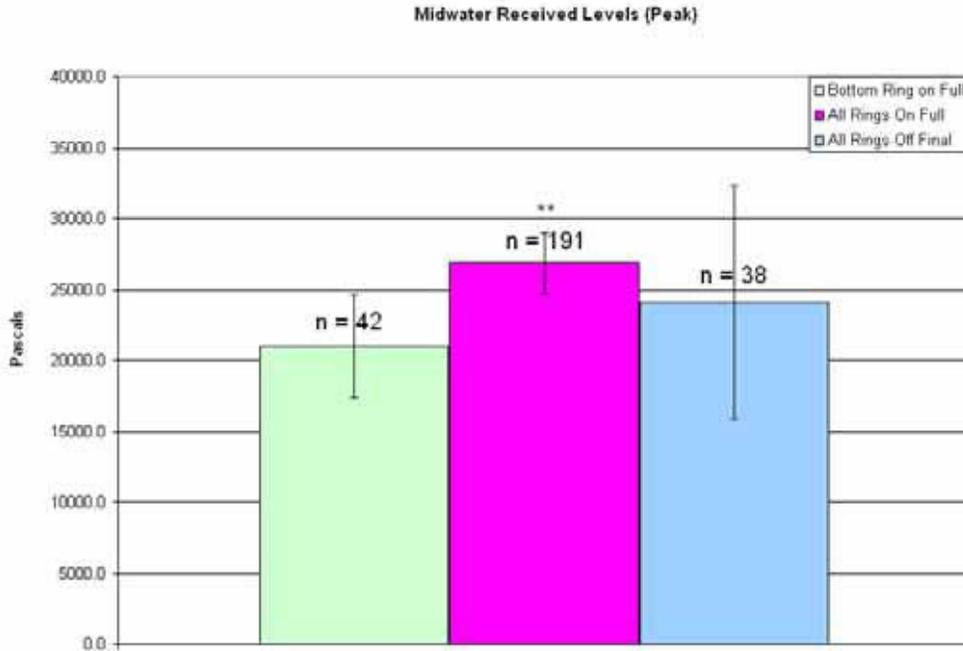
Figure 26 shows the average peak underwater sound pressure levels for Pile 5 ( $\pm$  one standard deviation). Midwater received peak level statistical comparisons made to the final bubbles off condition indicated that only the all rings on full condition was significantly higher. Although not significant, the bottom ring only on condition average peak was lower.

**Figure 26. Pile 5, midwater average peak received levels. Error bars represent one standard deviation. \* = Significant compared to bubbles off initial ( $p < 0.05$ ). \*\* Significant compared to bubbles off final ( $p < 0.05$ )**

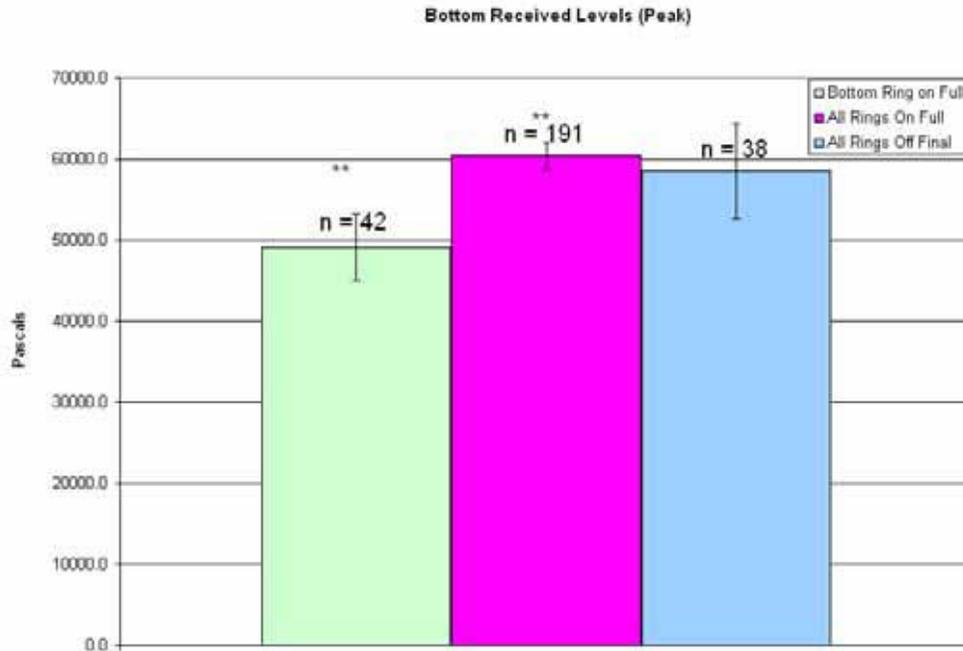
Figure 27 indicates the average peak underwater sound pressure levels for Pile 5 ( $\pm$  one standard deviation). Bottom received peak level statistical comparisons made to the final bubbles off condition indicated that all rings on full was significantly higher but the bottom ring only on full was significantly lower.

**Figure 27. Pile 5, midwater average peak received levels. Error bars represent one standard deviation. \* = Significant compared to bubbles off initial ( $p < 0.05$ ). \*\* Significant compared to bubbles off final ( $p < 0.05$ )**

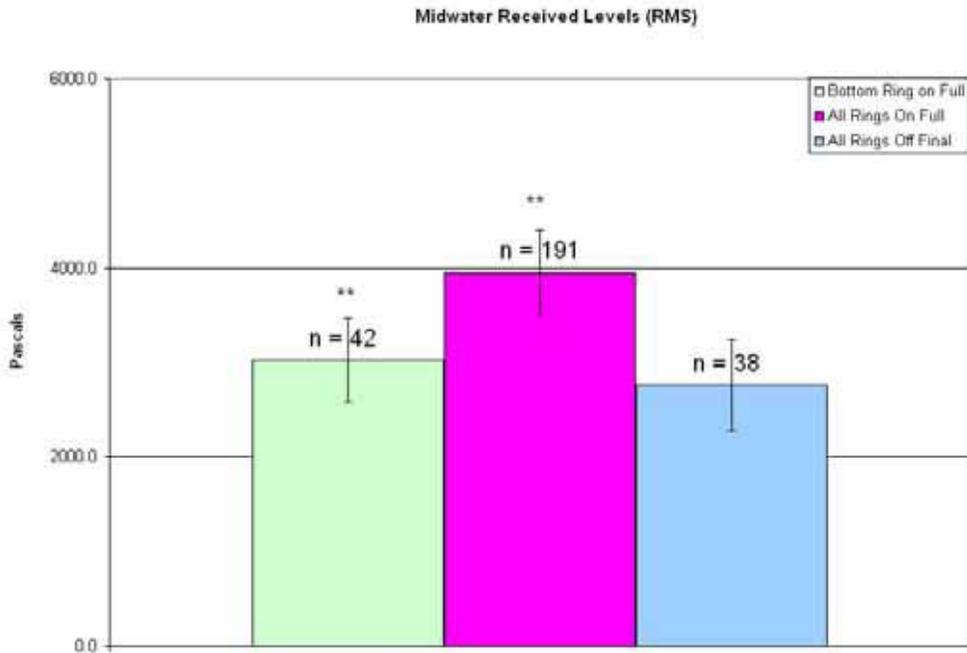
**Figure 28. Pile 5, midwater average RMS received levels. Error bars represent one standard deviation. \* = Significant compared to bubbles off initial (p<0.05). \*\* Significant compared to bubbles off final (p<0.05)**

RMS and SEL values are less variable than peak values. Both hydrophones indicated an inverse reduction in sound levels with increasing air flow. Midwater received RMS levels were compared statistically with the final bubbles off condition and all were significantly higher (Figure 28). Bottom received RMS levels were statistically compared with the final bubbles off condition and all were significantly higher (Figure 29). In both cases the smallest increase in RMS values occurred with the bottom ring only on full.

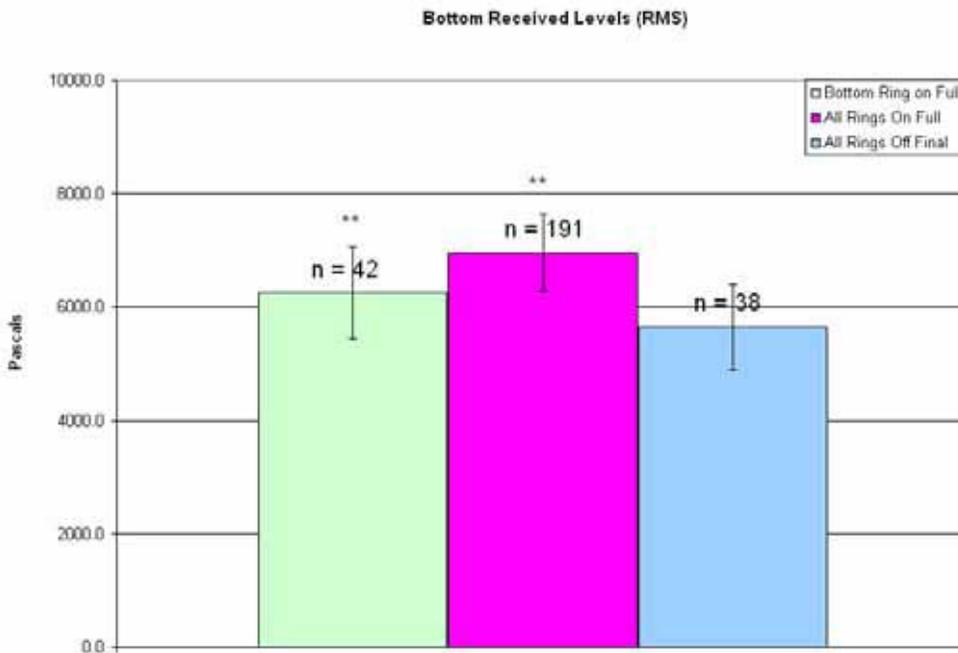
**Figure 29. Pile 5, bottom average RMS received levels. Error bars represent one standard deviation. \* = Significant compared to bubbles off initial (p<0.05). \*\* Significant compared to bubbles off final (p<0.05)**

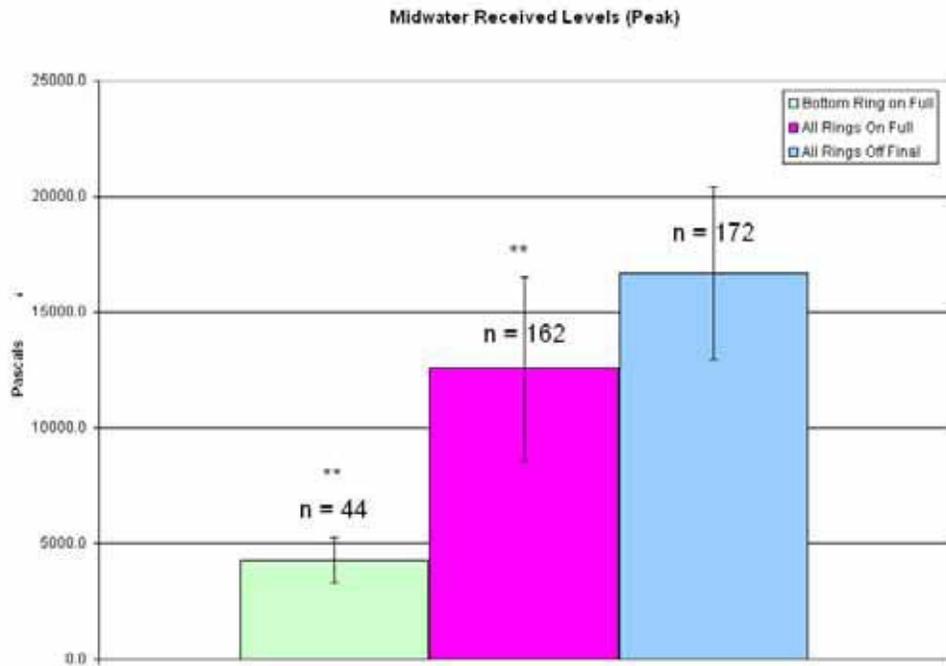
Figure 30 shows the average peak underwater sound pressure levels for Pile 6 ( $\pm$  one standard deviation). Midwater received peak level statistical comparisons made to the final bubbles off condition indicated that all were significantly lower. The greatest sound reduction was measured when only the bottom ring was on full.

**Figure 30. Pile 6, midwater average peak received levels. Error bars represent one standard deviation. \* = Significant compared to bubbles off initial ( $p < 0.05$ ). \*\* Significant compared to bubbles off final ( $p < 0.05$ )**

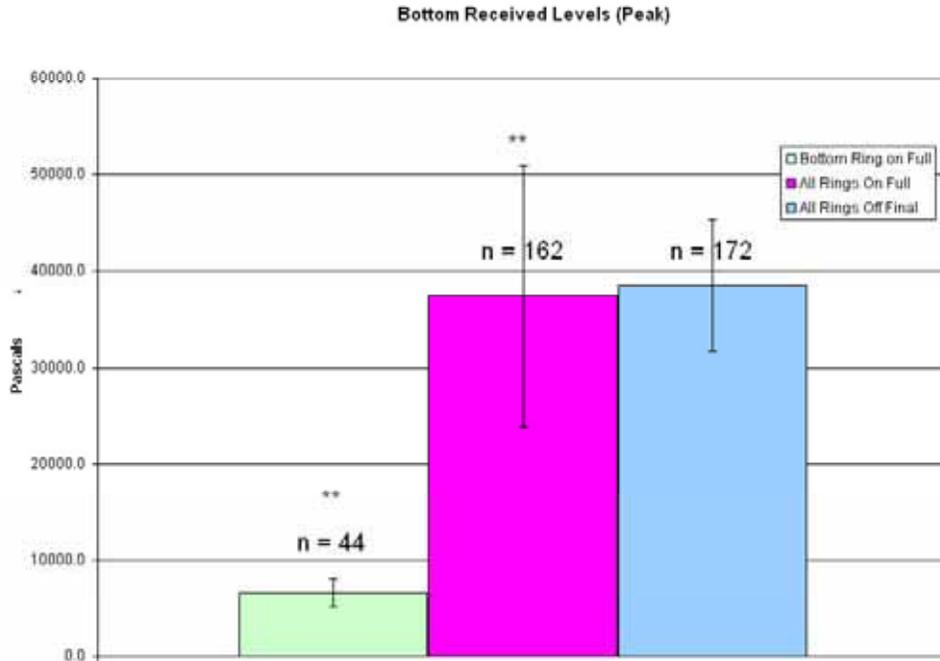
Figure 31 indicates the average peak underwater sound pressure levels for Pile 6 ( $\pm$  one standard deviation). Bottom received peak level statistical comparisons made to the final bubbles off condition indicated that all were significantly lower.

**Figure 31. Pile 6, bottom average peak received levels. Error bars represent one standard deviation. \* = Significant compared to bubbles off initial ( $p < 0.05$ ). \*\* Significant compared to bubbles off final ( $p < 0.05$ )**

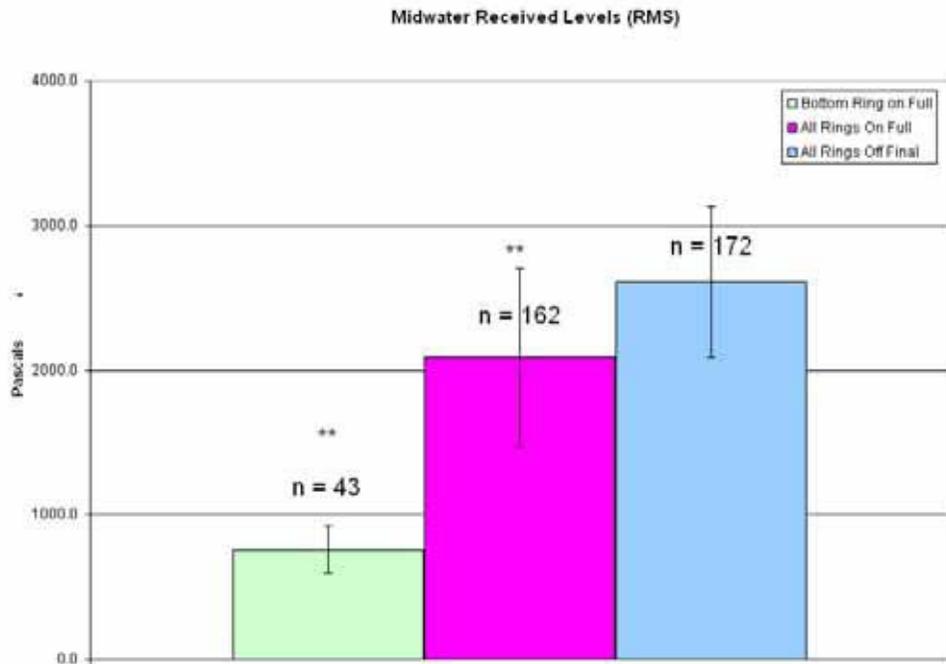
**Figure 32. Pile 6, midwater average RMS received levels. Error bars represent one standard deviation. \* = Significant compared to bubbles off initial (p<0.05). \*\* Significant compared to bubbles off final (p<0.05)**

Midwater received RMS levels were compared statistically with the final bubbles off condition and all were significantly lower (Figure 32). Bottom received RMS levels were statistically compared with the final bubbles off condition and only the bottom ring only on full was significantly lower (Figure 33).

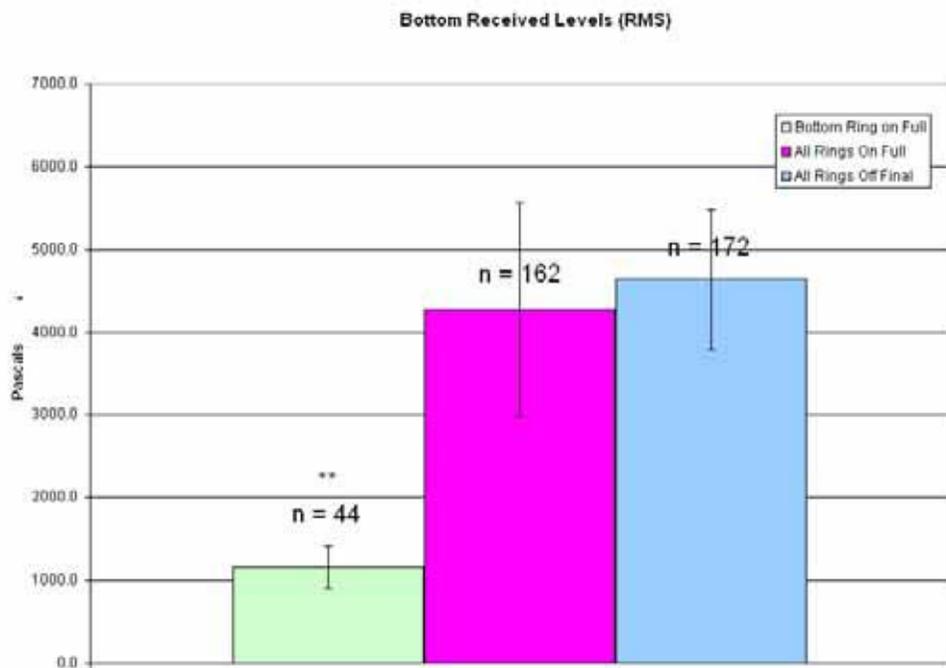
**Figure 33. Pile 6, bottom average RMS received levels. Error bars represent one standard deviation. \* = Significant compared to bubbles off initial (p<0.05). \*\* Significant compared to bubbles off final (p<0.05)**

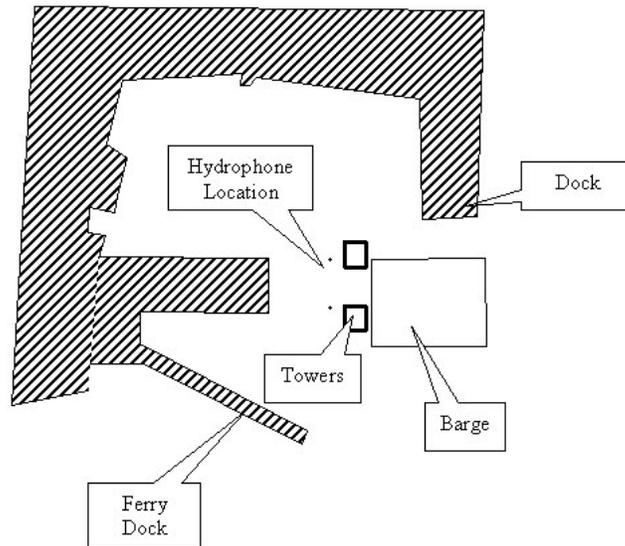
Figure 34 is a diagrammatic drawing of the hydrophone monitoring location in relation to the shoreline and other structures in the water for piles 7 and 8. The drawing is not to scale.

**Figure 34. Diagram of Monitoring Location in Relation to the Shoreline and Other Nearby Structures.**

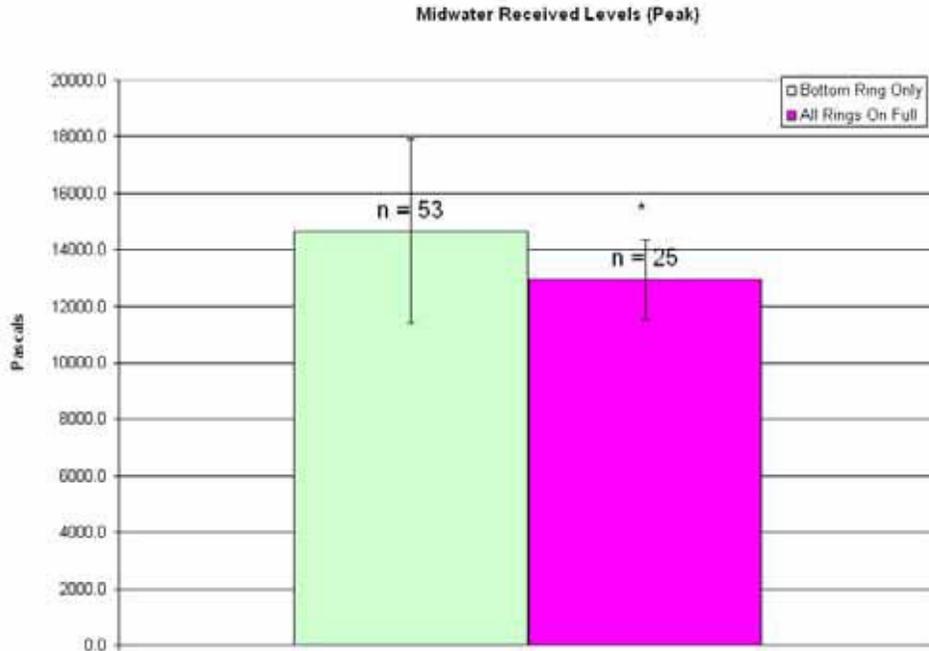
Figure 35 shows the average peak underwater sound pressure levels for Pile 7 ( $\pm$  one standard deviation). Midwater received peak level statistical comparisons made between the bottom ring only and all rings on full indicate that the all rings on full condition was significantly lower.

**Figure 35. Pile 7, midwater average peak received levels. Error bars represent one standard deviation. \* = Significant compared to bbottom ring on only (p<0.05).**

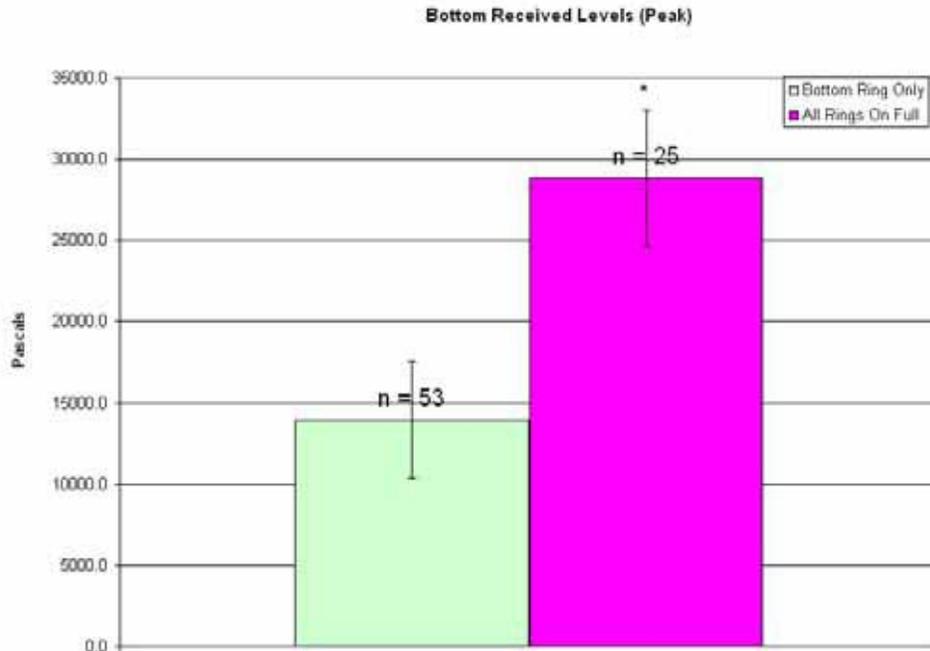
Figure 36 indicates the average peak underwater sound pressure levels for Pile 7 ( $\pm$  one standard deviation). Bottom received peak level statistical comparisons made between the bottom ring only and all rings on full conditions indicate that the all rings on full was significantly higher.

**Figure 36. Pile 7, bottom average peak received levels. Error bars represent one standard deviation. \* = Significant compared to bottom ring on only ( $p < 0.05$ ).**

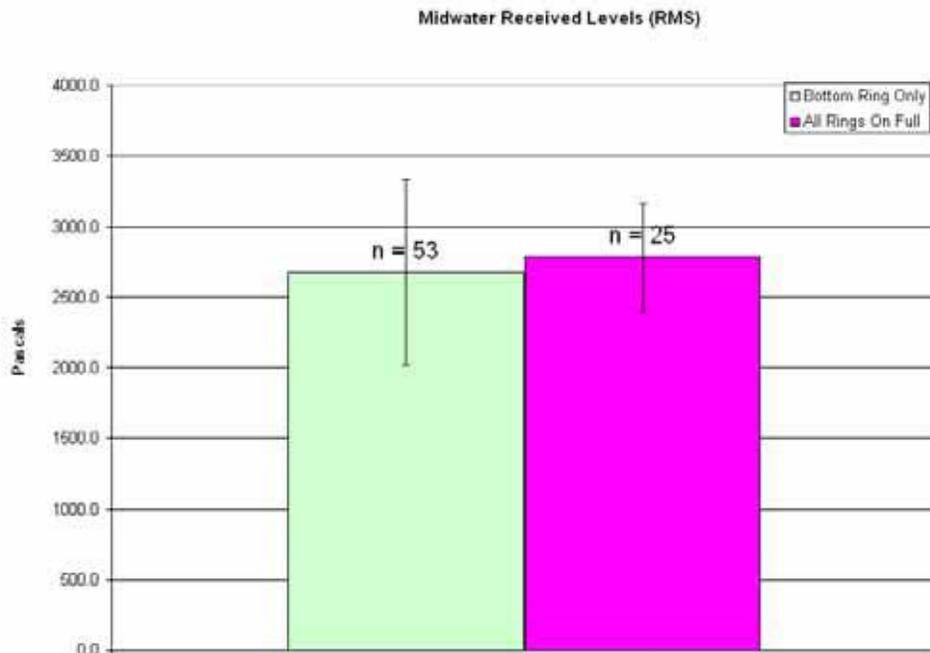
**Figure 37. Pile 7, midwater average RMS received levels. Error bars represent one standard deviation. \* = Significant compared to bottom ring on only ( $p < 0.05$ ).**

RMS and SEL values indicated very little difference between the bottom ring on only and the all rings on full conditions (Figure 37 & 38) for both midwater and bottom received RMS levels. Only the all rings on full condition at the bottom hydrophone was significantly greater than the bottom ring on only condition.

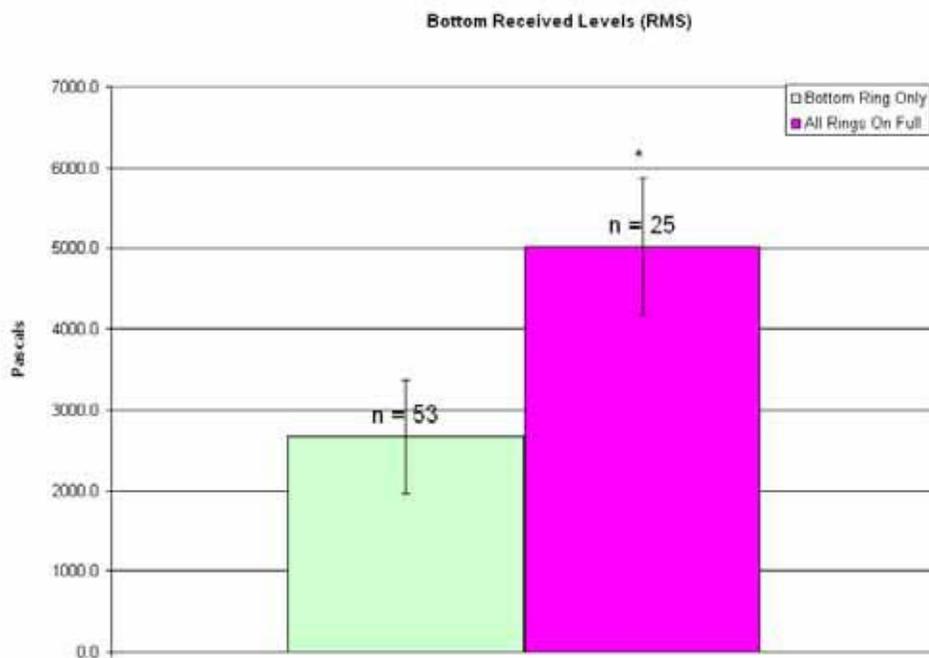
**Figure 38. Pile 7, bottom average RMS received levels. Error bars represent one standard deviation. \* = Significant compared to bottom ring on only ( $p < 0.05$ ).**

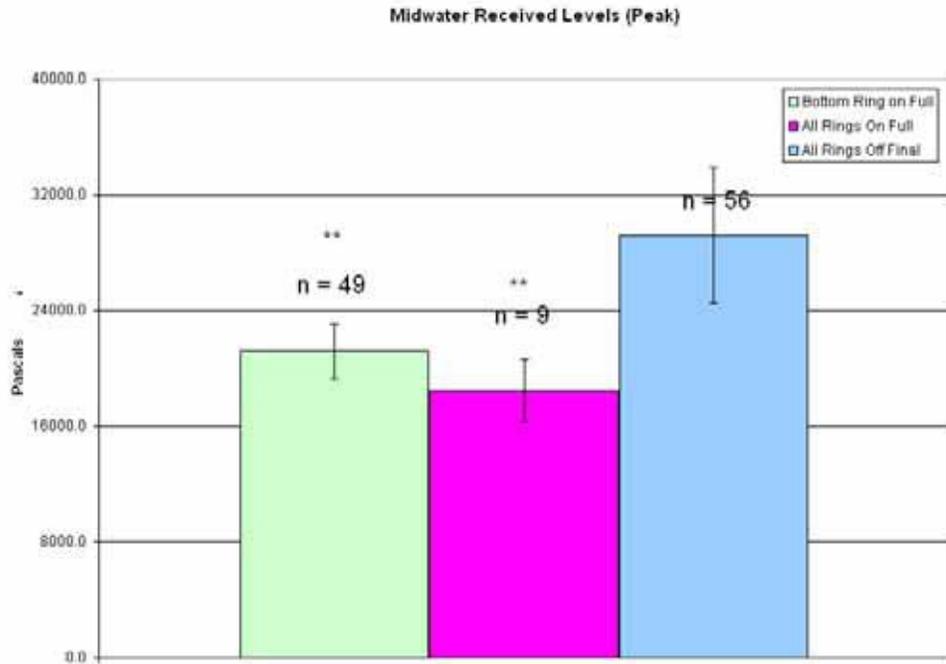
Figure 39 shows the average peak underwater sound pressure levels for Pile 8 ( $\pm$  one standard deviation). Midwater received peak levels were statistically compared with the final bubbles off condition and all were significantly lower

**Figure 39. Pile 8, midwater average peak received levels. Error bars represent one standard deviation. \* = Significant compared to bubbles off initial ( $p < 0.05$ ). \*\* Significant compared to bubbles off final ( $p < 0.05$ )**

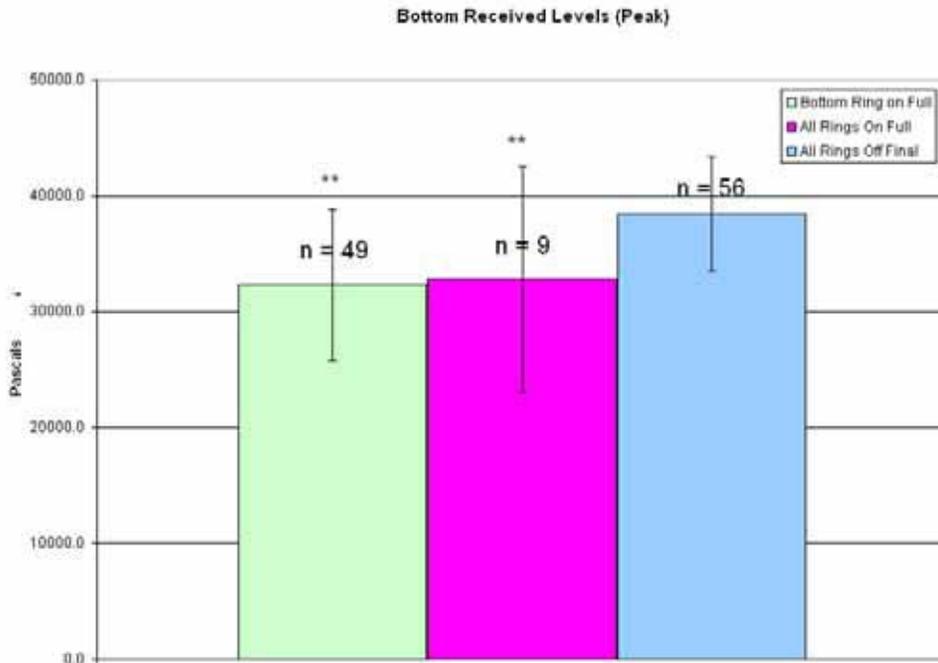
Figure 40 indicates the average peak underwater sound pressure levels for Pile 8 ( $\pm$  one standard deviation). Bottom received peak levels were statistically compared with the final bubbles off condition and all were significantly lower

**Figure 40. Pile 1, bottom average peak received levels. Error bars represent one standard deviation. \* = Significant compared to bubbles off initial ( $p < 0.05$ ). \*\* Significant compared to bubbles off final ( $p < 0.05$ )**

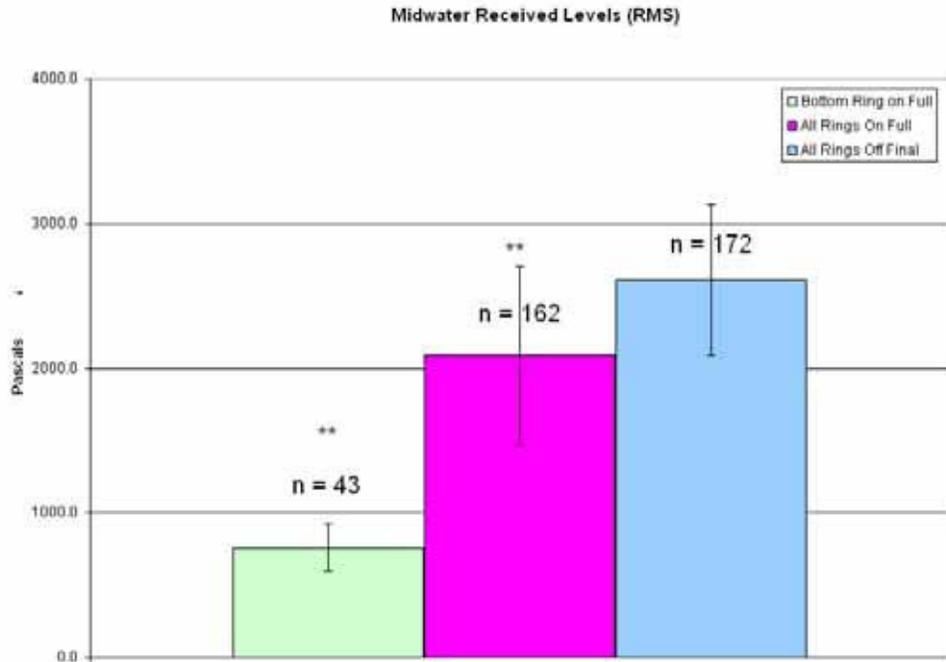
**Figure 41. Pile 8, midwater average RMS received levels. Error bars represent one standard deviation. \* = Significant compared to bubbles off initial (p<0.05). \*\* Significant compared to bubbles off final (p<0.05)**

Midwater received RMS levels were compared statistically with the final bubbles off condition and all were significantly lower (Figure 41). Bottom received RMS levels were statistically compared with the final bubbles off condition and all were significantly lower (Figure 42).

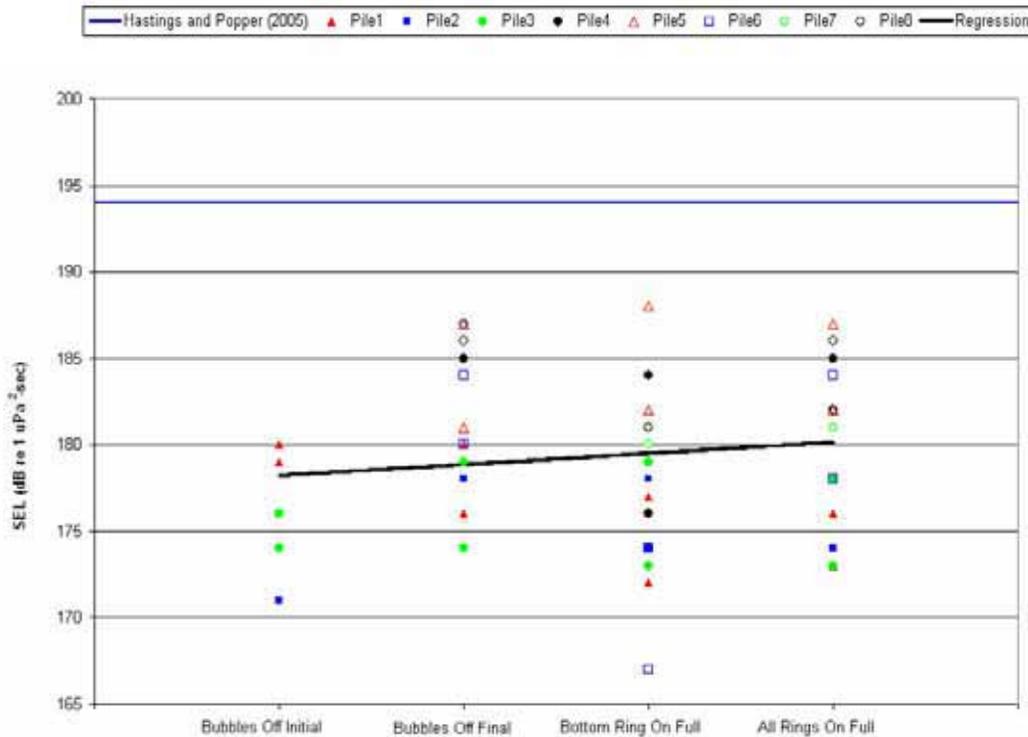
SEL was calculated for each of the absolute peak strikes for each pile and for each bubble curtain scenario. Figure 43 graphically shows the overall trend for SEL for each bubble curtain scenario. As can be seen in Figure 43 none of the SEL values exceeded the proposed threshold of 194 dB SEL from Hastings and Popper (2005). Because decibels are on a logarithmic scale, it would require a substantially more energy to exceed this threshold. Although there is considerable variation between the individual strikes for each pile we have included a regression line indicating a general increase in SEL with increasing air flow.

**Figure 43. SEL values for each pile compared with the 194 dB SEL proposed threshold from Hastings and Popper (2005). Regression line formula is:  $y=0.639X + 177.6$ .**

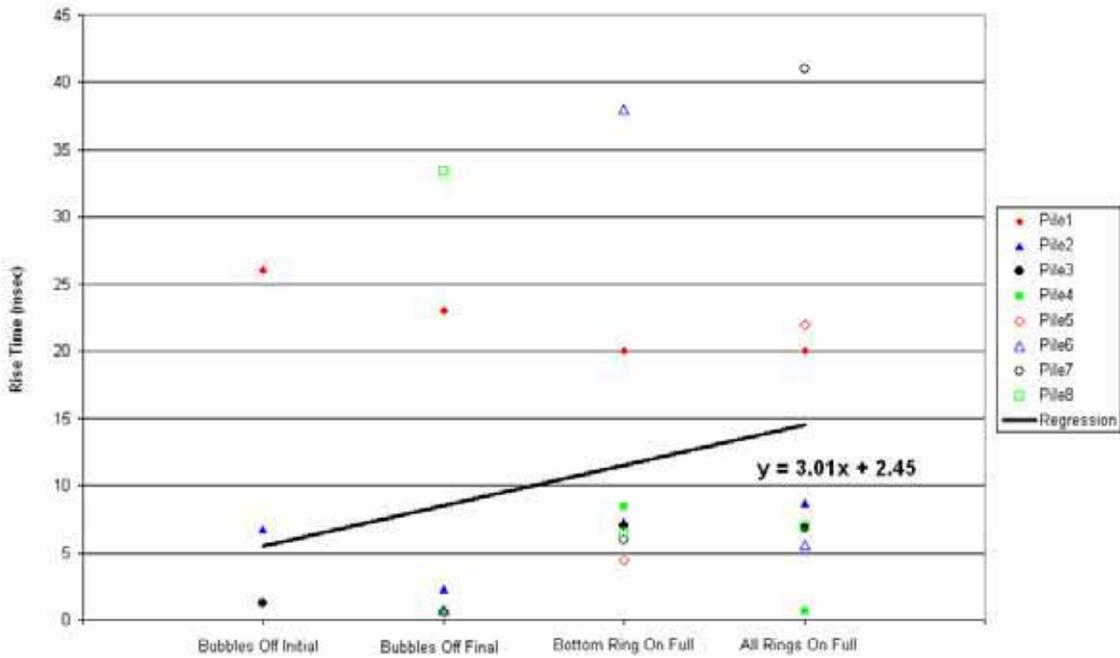
**Figure 44. Rise times for each bottom received level peak pile strike with linear regression line**

Rise time, however, indicates a clear increase in the midwater received levels (Figure 44) as more air is supplied to the bubble curtain. Some of the highest rise times seen in Figure 44 are actually the ringing of the pile. However, for the bottom received levels, rise times were generally lower and this trend is not as clear (Figure 45). The bubble curtain differentially attenuates high frequencies. It is also possible that some sound may have “bounced” between

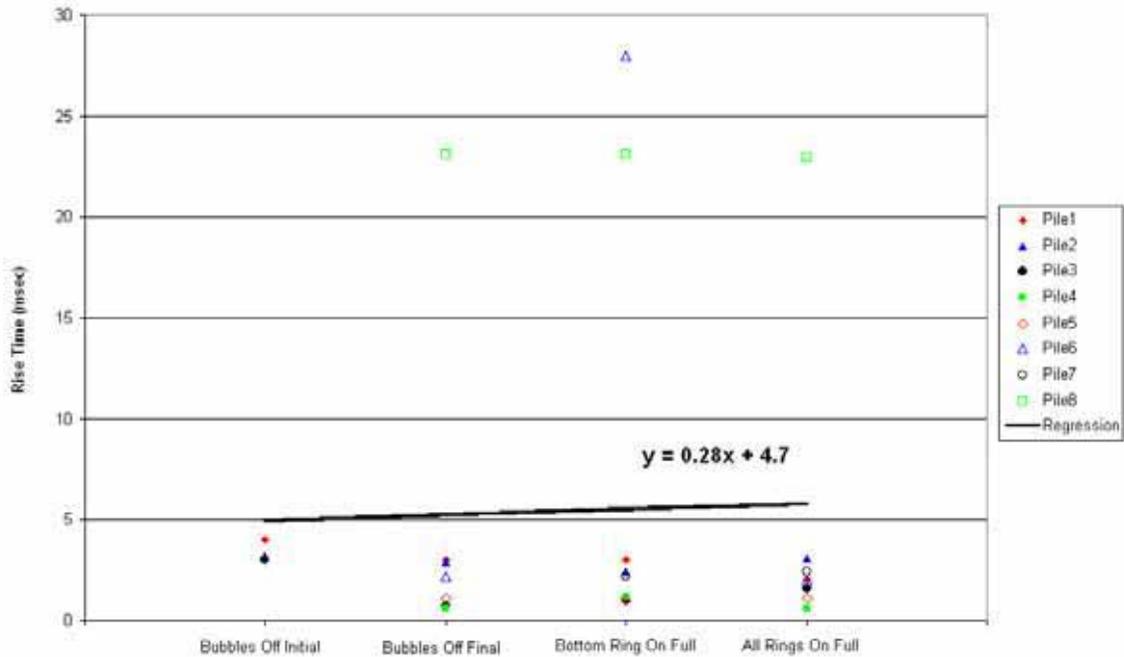
**Figure 45. Rise times for each bottom received level peak pile strike with linear regression line.**

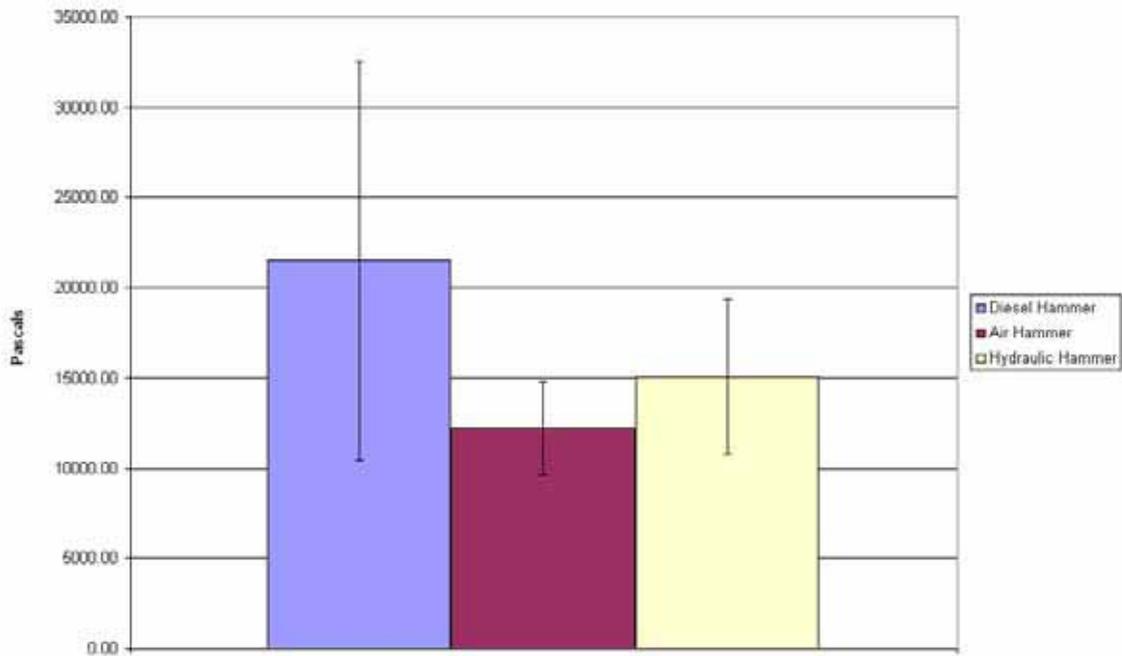
**Figure 46. Average absolute peak midwater received values for each hammer type, all bubble rings off. Error bars are  $\pm$  one standard deviation.**

Figure 46 appears to indicate that the diesel hammer created absolute peak levels that were higher than the other two hammer types. However, because of the large degree of variability indicated by the error bars it would appear that generally there was no substantial difference between the diesel hammer, the air hammer, and the hydraulic hammer.

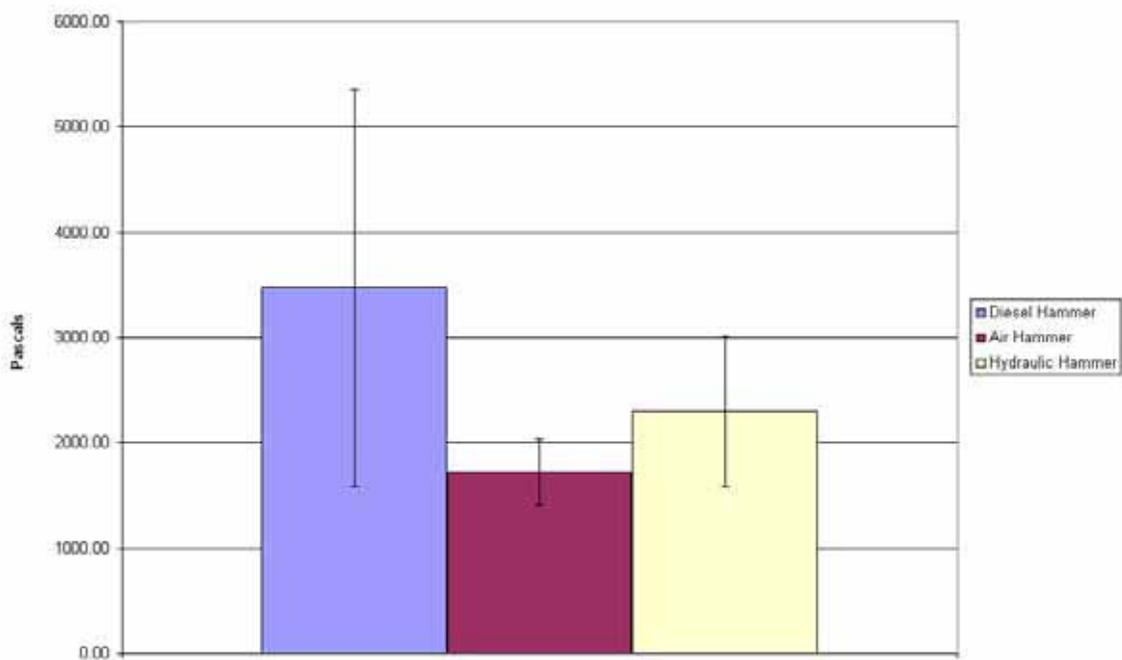
**Figure 47. Average RMS midwater received values for each hammer type, all bubble rings off. Error bars are  $\pm$  one standard deviation**

Average midwater received RMS values are shown in figure 47. The figure indicates that the diesel hammer had the highest RMS values. However, because of the large degree of variability between the samples there is no substantial difference between the three hammer types for RMS.

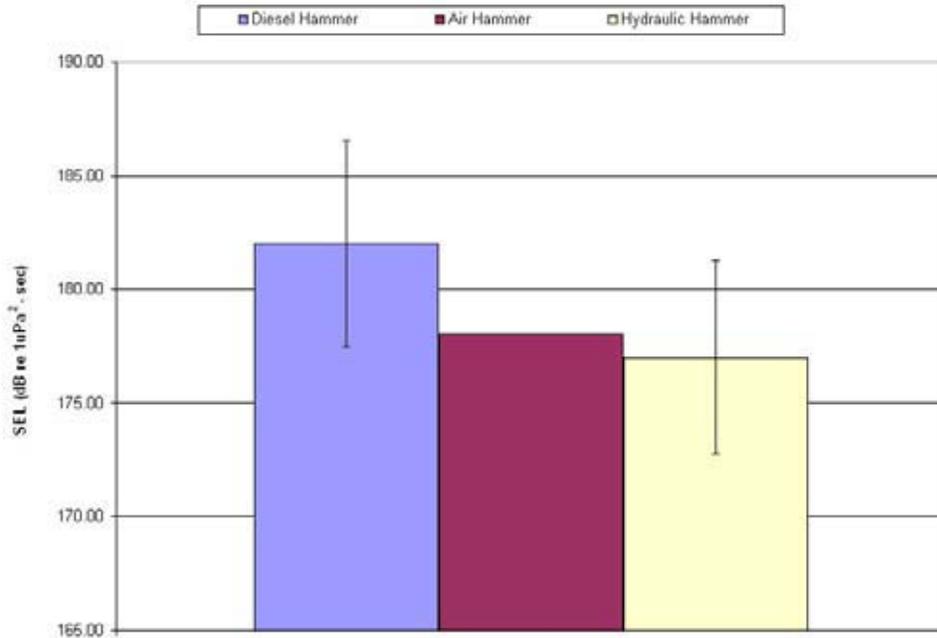
**Figure 48. SEL midwater received values for each hammer type, all bubble rings off. Error bars are  $\pm$  one standard deviation. SEL for the air hammer represents only one sample.**

Average midwater received SEL values shown in Figure 48 indicate that the diesel hammer had the highest SEL values. Again due to the relatively small sample size and the high degree of variability between values there is no substantial difference between the three hammer types for SEL.

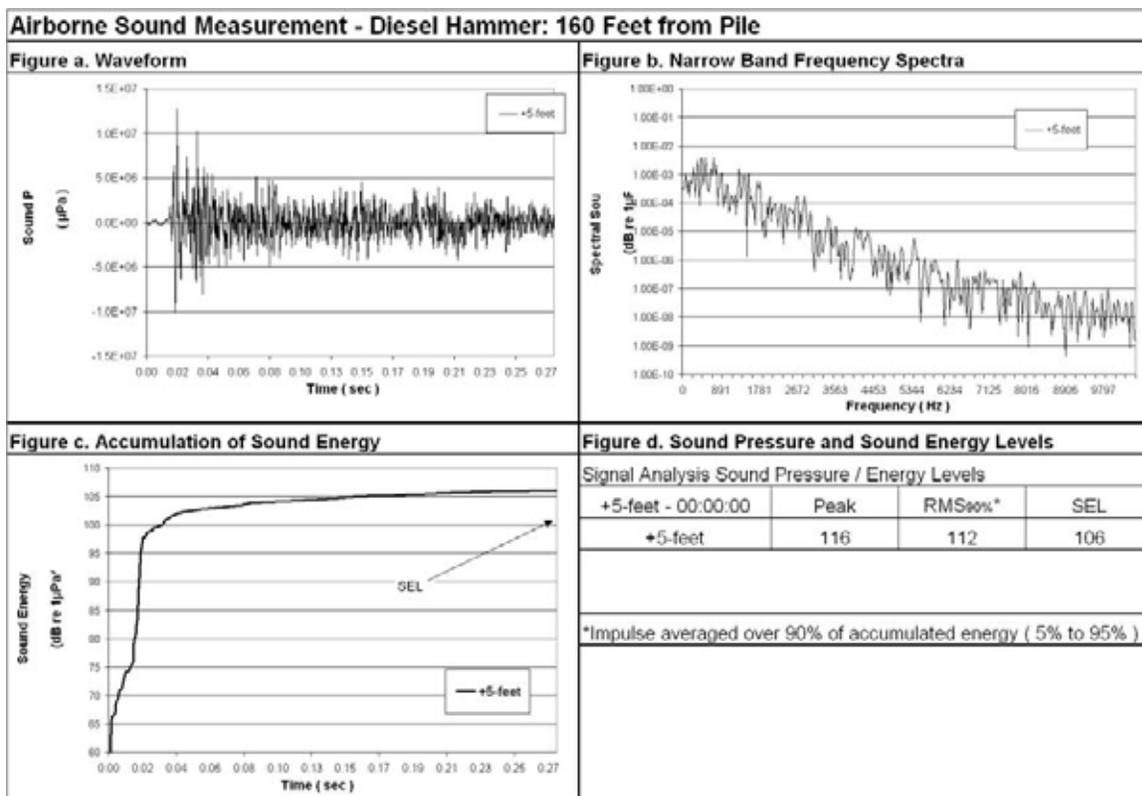
**Figure 49: Airborne Sound Levels of a Diesel Pile Driver and Steel Pile , 160 feet from pile.**

Airborne sound levels were measured with a standard airborne free field microphone. The microphone was mounted on a tripod approximately 5 feet above the water surface. Figure 8 presents the waveform analysis results of the airborne sound level measurements. The peak sound level was 116 dB<sub>peak</sub> re: 20 micropascals. The RMS value 112 dB re: 20 micropascal and the SEL value was 106 dB re: 20 micropascals. The rise time was moderate at 5.7 seconds.

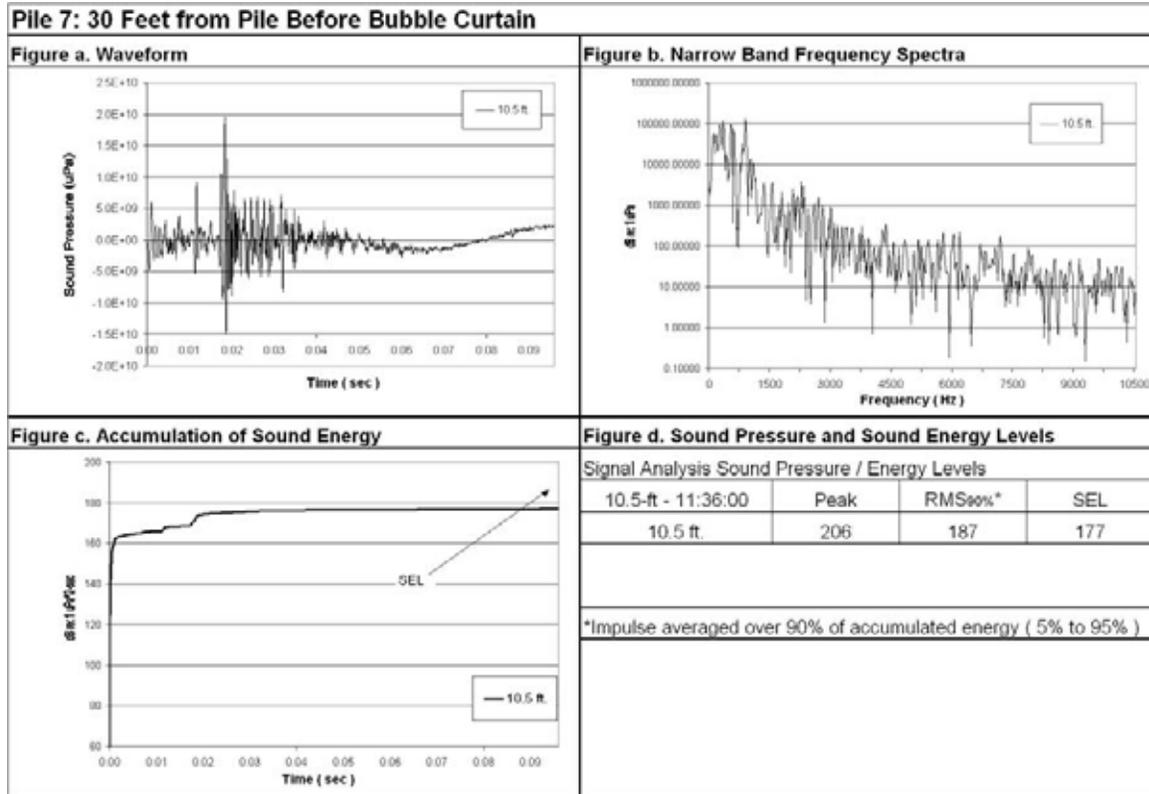
**Figure 50: Results of Sound Pressure Levels without Bubble Curtain**

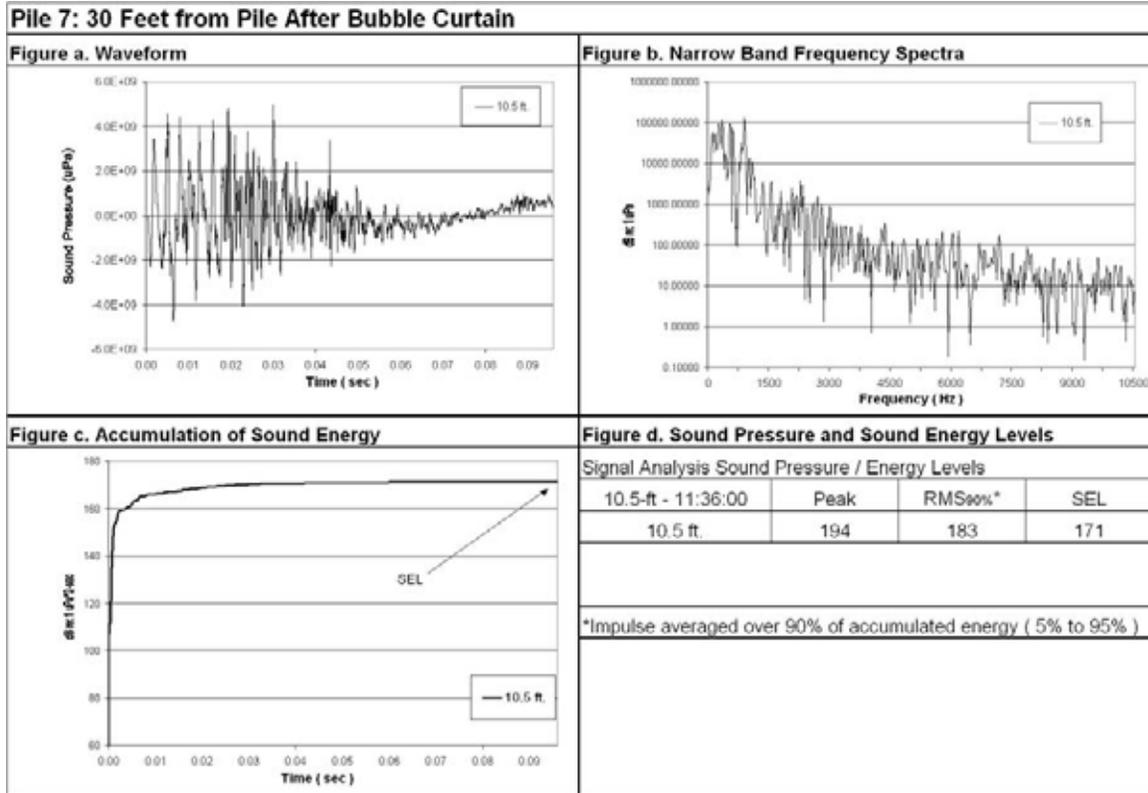
**Figure 51: Results of Sound Pressure Levels with Bubble Curtain.**

In September of 2004 the newly designed bubble curtain system was tested on 24-inch steel piles and a diesel hammer. Results indicated that with the bubble curtain sound levels at the midwater hydrophone were reduced to 194 dB (re: 1 micropascal), RMS was 182 dB and the SEL was 171 dB. This was a 12 dB reduction in sound levels.

Sound levels for the hydrophone placed one foot from the bottom did not show any noticeable change in sound level. The reason for this difference between the two hydrophones is not clear, however, it could be that the bottom mounted hydrophone was measuring additional sound that was flanking through the sediment or was located in some unusual amplification node of sound reflected off of the various structures and bottom sediment in the area.

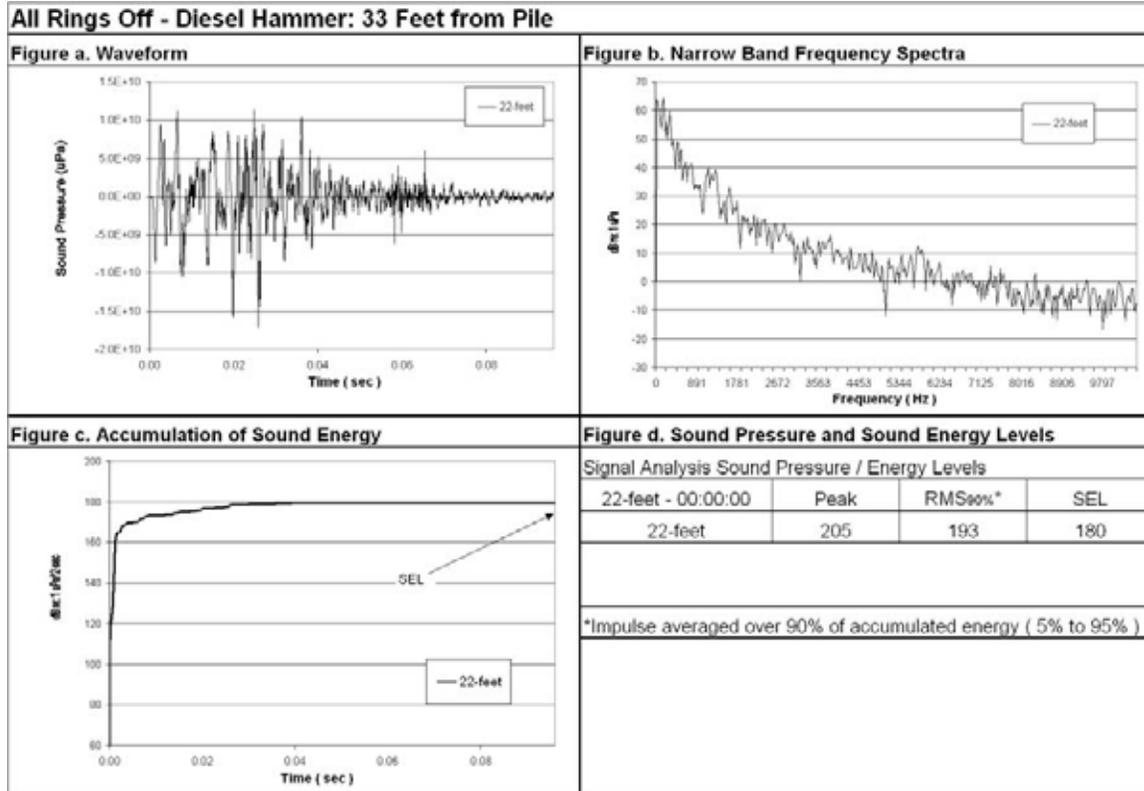
**Figure 52: Waveform Analysis for Pile Number 1, 22-Feet Deep, 33-Feet from Pile, All Rings Off.**
