*FRIDAY HARBOR FERRY TERMINAL RESTORATION PROJECT*

**UNDERWATER SOUND LEVELS  
ASSOCIATED WITH RESTORATION OF  
THE FRIDAY HARBOR FERRY  
TERMINAL**

*Prepared by:  
Jim Laughlin  
Washington State Department of Transportation  
Office of Air Quality and Noise  
15700 Dayton Avenue North, P.O. Box 330310  
Seattle, WA 98133-9710*

**May 2005**

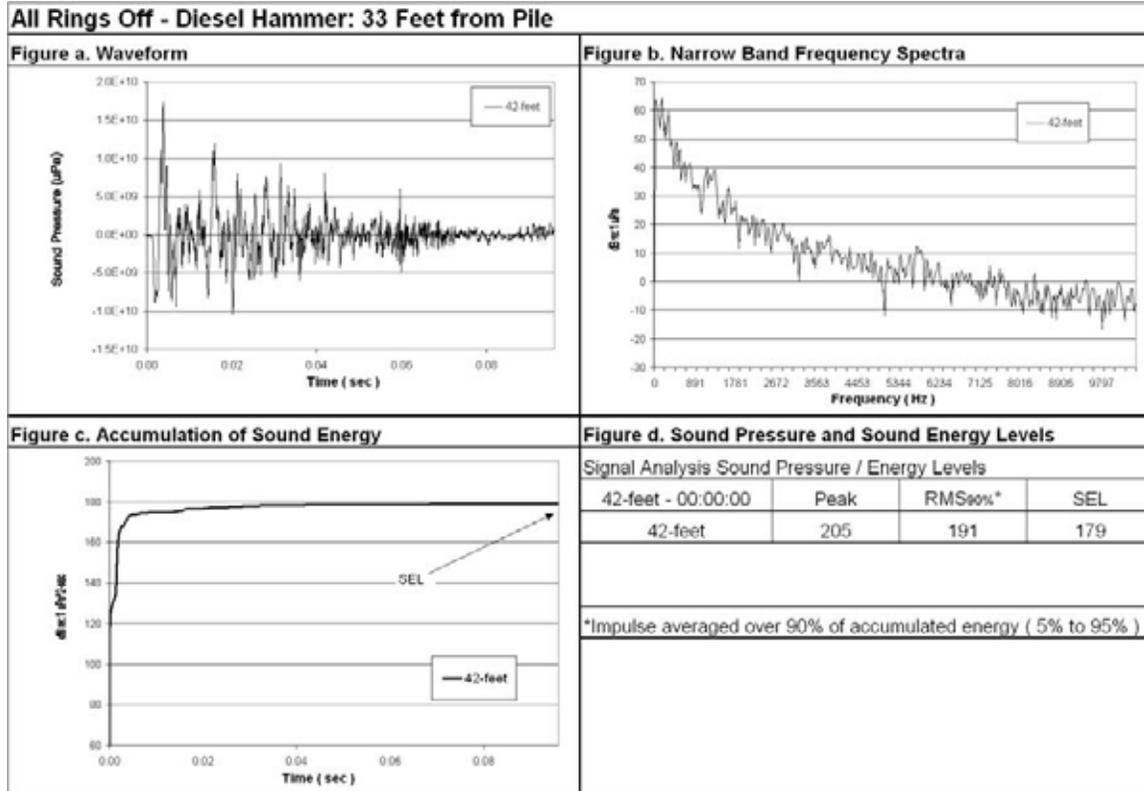
**Figure 53: Waveform Analysis for Pile Number 1, 42-feet (Bottom), 33-Feet from Pile, All Rings Off.**

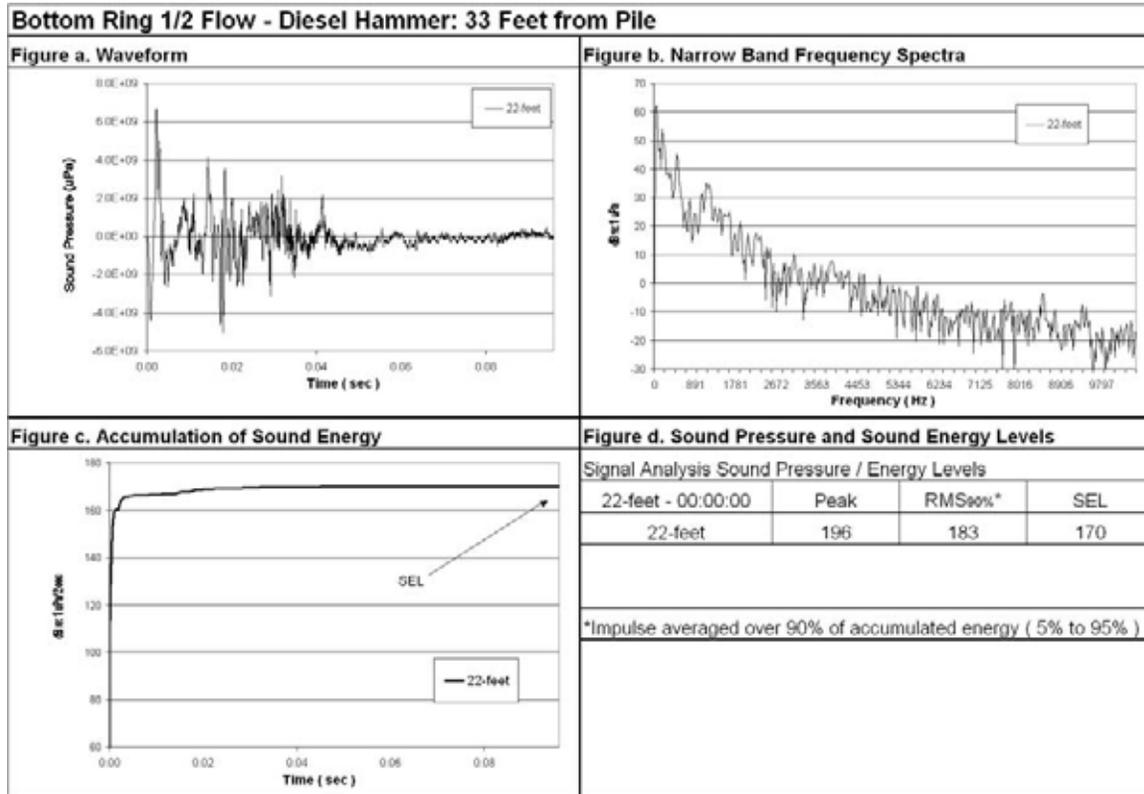
**Figure 54: Waveform Analysis for Pile Number 1, 22-Foot Deep, 33-Foot from Pile, Bottom Ring 1/2 Flow.**

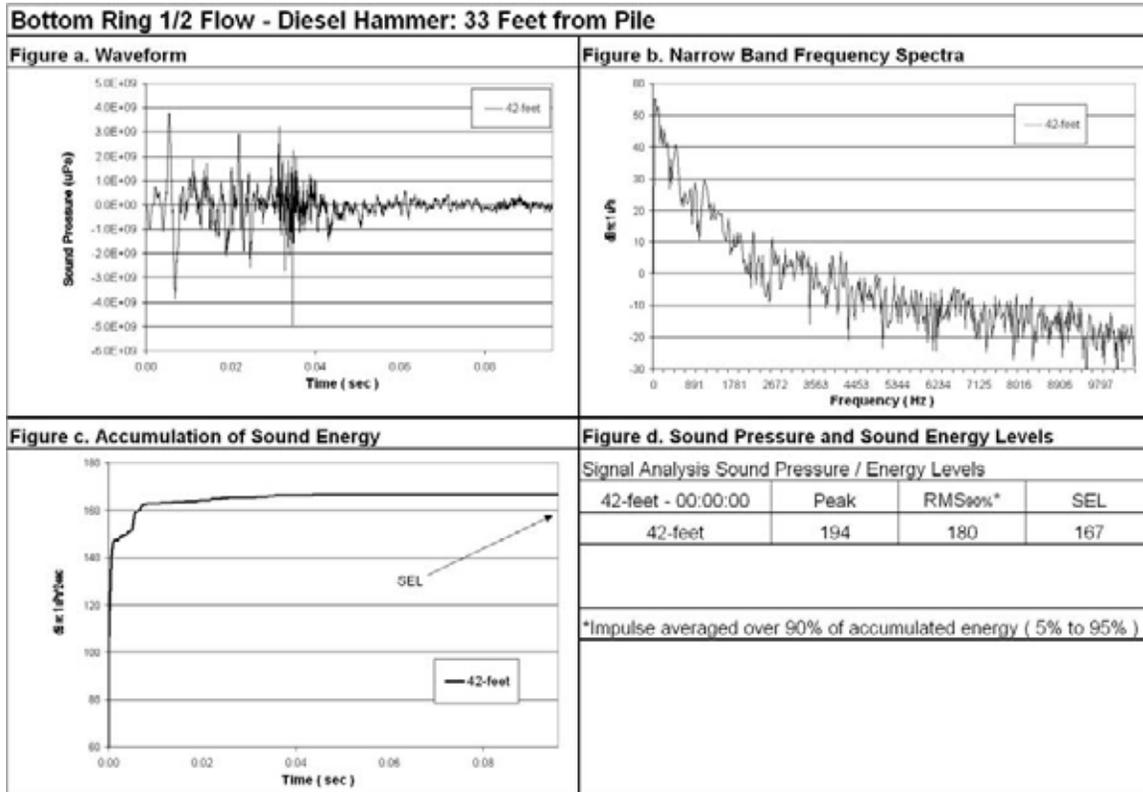
**Figure 55: Waveform Analysis for Pile Number 1, 42-foot Deep (Bottom), 33-Foot from Pile, Bottom Ring 1/2 Flow.**

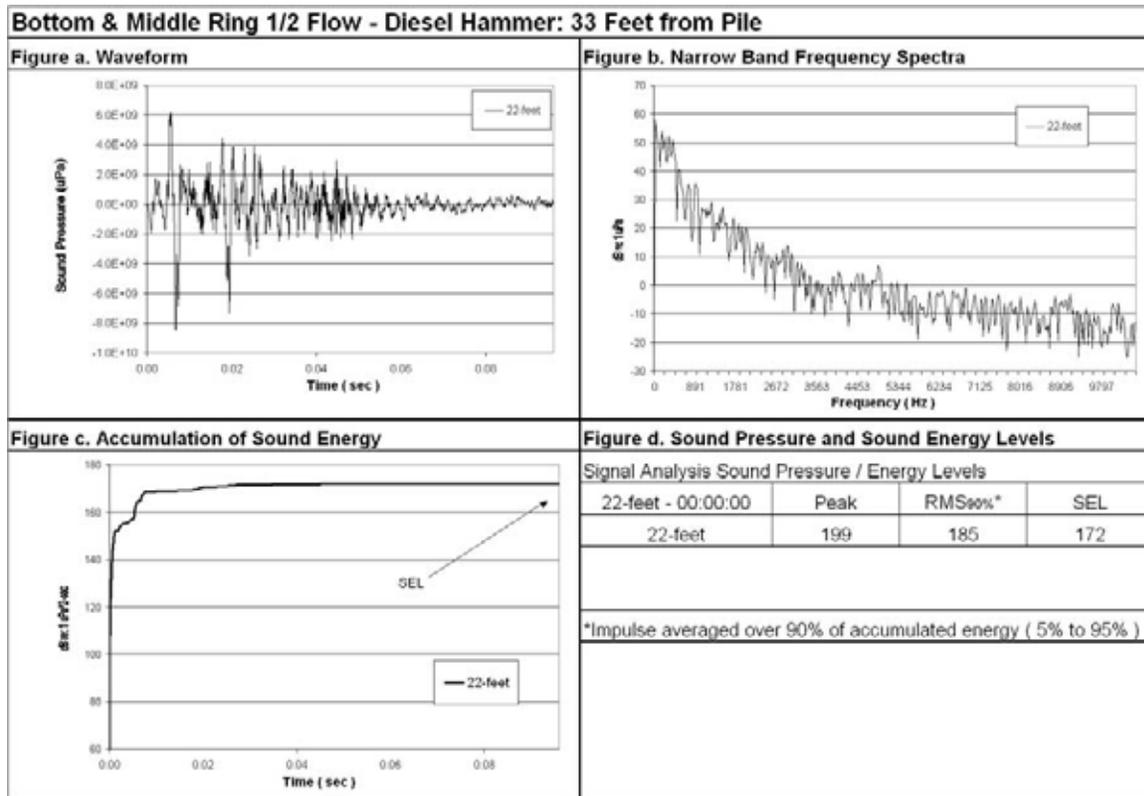
**Figure 56: Waveform Analysis for Pile Number 1, 22-foot Deep, 33-Foot from Pile, Bottom and Middle Ring 1/2 Flow.**

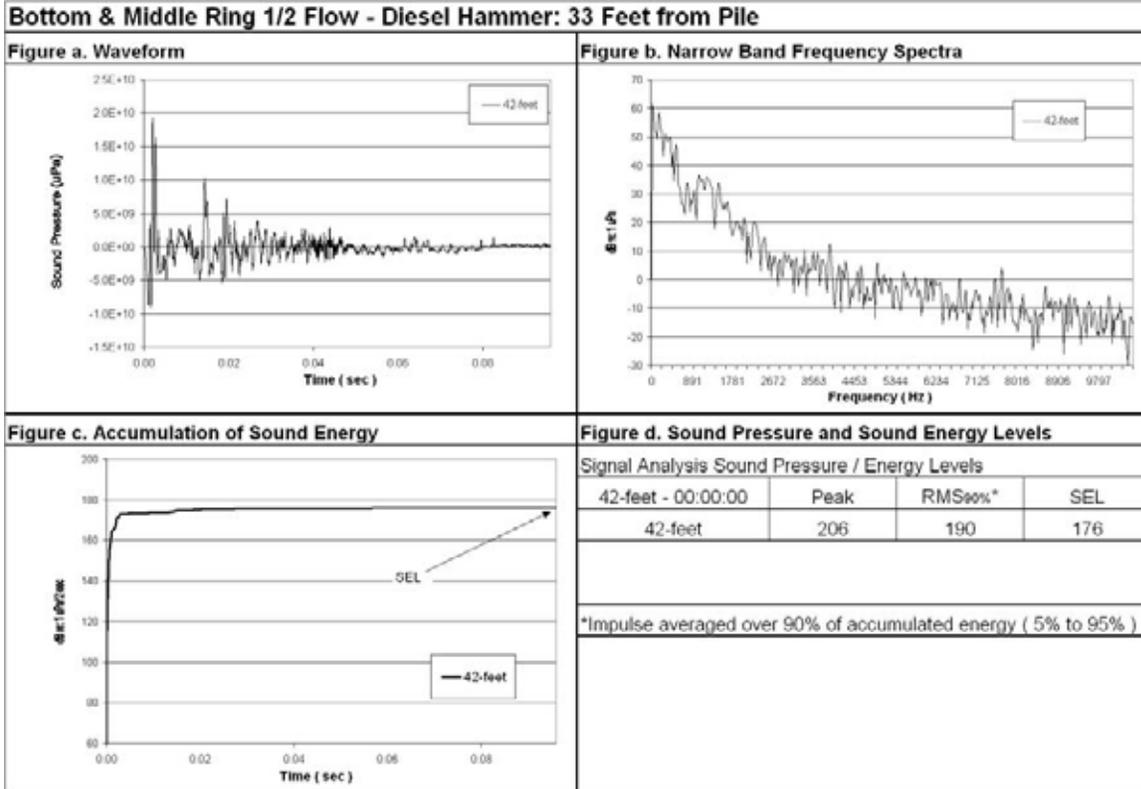
**Figure 57: Waveform Analysis for Pile Number 1, 42-foot Deep (Bottom), 33-Foot from Pile, Bottom and Middle Ring 1/2 Flow.**

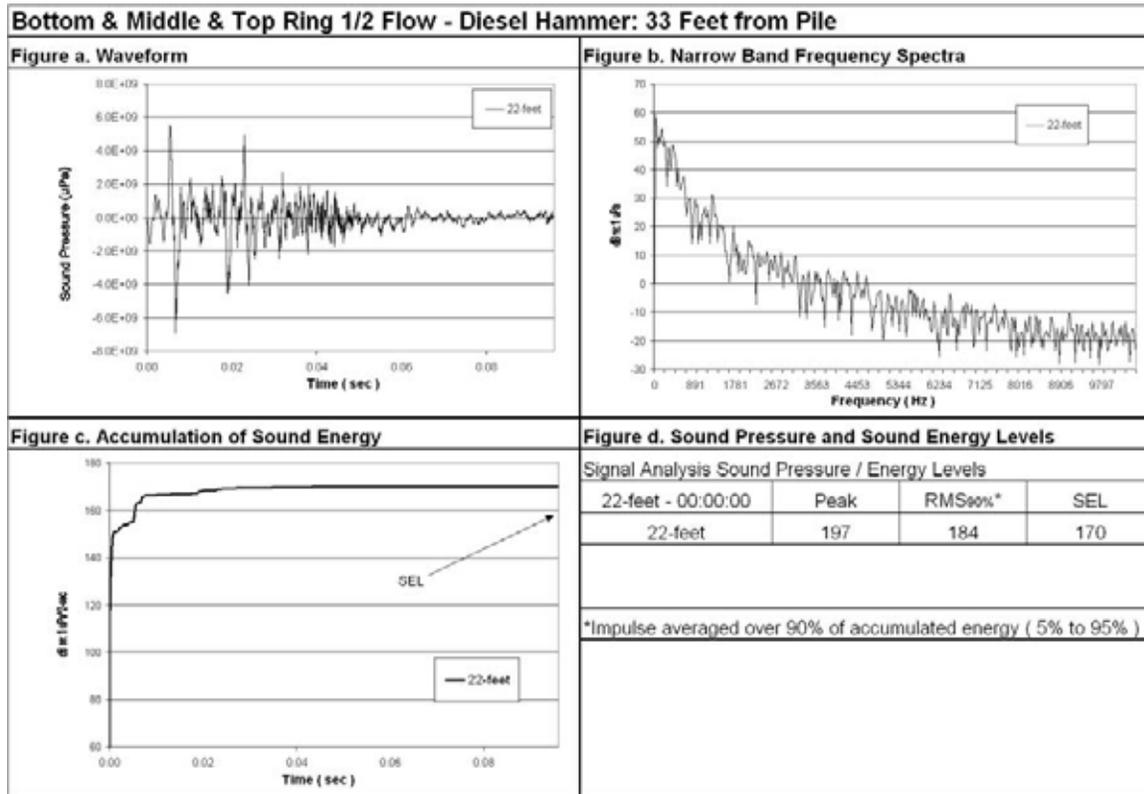
**Figure 58 Waveform Analysis for Pile Number 1, 22-feet Deep, 33-Feet from Pile, Bottom, Middle, and Top Ring 1/2 Flow.**

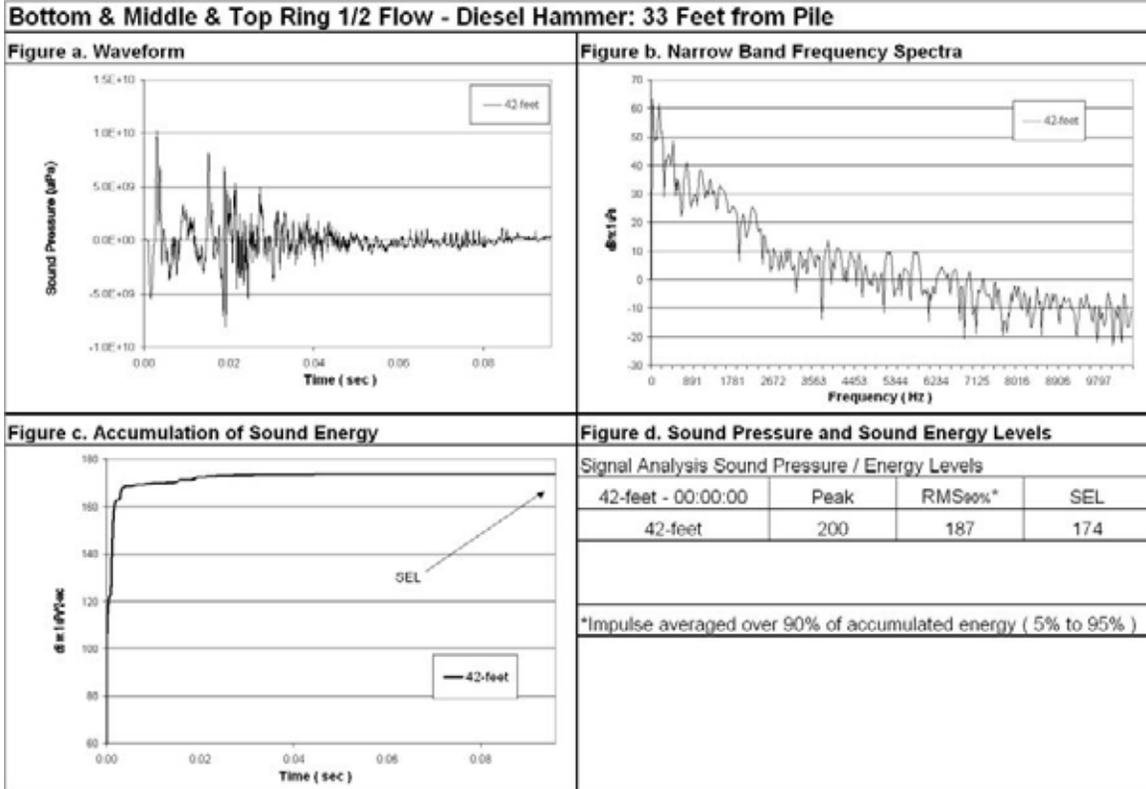
**Figure 59 Waveform Analysis for Pile Number 1, 42-foot Deep (bottom), 33-Feet from Pile, Bottom, Middle, and Top Ring 1/2 Flow.**

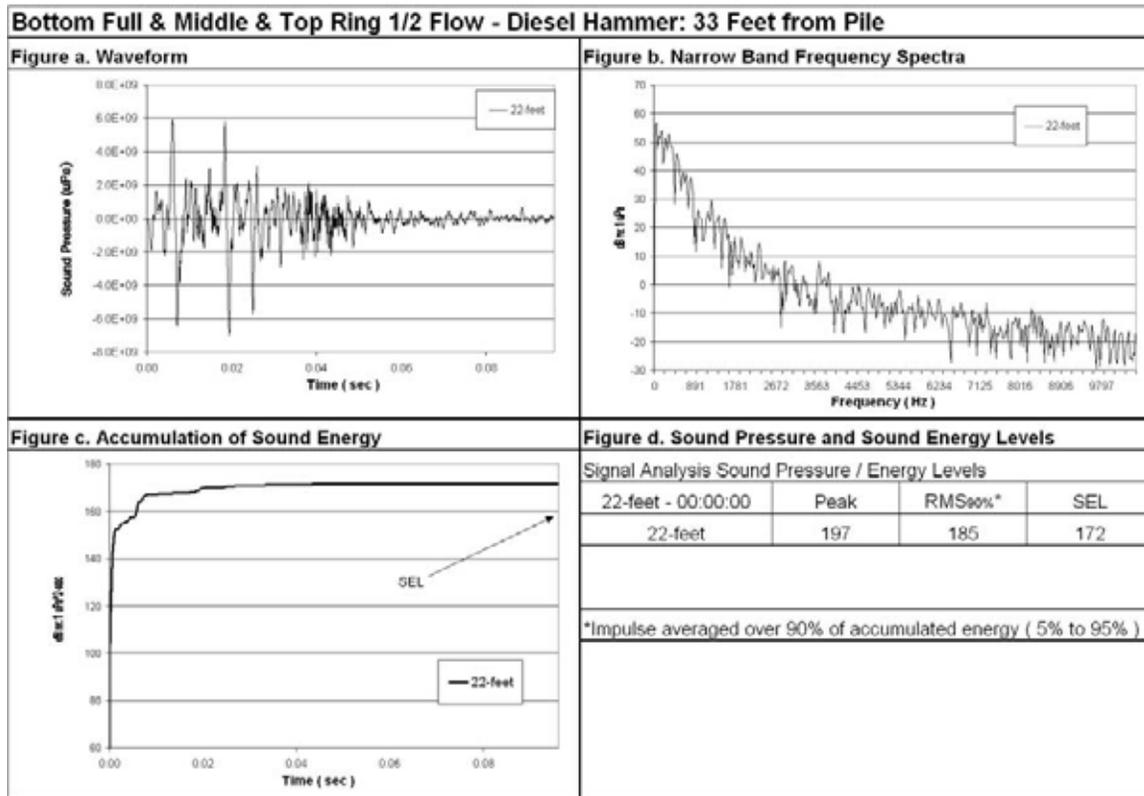
**Figure 60 Waveform Analysis for Pile Number 1, 22-feet Deep, 33-Feet from Pile, Bottom Ring Full Flow, Middle, and Top Ring 1/2 Flow.**

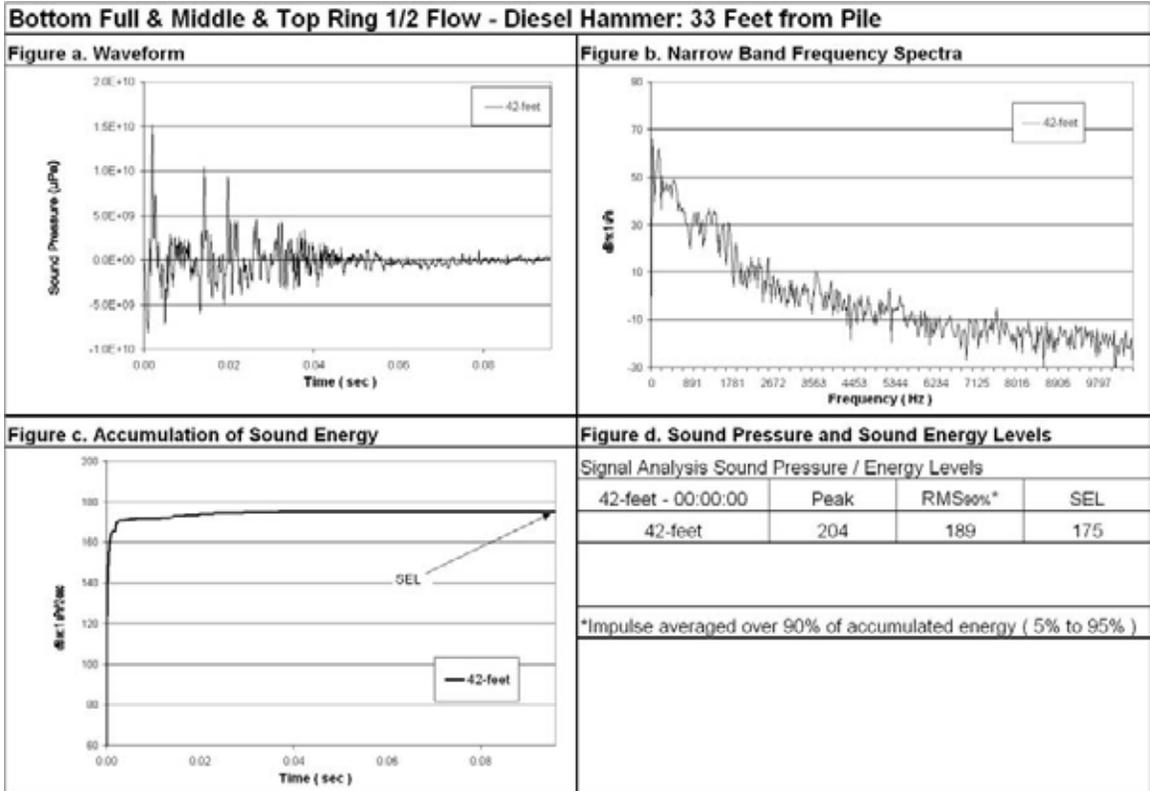
**Figure 61 Waveform Analysis for Pile Number 1, 42-foot Deep (bottom), 33-Feet from Pile, Bottom Ring Full, Middle, and Top Ring 1/2 Flow.**

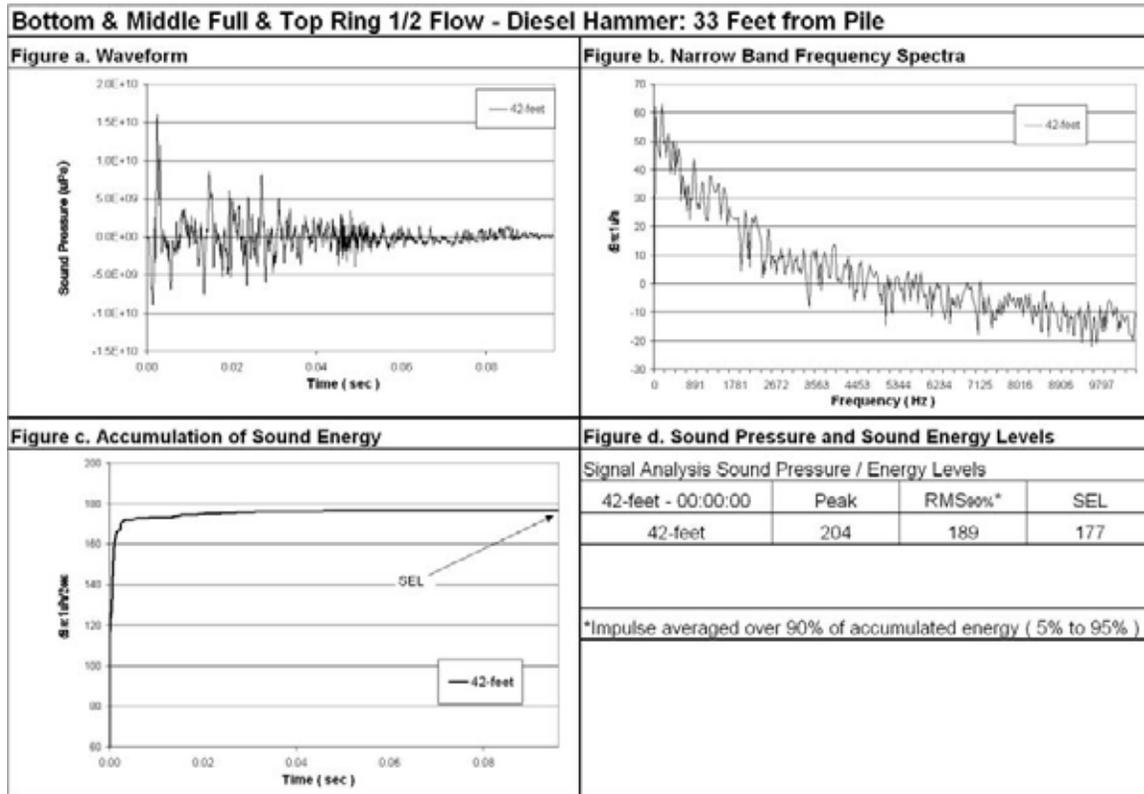
**Figure 62 Waveform Analysis for Pile Number 1, 42-foot Deep (bottom), 33-Feet from Pile, Bottom Ring and Middle Full, Top Ring 1/2 Flow.**

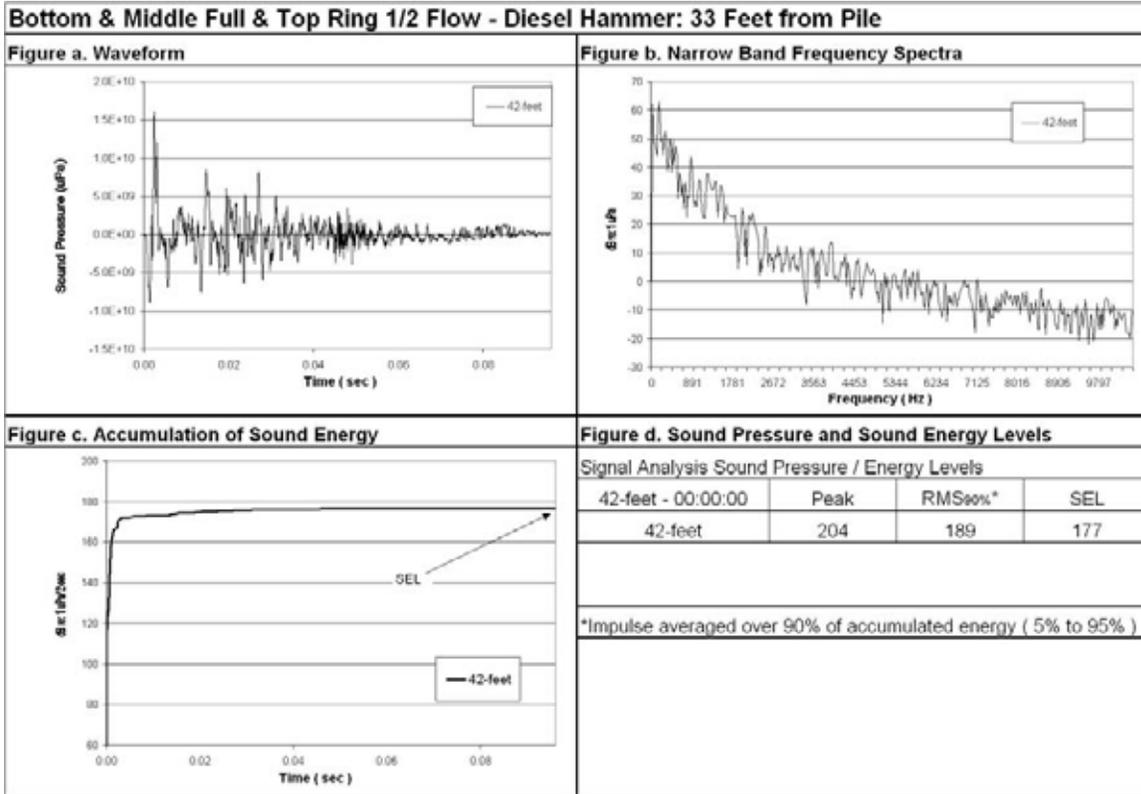
**Figure 63 Waveform Analysis for Pile Number 1, 42-feet Deep (bottom), 33-Feet from Pile, Bottom and Middle Ring Full, Top Ring 1/2 Flow**

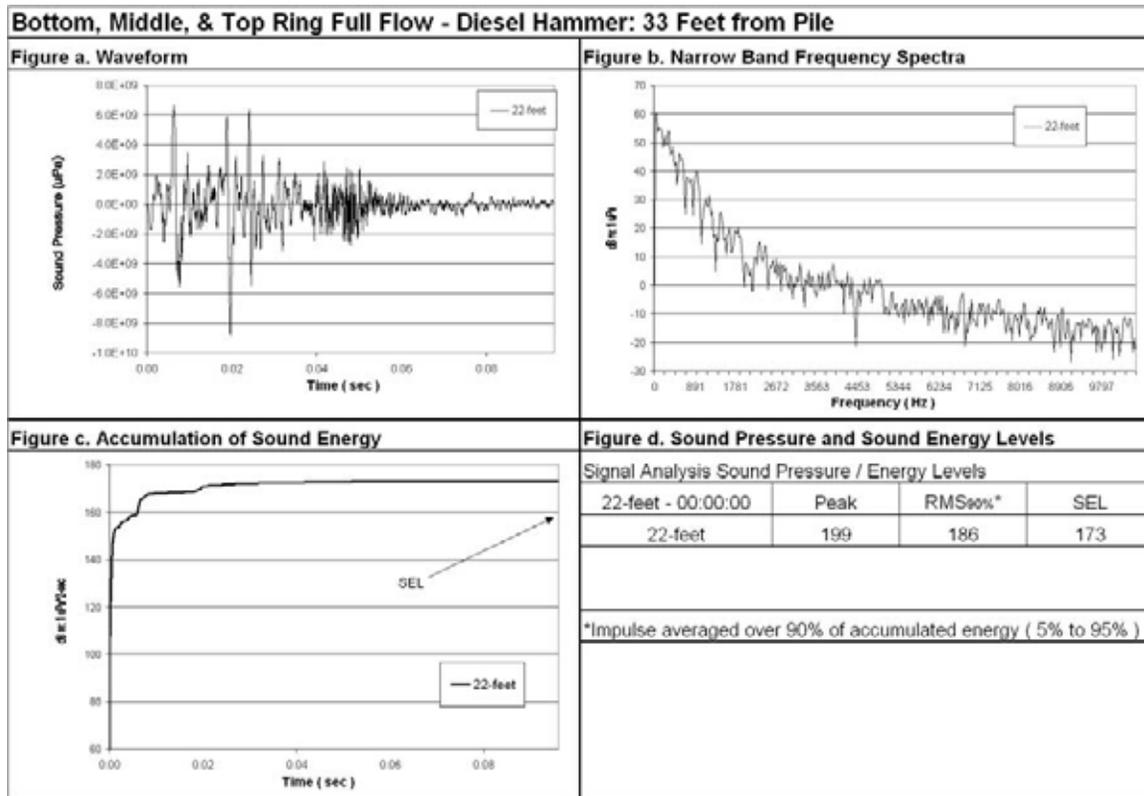
**Figure 64 Waveform Analysis for Pile Number 1, 22-feet Deep, 33-Feet from Pile, Bottom Ring, Middle, and Top Ring Full Flow**

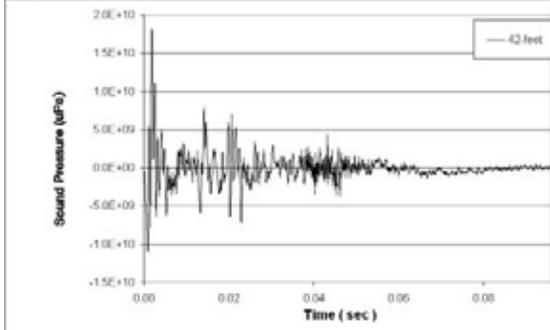
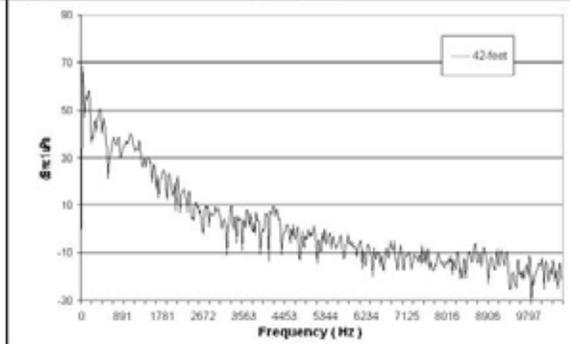
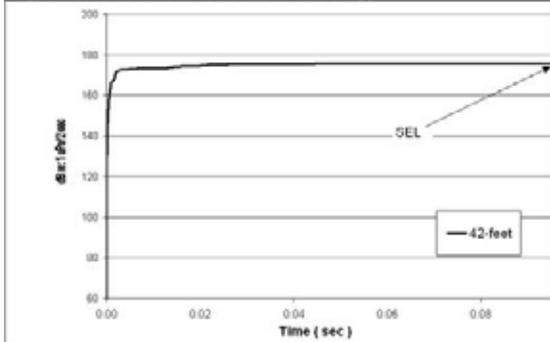
**Bottom, Middle, & Top Ring Full Flow - Diesel Hammer: 33 Feet from Pile**

**Figure a. Waveform**

**Figure b. Narrow Band Frequency Spectra**

**Figure c. Accumulation of Sound Energy**

**Figure d. Sound Pressure and Sound Energy Levels**

Signal Analysis Sound Pressure / Energy Levels			
42-feet - 00:00:00	Peak	RMS <sub>90%</sub> *	SEL
42-feet	205	189	176

**Figure 65 Waveform Analysis for Pile Number 1, 42-foot Deep (bottom), 33-Foot from Pile, Bottom, Middle, and Top Ring Full Flow**

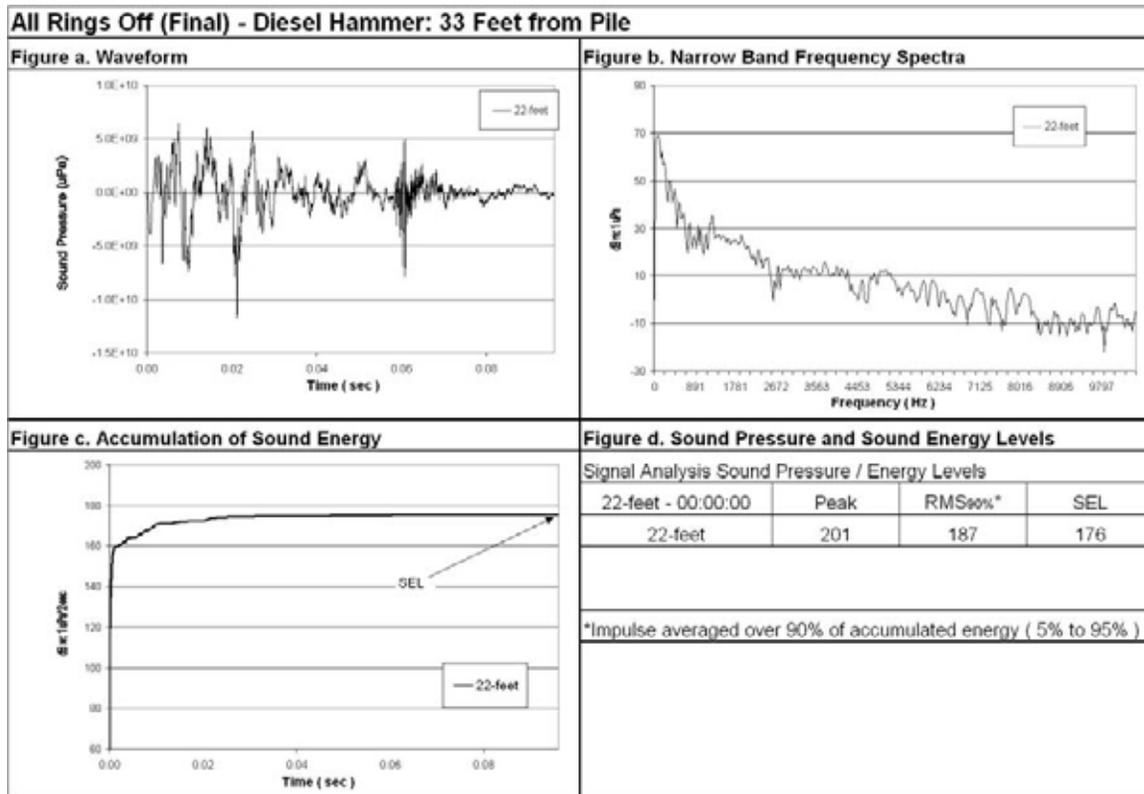
**Figure 66 Waveform Analysis for Pile Number 1, 22-feet Deep, 33-Feet from Pile, All Rings Off (Final).**

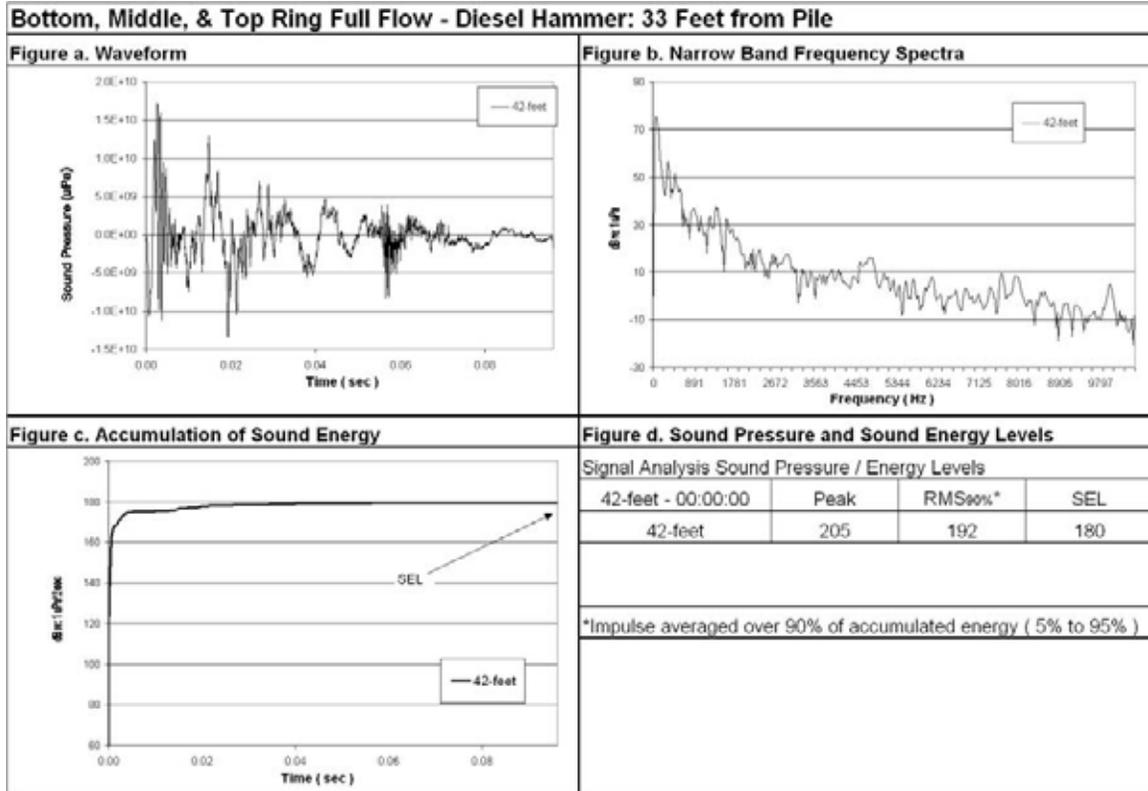
**Figure 67 Waveform Analysis for Pile Number 1, 42-foot Deep (bottom), 33-Feet from Pile, All Rings Off (Final).**

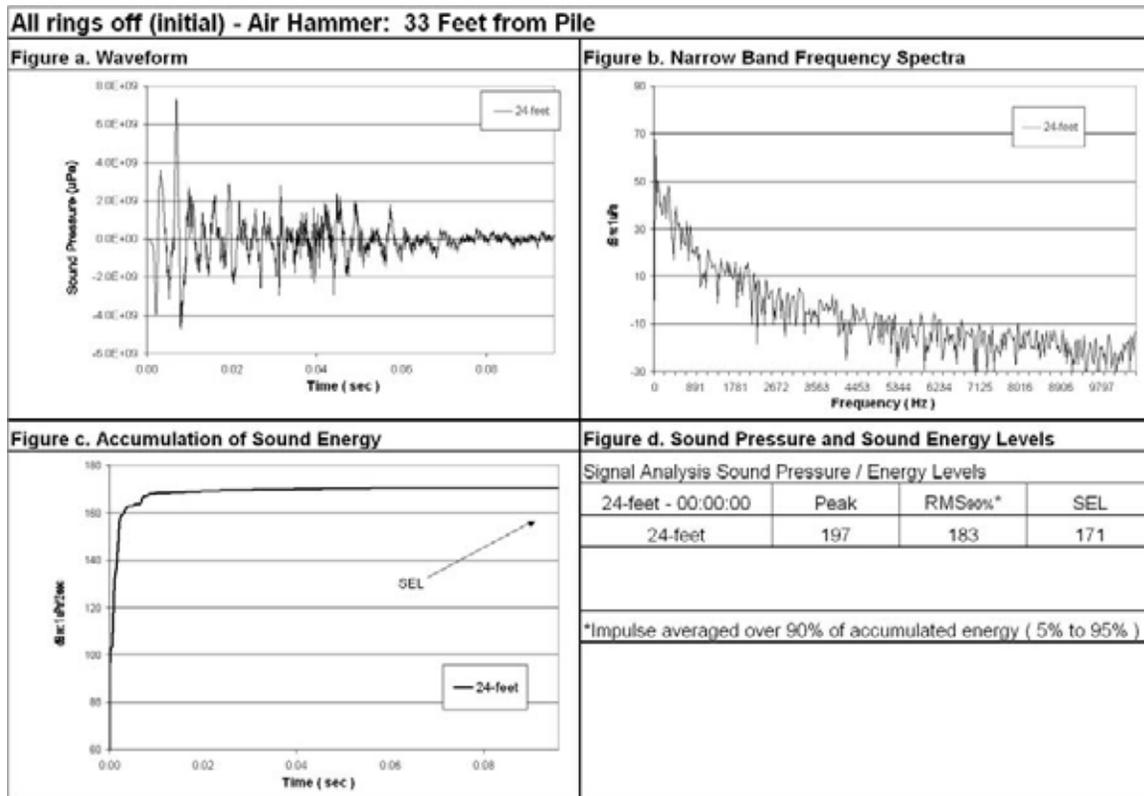
**Figure 68: Waveform Analysis for Pile Number 2, 24-Foot Deep, 33-Foot from Pile, All Rings Off.**

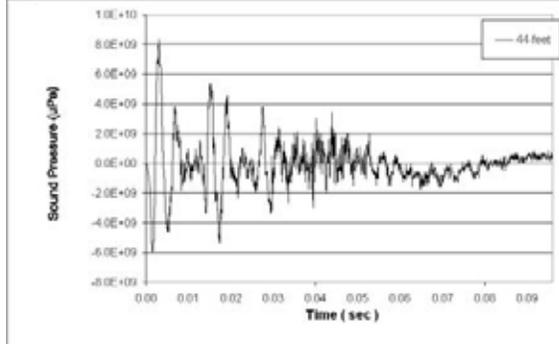
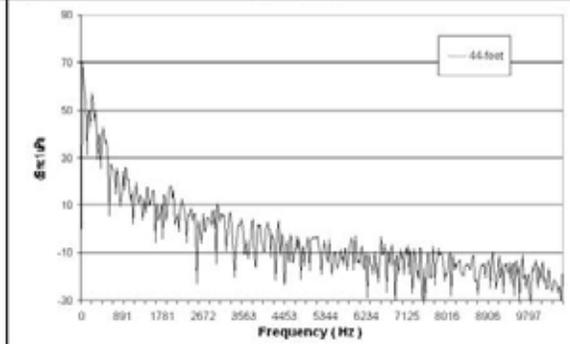
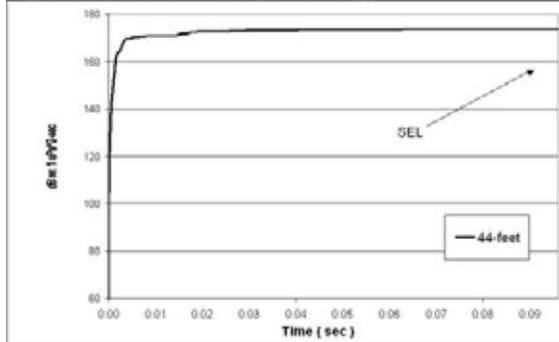
**All rings off (initial) - Air Hammer: 33 Feet from Pile**

**Figure a. Waveform**

**Figure b. Narrow Band Frequency Spectra**

**Figure c. Accumulation of Sound Energy**

**Figure d. Sound Pressure and Sound Energy Levels**

Signal Analysis Sound Pressure / Energy Levels			
44-feet - 00:00:00	Peak	RMS <sub>90%</sub> *	SEL
44-feet	198	185	174

**Figure 69: Waveform Analysis for Pile Number 2, 44-Feet Deep (bottom), 33-Feet from Pile, All Rings Off.**

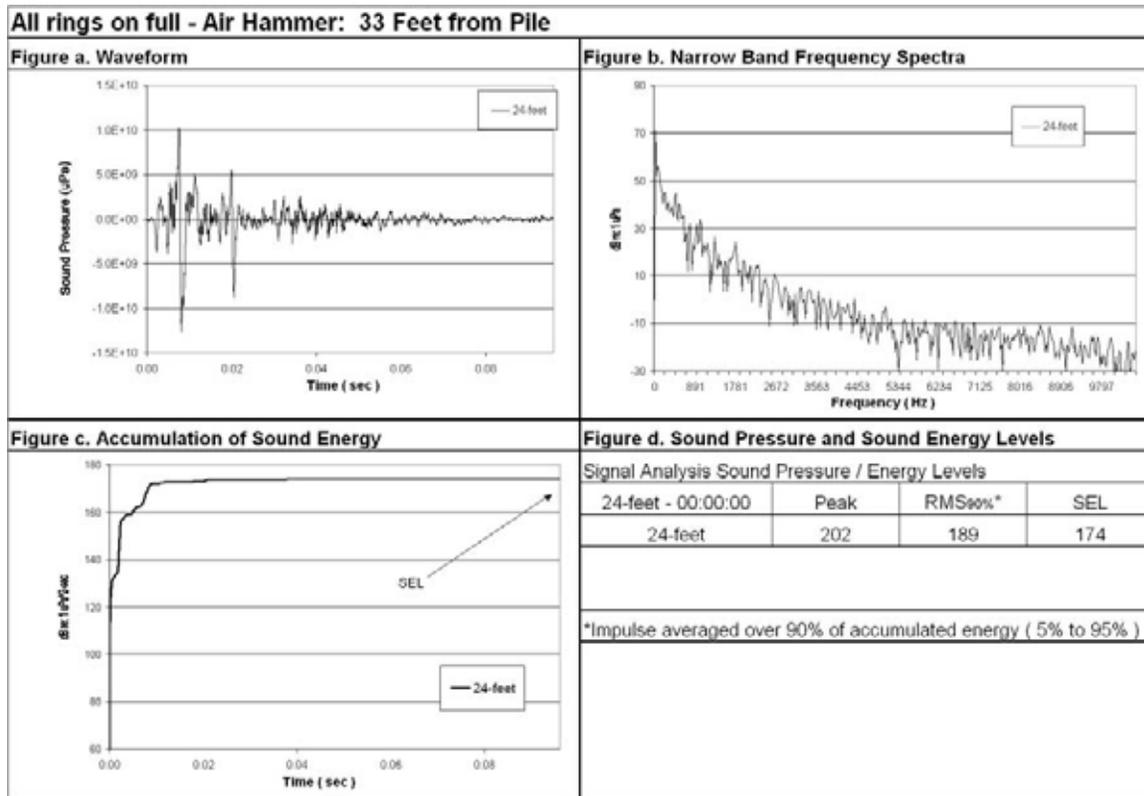
**Figure 70 Waveform Analysis for Pile Number 2, 24-Foot Deep, 33-Foot from Pile, Bottom Ring On Full.**

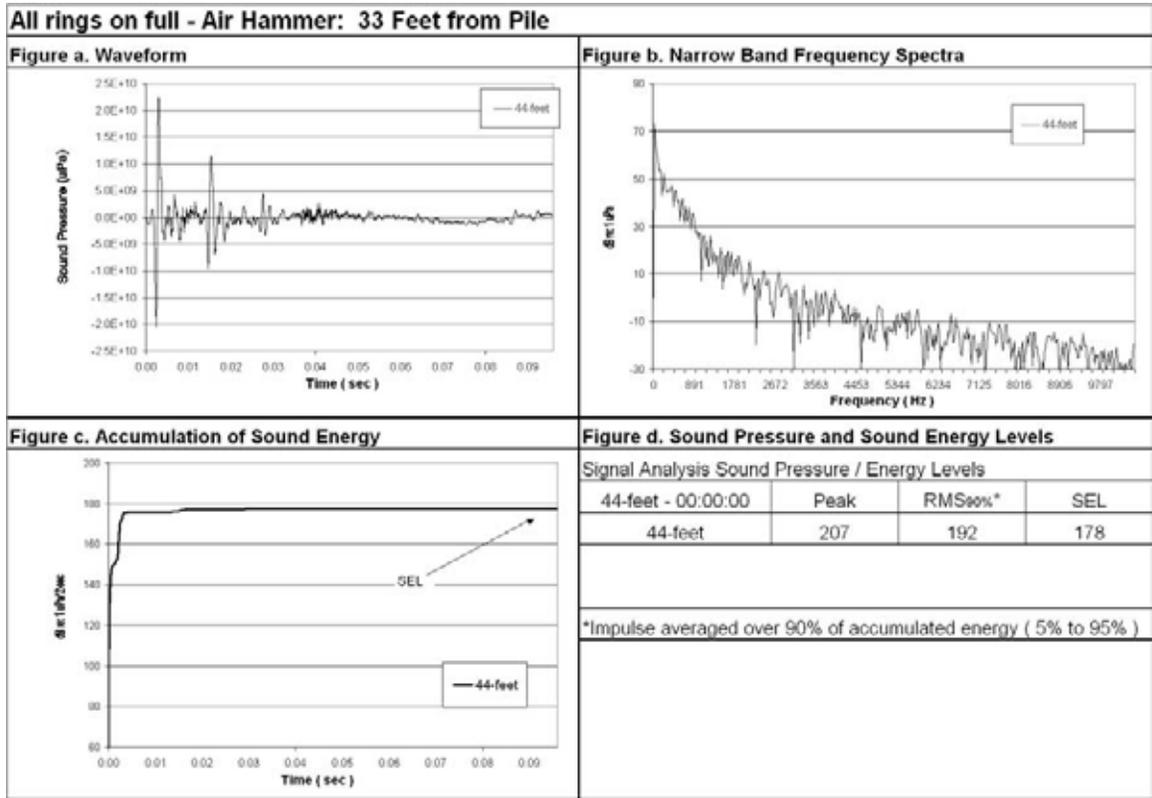
**Figure 71 Waveform Analysis for Pile Number 2, 44-Foot Deep (bottom), 33-Foot from Pile, Bottom Ring On Full.**

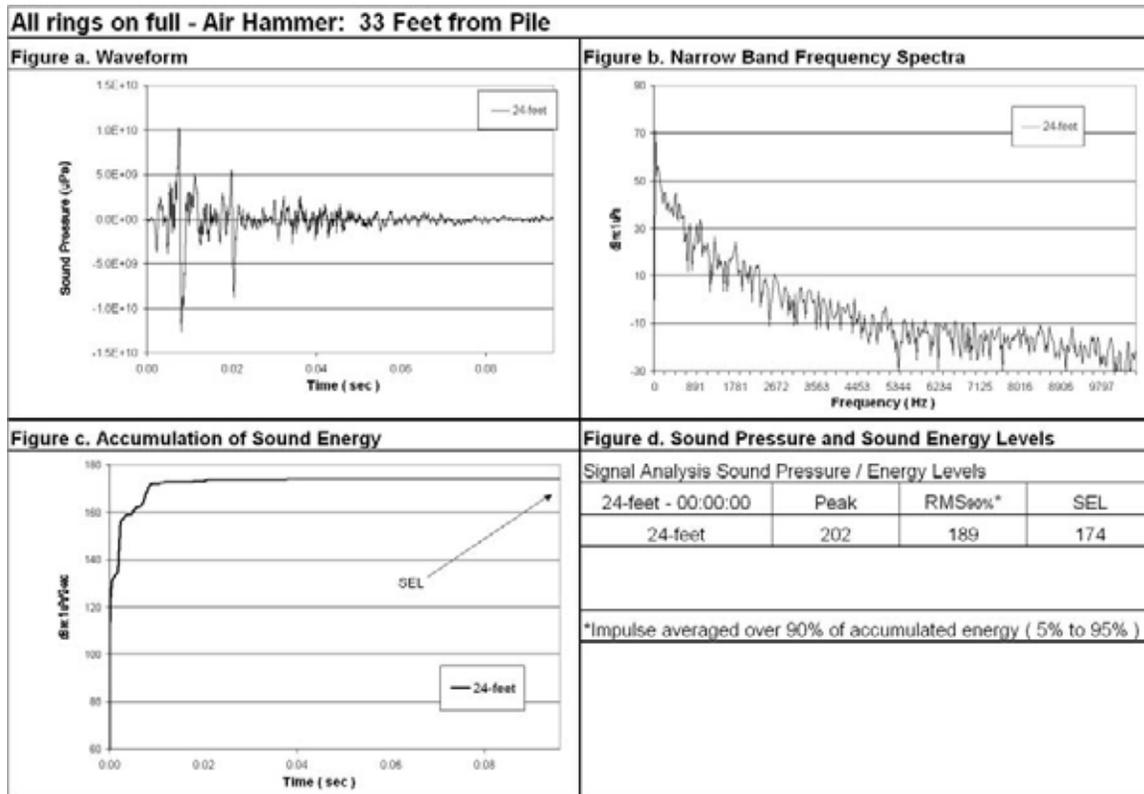
**Figure 72 Waveform Analysis for Pile Number 2, 24-Foot Deep, 33-Foot from Pile, All Rings On Full.**

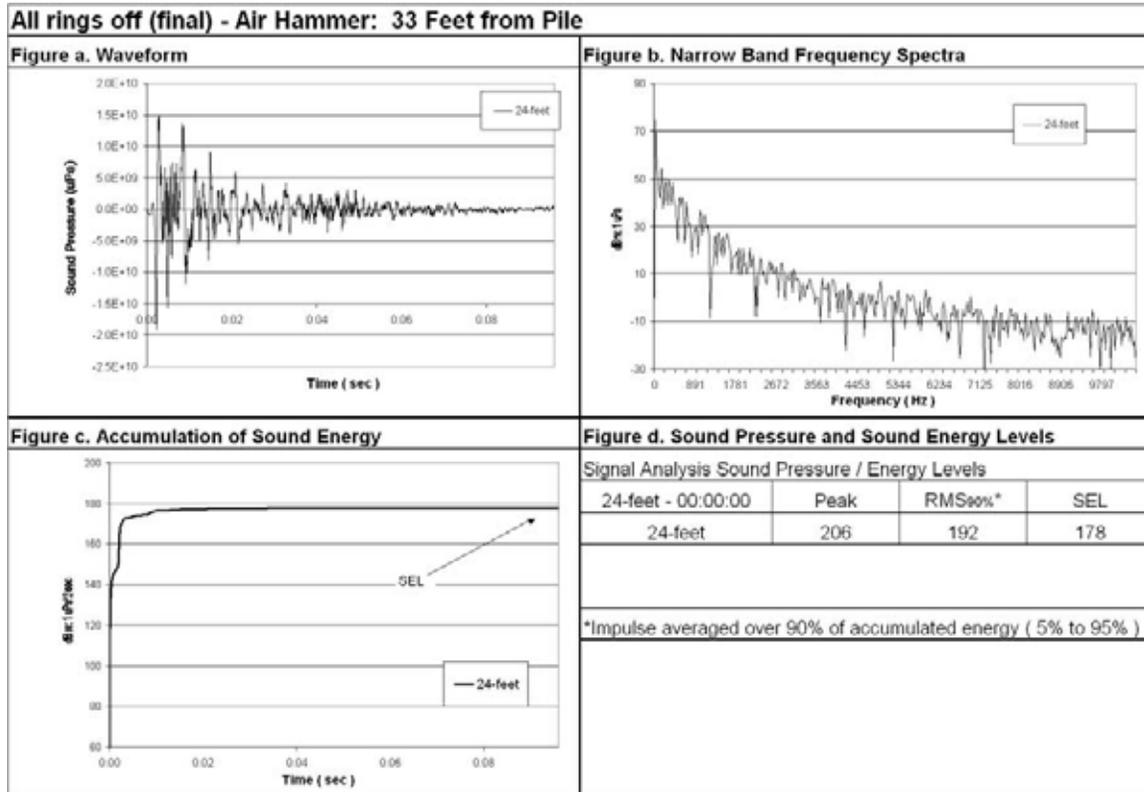
Figure 74 Waveform Analysis for Pile Number 2, 24-Foot Deep, 33-Foot from Pile, All Rings Off (Final).

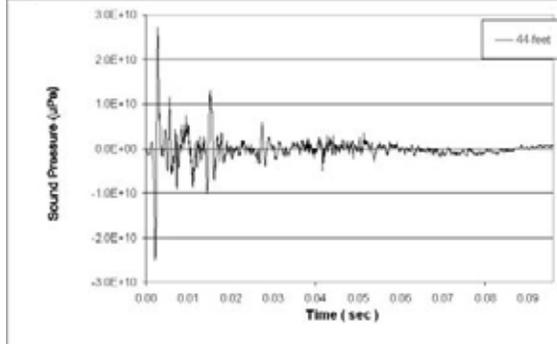
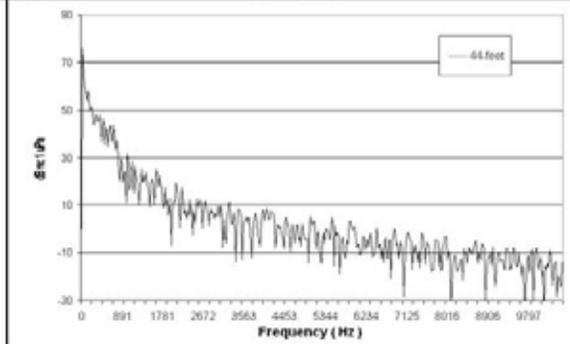
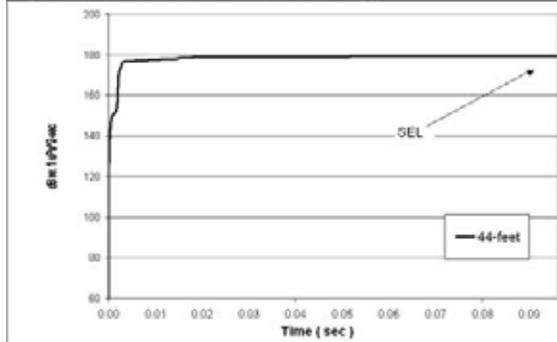
**All rings off (final)- Air Hammer: 33 Feet from Pile**

**Figure a. Waveform**

**Figure b. Narrow Band Frequency Spectra**

**Figure c. Accumulation of Sound Energy**

**Figure d. Sound Pressure and Sound Energy Levels**

Signal Analysis Sound Pressure / Energy Levels			
44-feet - 00:00:00	Peak	RMS <sub>90%</sub> *	SEL
44-feet	209	193	179

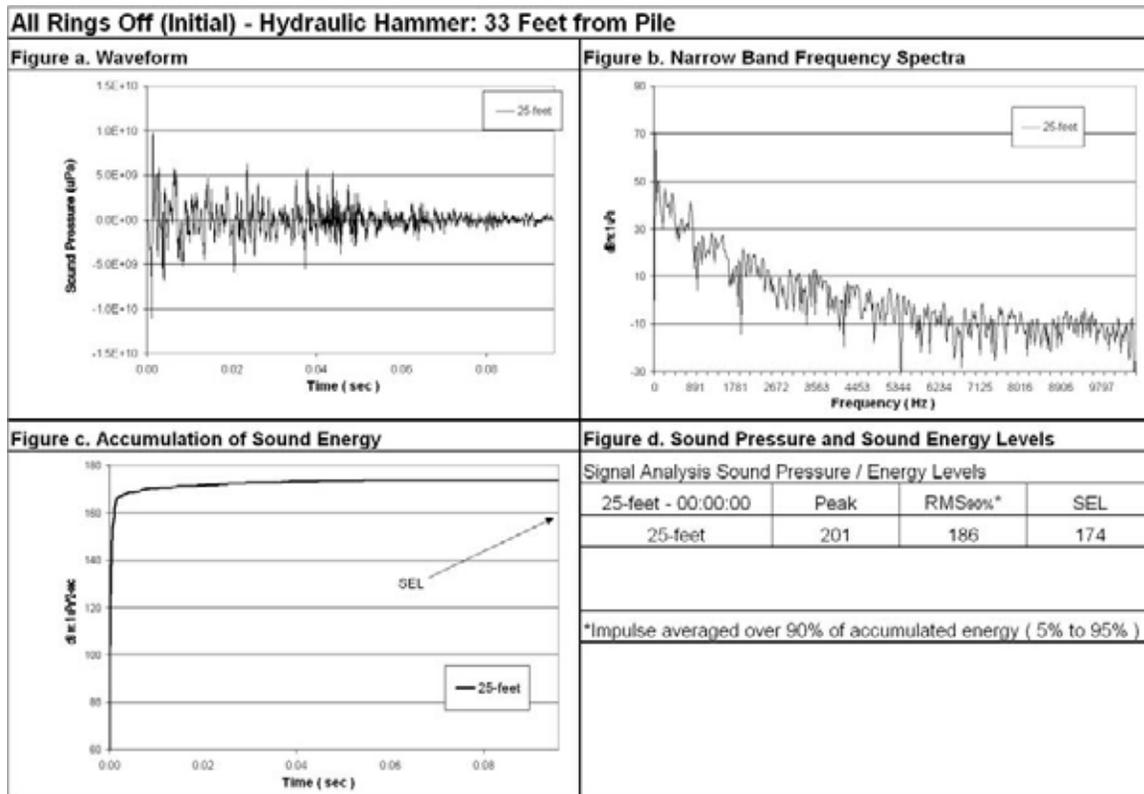
**Figure 76 Waveform Analysis for Pile Number 3, 25-foot Deep, 33-Foot from Pile, All Rings Off (Initial).**

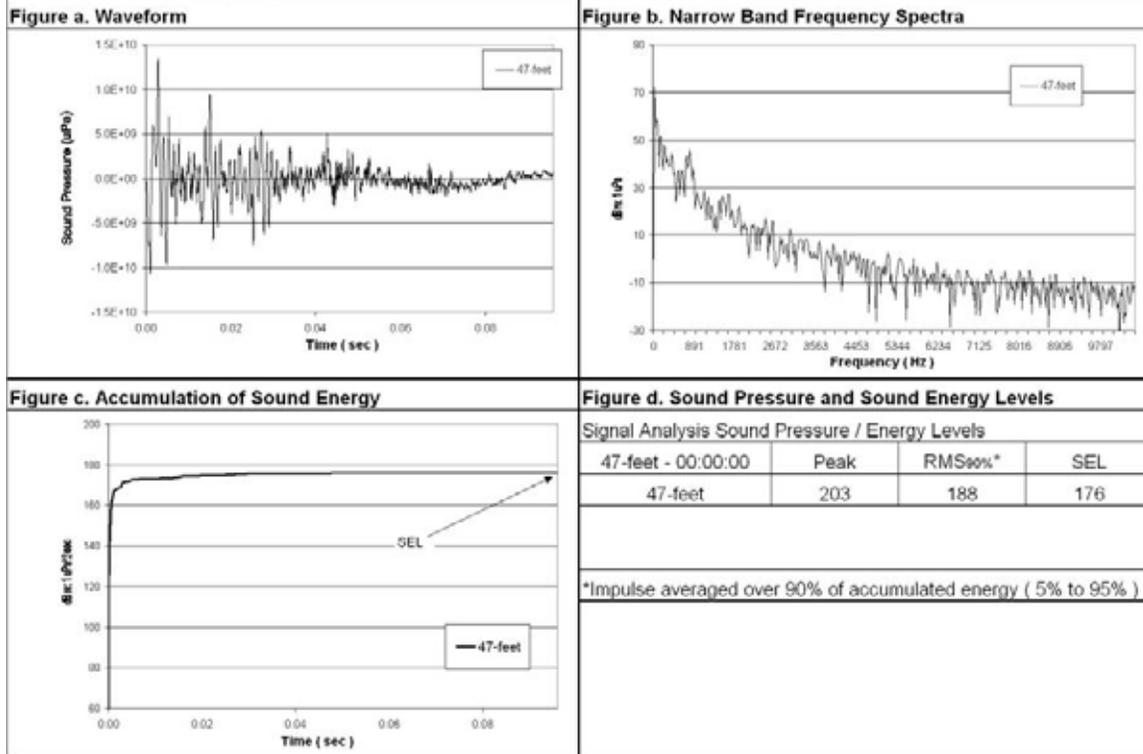
**All Rings Off (Initial) - Hydraulic Hammer: 33 Feet from Pile**

**Figure 77 Waveform Analysis for Pile Number 3, 47-foot Deep (bottom), 33-Feet from Pile, All Rings Off.**

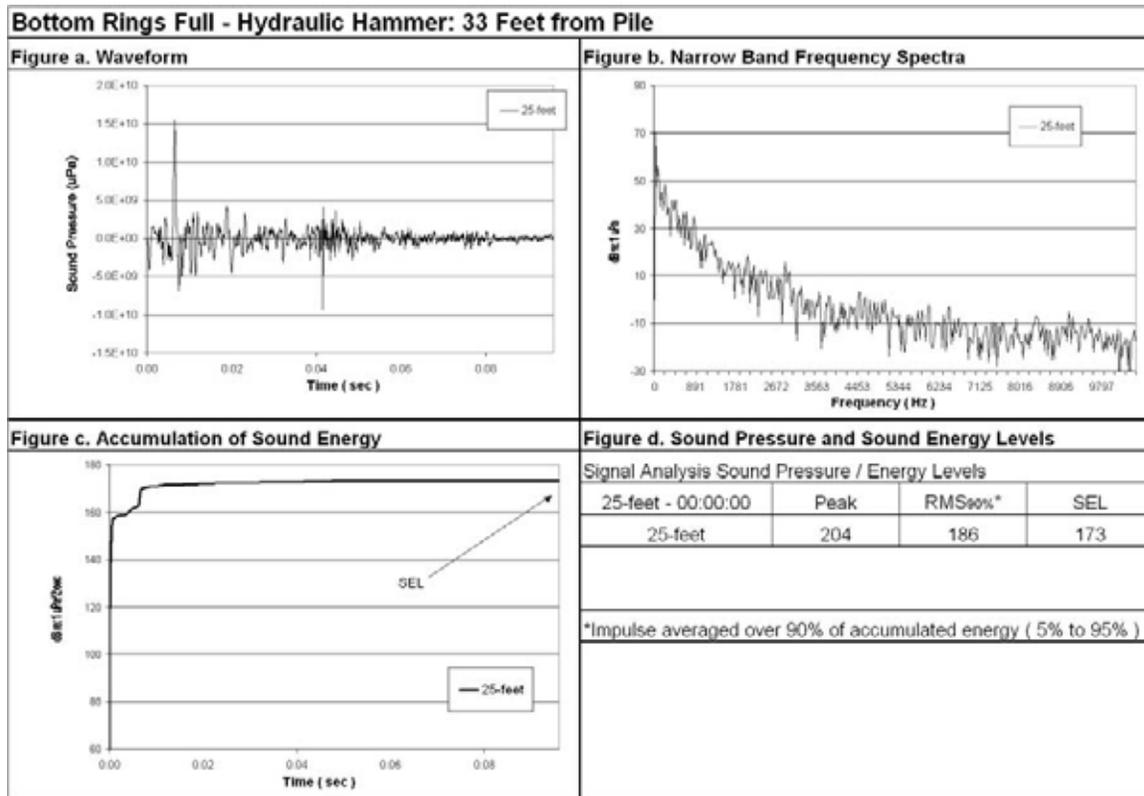
**Figure 78 Waveform Analysis for Pile Number 3, 25-feet Deep, 33-Feet from Pile, Bottom Ring On Full.**
