*FRIDAY HARBOR FERRY TERMINAL RESTORATION PROJECT*

**UNDERWATER SOUND LEVELS  
ASSOCIATED WITH RESTORATION OF  
THE FRIDAY HARBOR FERRY  
TERMINAL**

*Prepared by:  
Jim Laughlin  
Washington State Department of Transportation  
Office of Air Quality and Noise  
15700 Dayton Avenue North, P.O. Box 330310  
Seattle, WA 98133-9710*

**May 2005**

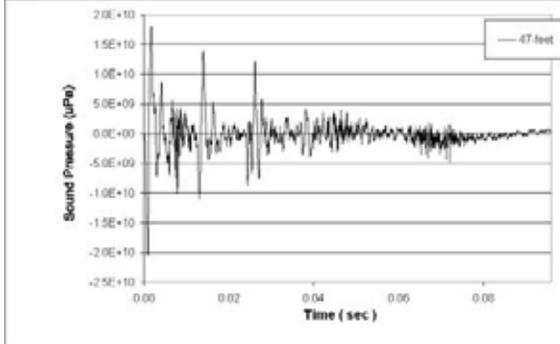
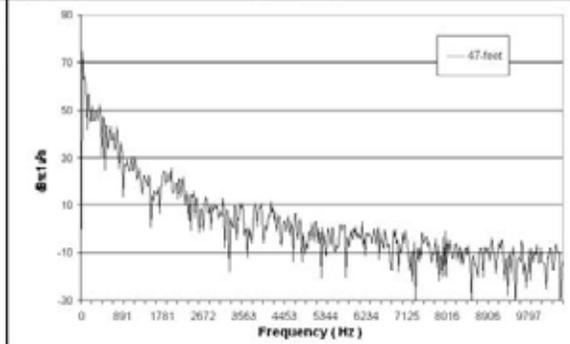
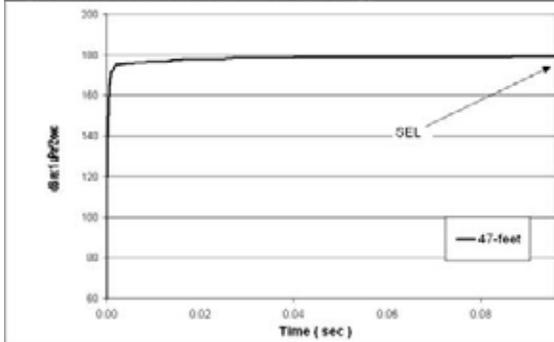
**Bottom Rings Full - Hydraulic Hammer: 33 Feet from Pile**

**Figure a. Waveform**

**Figure b. Narrow Band Frequency Spectra**

**Figure c. Accumulation of Sound Energy**

**Figure d. Sound Pressure and Sound Energy Levels**

Signal Analysis Sound Pressure / Energy Levels			
47-feet - 00:00:00	Peak	RMS <sub>90%</sub> *	SEL
47-feet	206	192	179

**Figure 79 Waveform Analysis for Pile Number 3, 47-foot Deep (Bottom), 33-Feet from Pile, Bottom Ring On Full.**

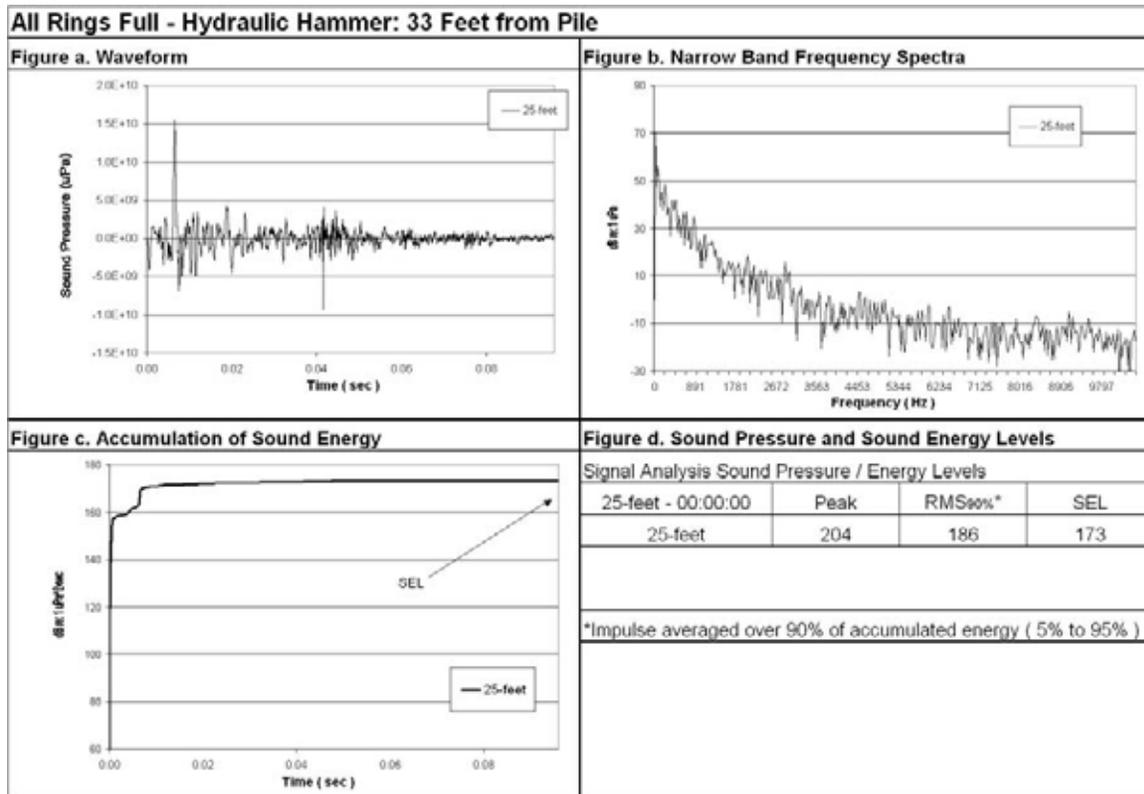
Figure 80 Waveform Analysis for Pile Number 3, 25-feet Deep, 33-Feet from Pile, All Rings Full.

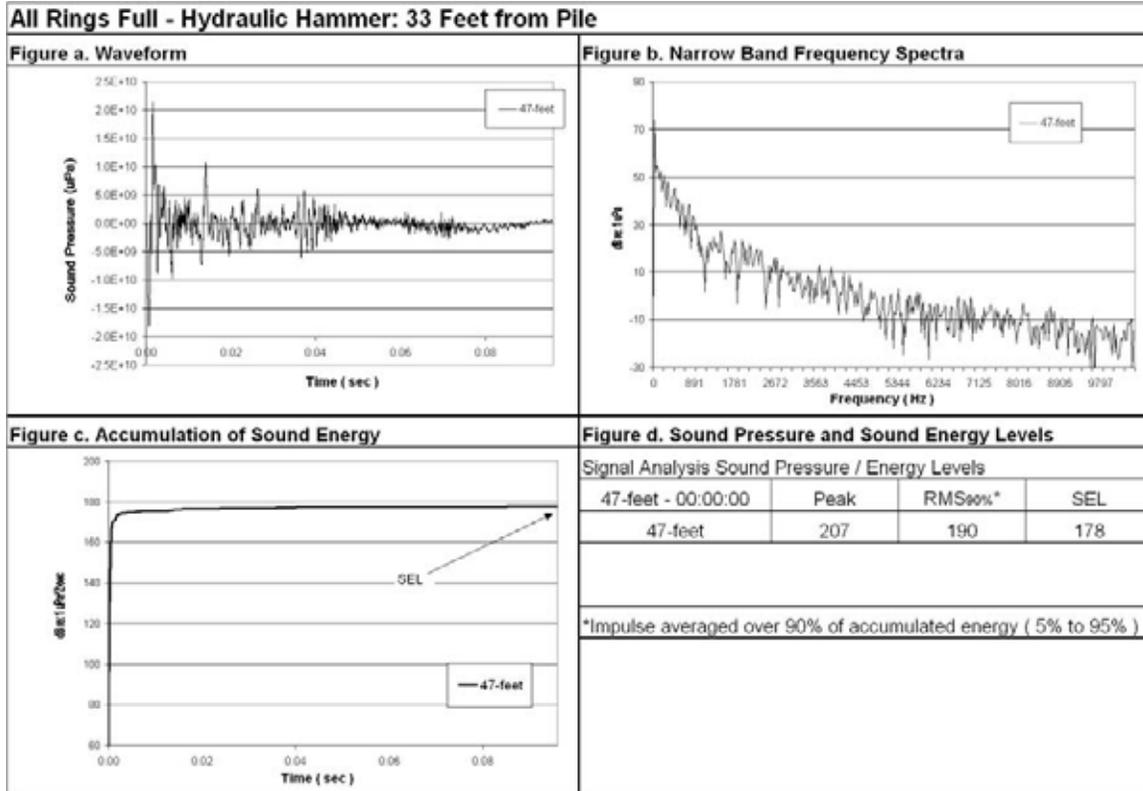
**Figure 81 Waveform Analysis for Pile Number 3, 47-foot Deep (Bottom), 33-Feet from Pile, All Rings Full.**

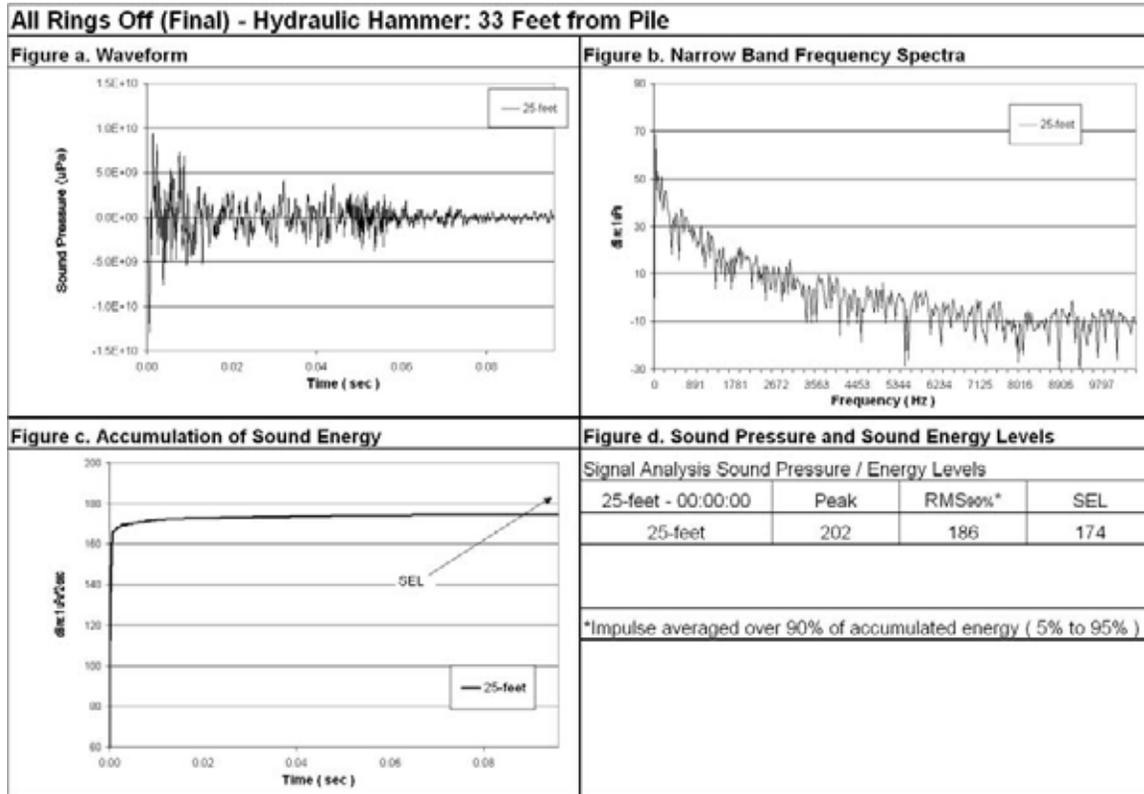
Figure 82 Waveform Analysis for Pile Number 3, 25-foot Deep, 33-Foot from Pile, All Rings Off (Final).

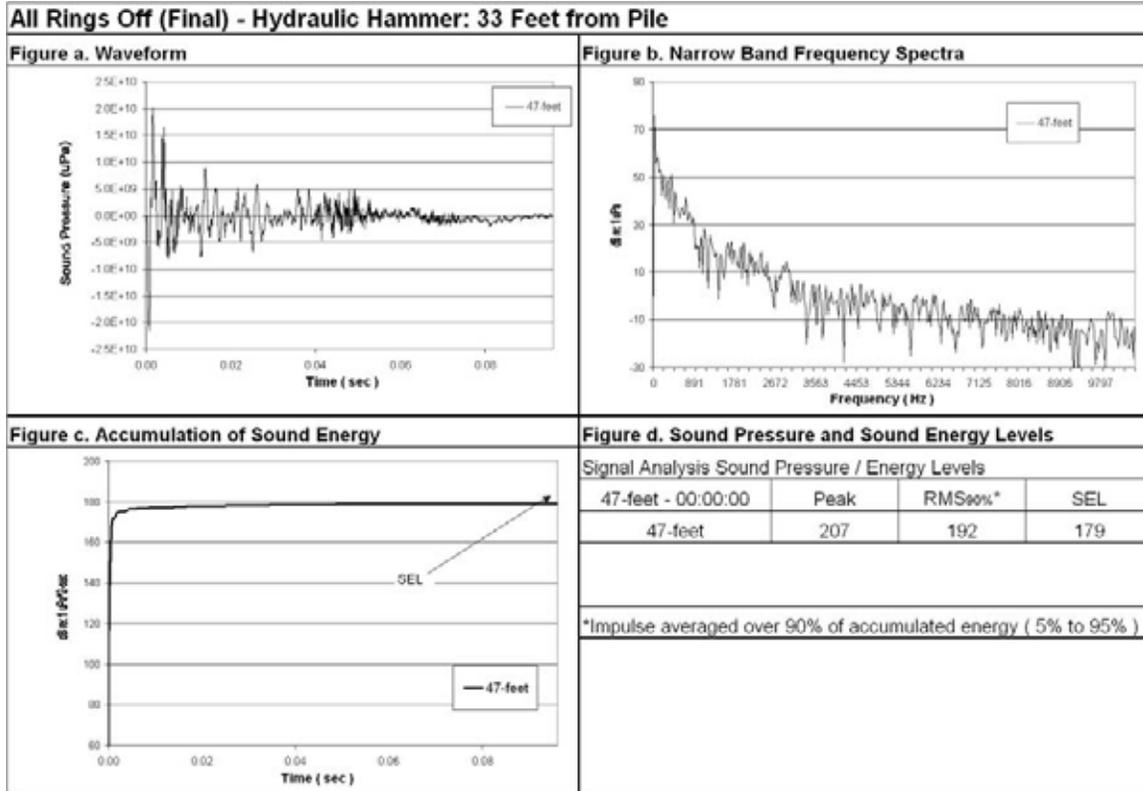
**Figure 83 Waveform Analysis for Pile Number 3, 47-foot Deep (Bottom), 33-Feet from Pile, All Rings Off (Final).**

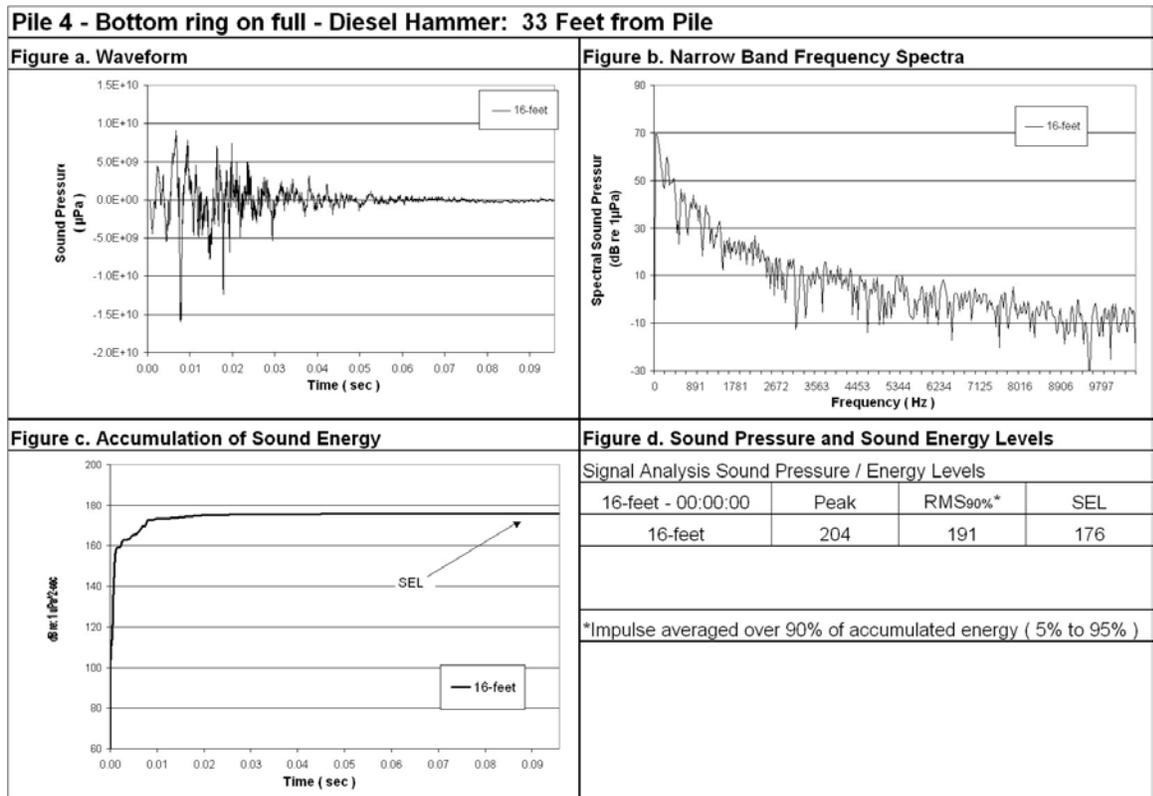
**Figure 84: Waveform Analysis for Pile Number 4, 16-Foot Deep, 33-Foot from Pile, Bottom Ring On Full.**

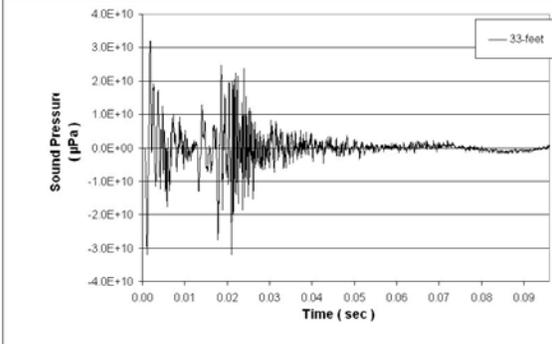
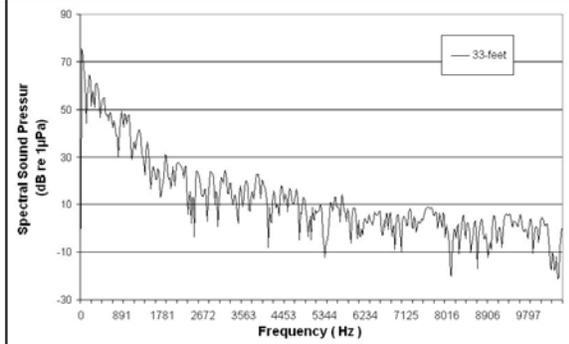
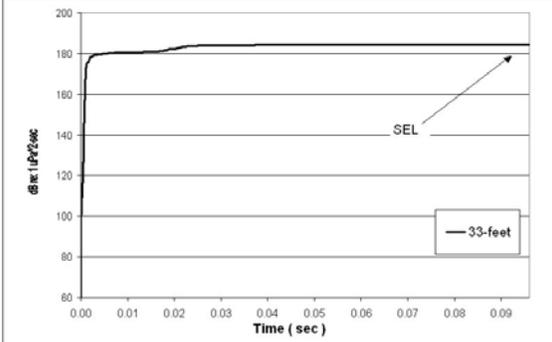
**Pile 4 - Bottom ring on full - Diesel Hammer: 33 Feet from Pile**

**Figure a. Waveform**

**Figure b. Narrow Band Frequency Spectra**

**Figure c. Accumulation of Sound Energy**

Signal Analysis Sound Pressure / Energy Levels			
33-feet - 00:00:00	Peak	RMS <sub>90%</sub> *	SEL
33-feet	210	199	184

**Figure 85: Waveform Analysis for Pile Number 4, 33-Feet Deep (Bottom), 33-Feet from Pile, Bottom Ring On Full.**

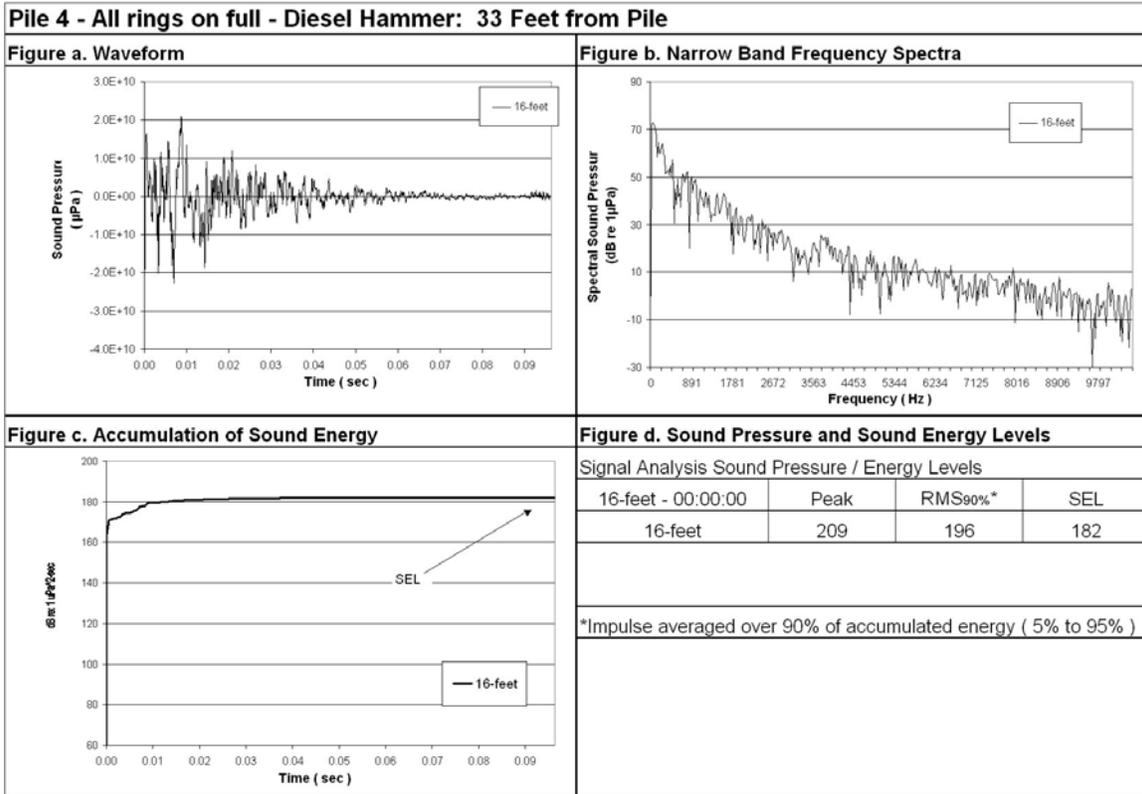
**Figure 86: Waveform Analysis for Pile Number 4, 16-Foot Deep, 33-Foot from Pile, All Rings On Full.**

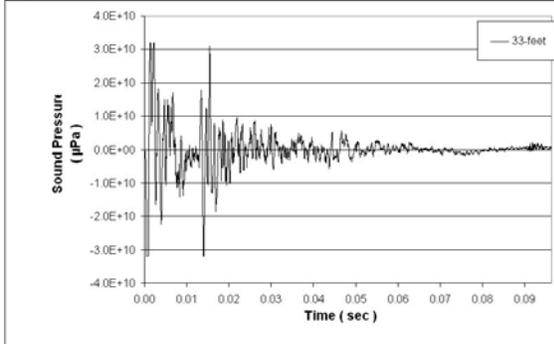
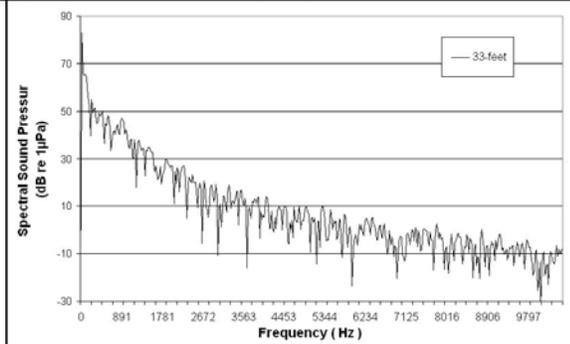
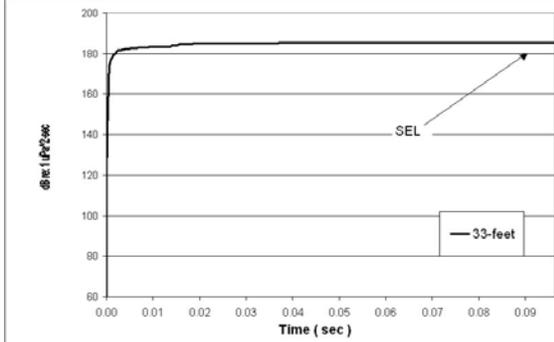
**Pile 4 - All rings on full - Diesel Hammer: 33 Feet from Pile**

**Figure a. Waveform**

**Figure b. Narrow Band Frequency Spectra**

**Figure c. Accumulation of Sound Energy**

Signal Analysis Sound Pressure / Energy Levels			
33-feet - 00:00:00	Peak	RMS <sub>90%</sub> *	SEL
33-feet	210	200	185

**Figure 87: Waveform Analysis for Pile Number 4, 33-Foot Deep (Bottom), 33-Foot from Pile, All Rings On Full.**

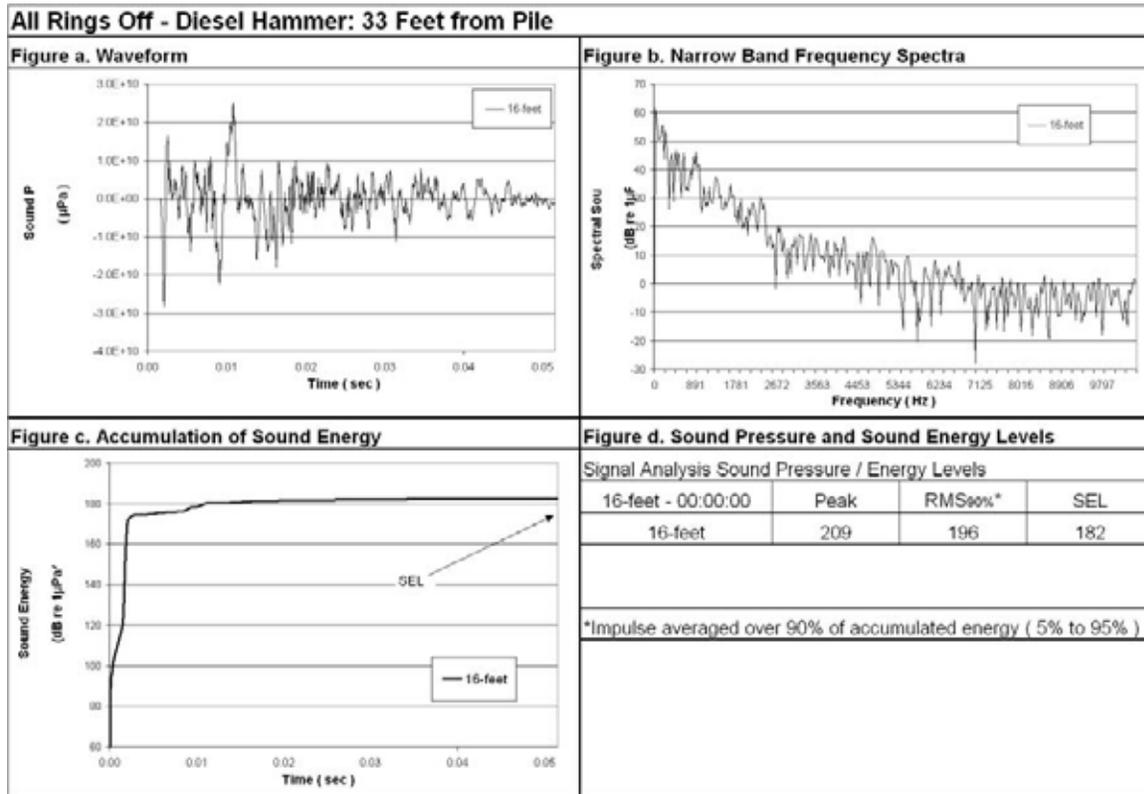
**Figure 88: Waveform Analysis for Pile Number 4, 16-Foot Deep, 33-Foot from Pile, All Rings Off.**

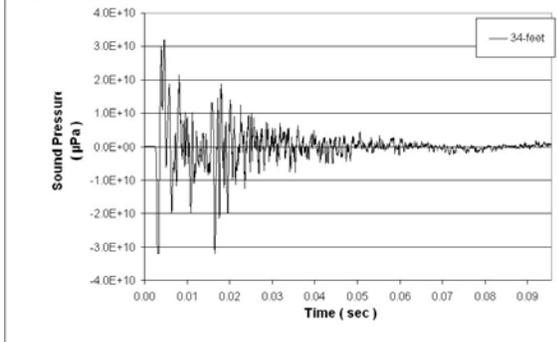
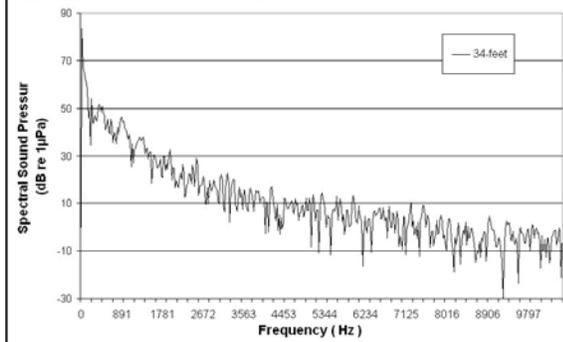
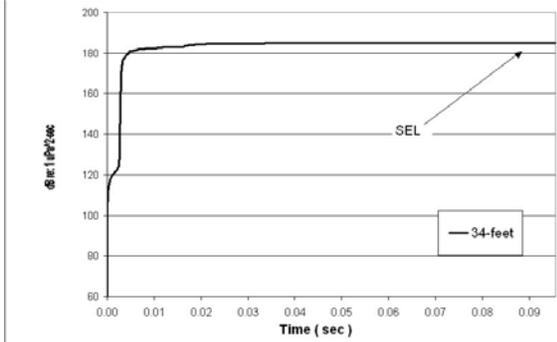
**Pile 4 - All Rings Off - Diesel Hammer: 33 Feet from Pile**

**Figure a. Waveform**

**Figure b. Narrow Band Frequency Spectra**

**Figure c. Accumulation of Sound Energy**

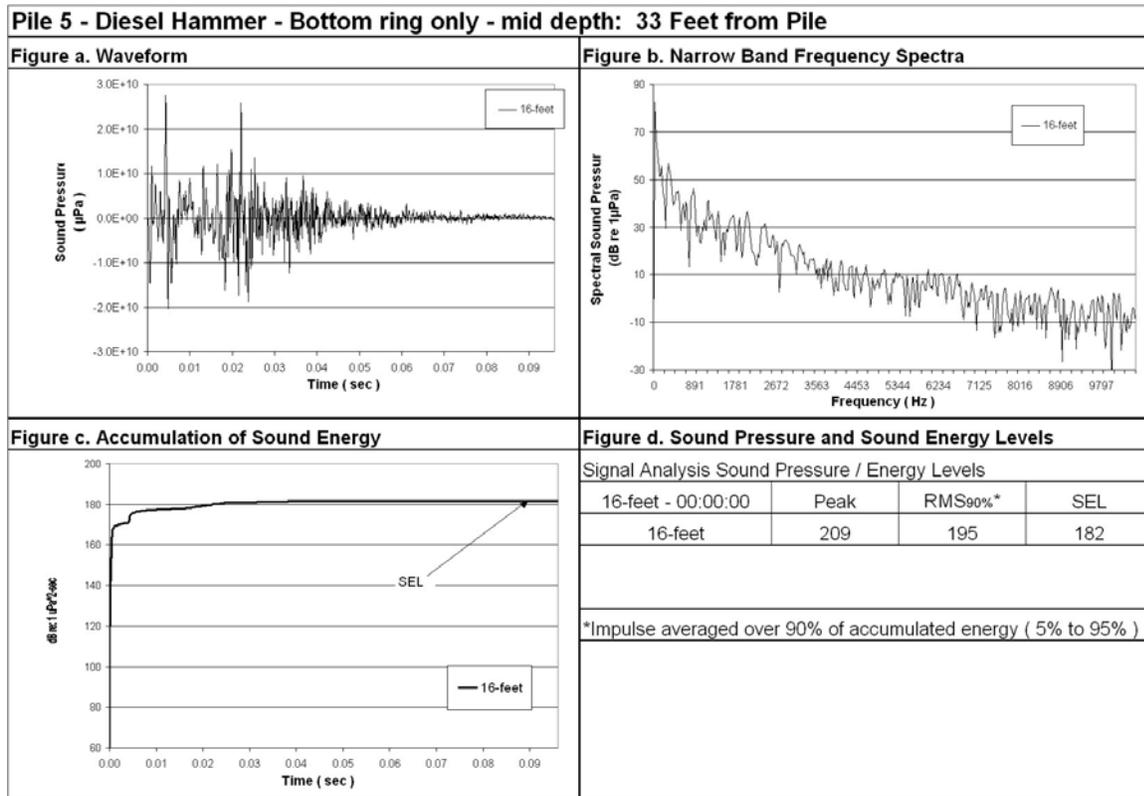
**Figure 90: Waveform Analysis for Pile Number 5, 16-feet Deep, 33-Foot from Pile, Bottom Ring On Full.**

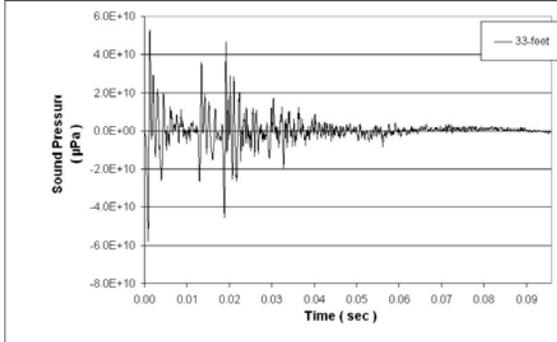
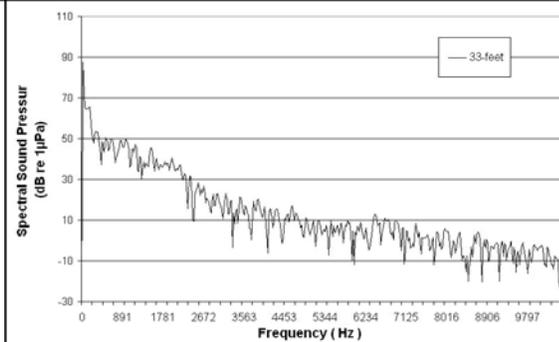
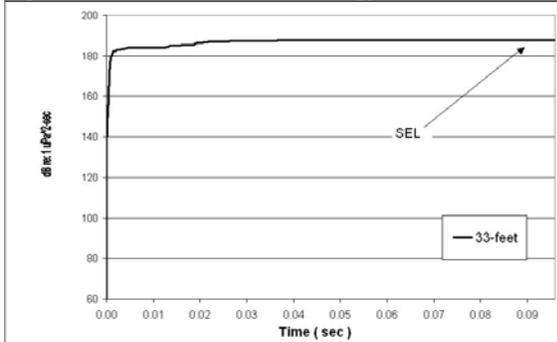
**Pile 5 - Diesel Hammer - Bottom ring only - 1 foot from bottom: 33 Feet from Pile**

**Figure a. Waveform**

**Figure b. Narrow Band Frequency Spectra**

**Figure c. Accumulation of Sound Energy**

**Figure 91: Waveform Analysis for Pile Number 5, 33-feet Deep (Bottom), 33-Feet from Pile, Bottom Ring On Full.**

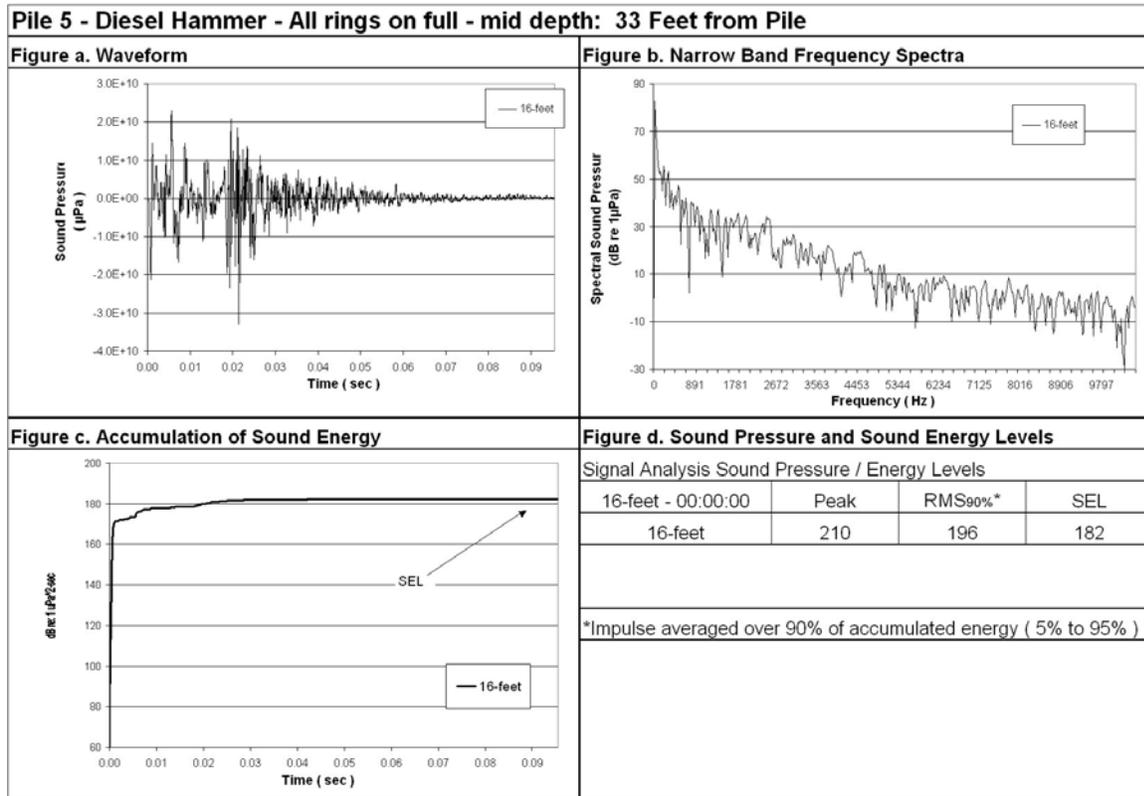
**Figure 92: Waveform Analysis for Pile Number 5, 16-Foot Deep, 33-Foot from Pile, All Rings On Full.**

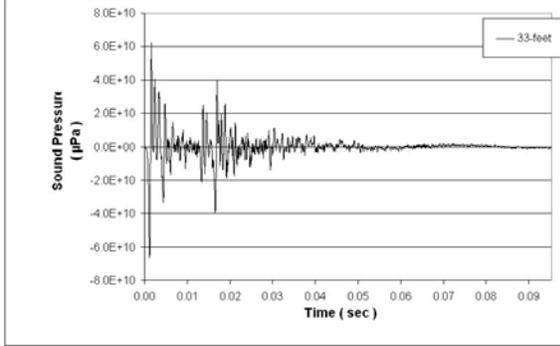
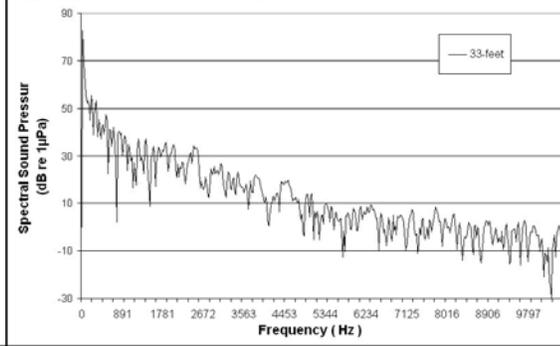
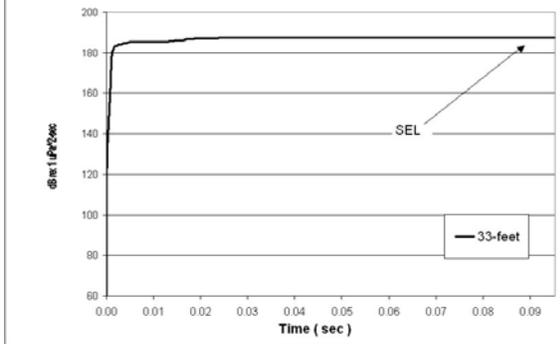
**Pile 5 - Diesel Hammer - all rings on full - 1 foot from bottom: 33 Feet from Pile**

**Figure a. Waveform**

**Figure b. Narrow Band Frequency Spectra**

**Figure c. Accumulation of Sound Energy**

**Figure 93: Waveform Analysis for Pile Number 5, 33-Feet Deep (Bottom), 33-Feet from Pile, All Rings On Full.**

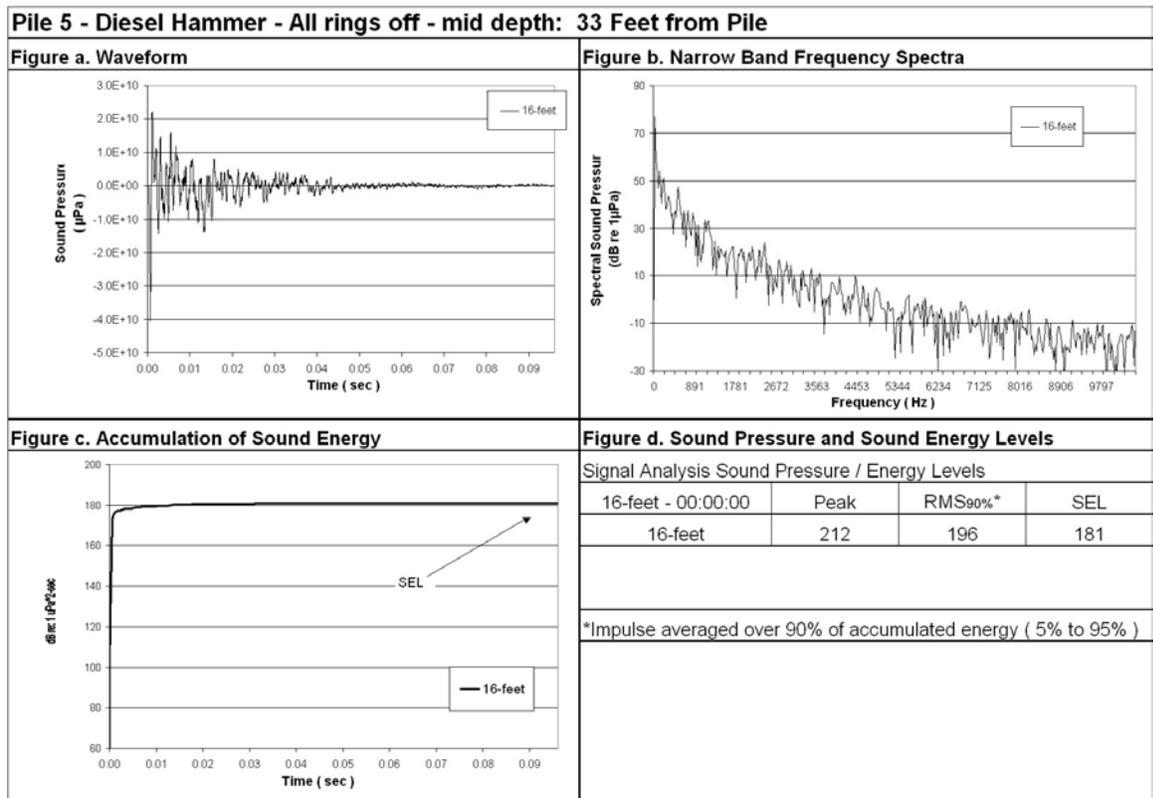
**Figure 94: Waveform Analysis for Pile Number 5, 16-Foot Deep (Bottom), 33-Foot from Pile, All Rings Off.**

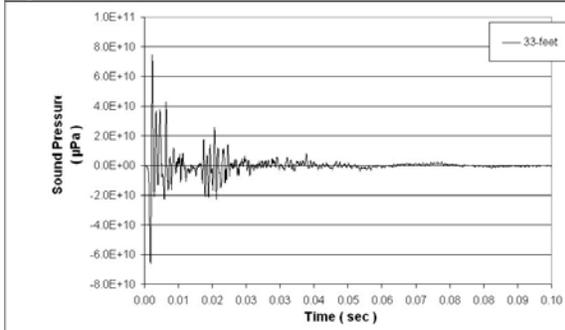
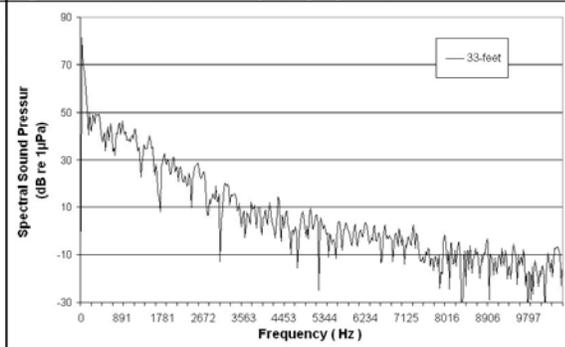
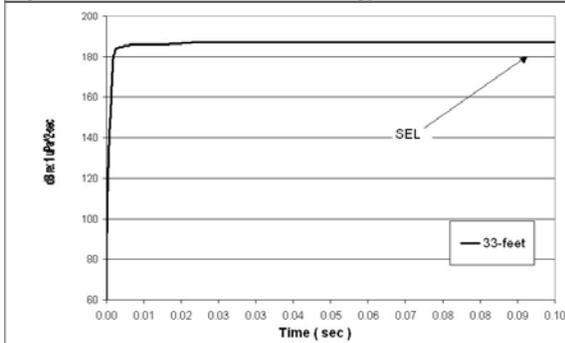
**Pile 5 - Diesel Hammer - All rings off - bottom depth: 33 Feet from Pile**

**Figure a. Waveform**

**Figure b. Narrow Band Frequency Spectra**

**Figure c. Accumulation of Sound Energy**

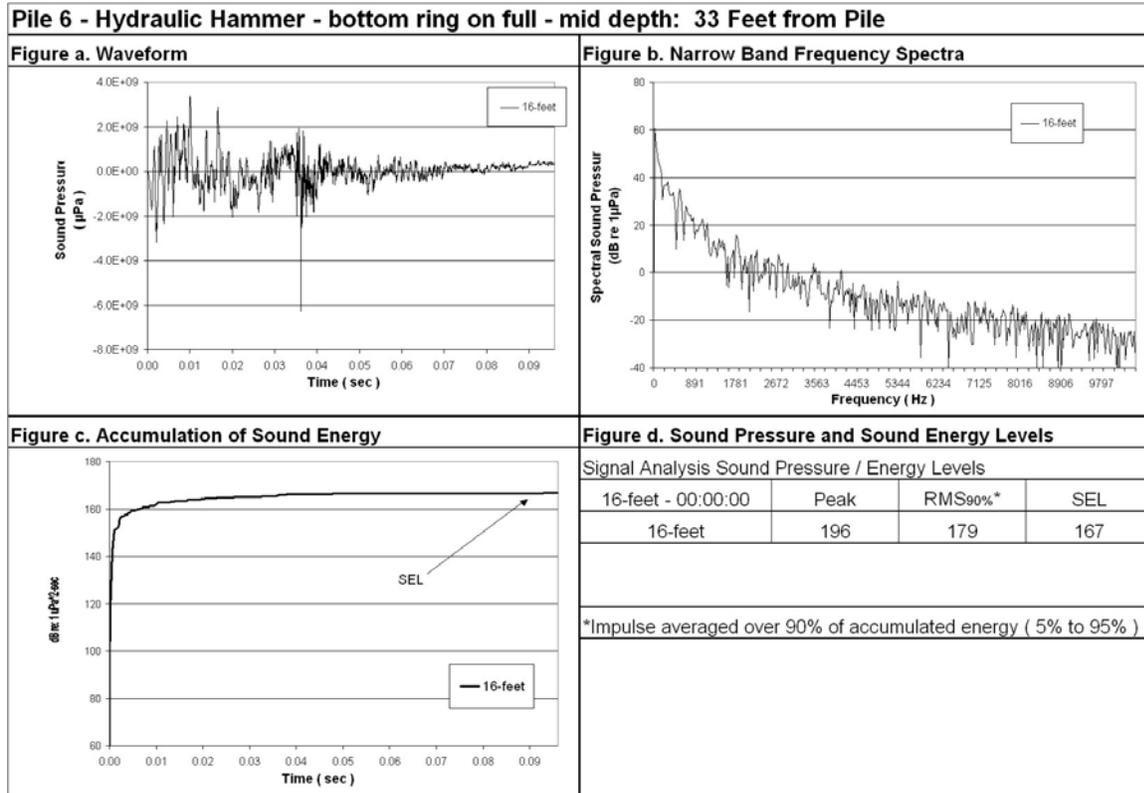
**Figure 96: Waveform Analysis for Pile Number 6, 16-Foot Deep, 33-Foot from Pile, Bottom Ring On Full.**

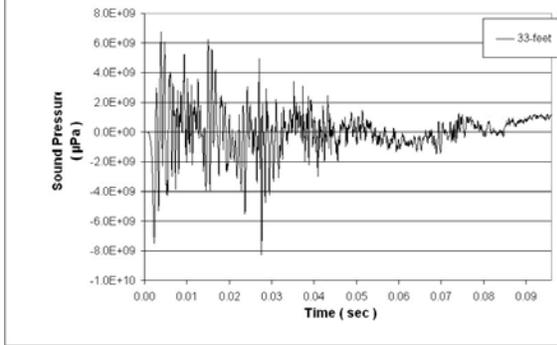
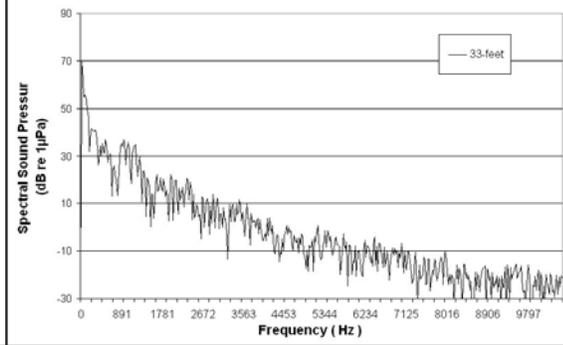
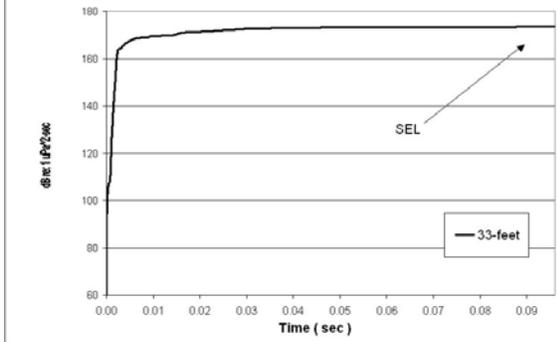
**Pile 6 - Hydraulic Hammer - bottom ring on full - 1 foot from bottom: 33 Feet from Pile**

**Figure a. Waveform**

**Figure b. Narrow Band Frequency Spectra**

**Figure c. Accumulation of Sound Energy**

**Figure 97: Waveform Analysis for Pile Number 6, 33-Feet Deep (Bottom), 33-Feet from Pile, Bottom Ring On Full.**

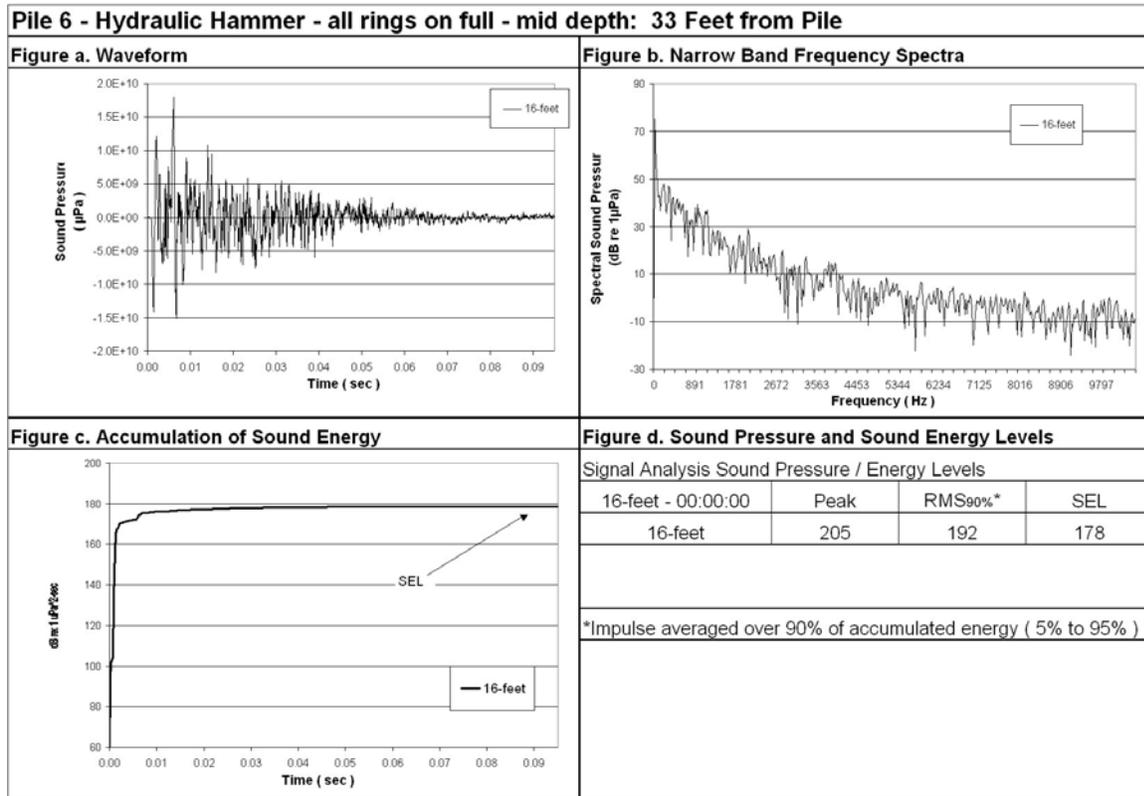
**Figure 98: Waveform Analysis for Pile Number 6, 16-Foot Deep, 33-Foot from Pile, All Rings On Full.**

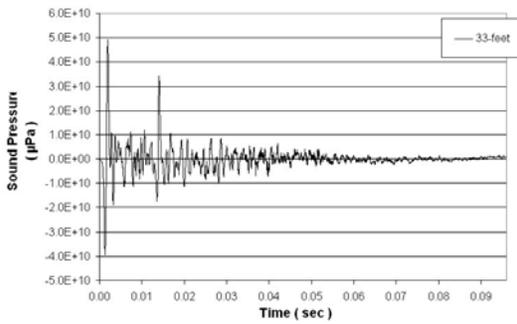
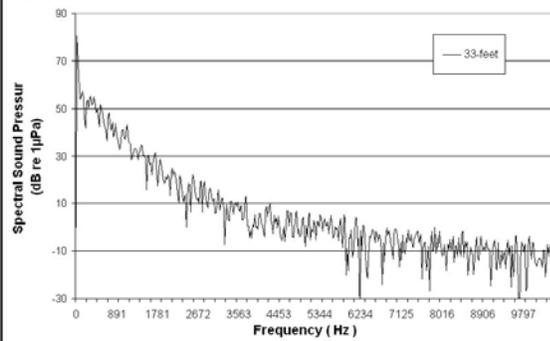
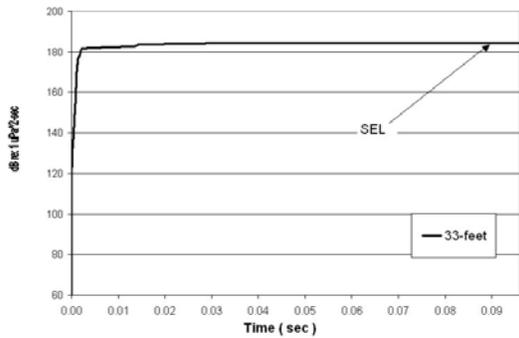
**Pile 6 - Hydraulic Hammer - all rings on full - 1 foot from bottom: 33 Feet from Pile**

**Figure a. Waveform**

**Figure b. Narrow Band Frequency Spectra**

**Figure c. Accumulation of Sound Energy**

**Figure 99: Waveform Analysis for Pile Number 6, 33-Foot Deep (Bottom), 33-Foot from Pile, All Rings On Full.**

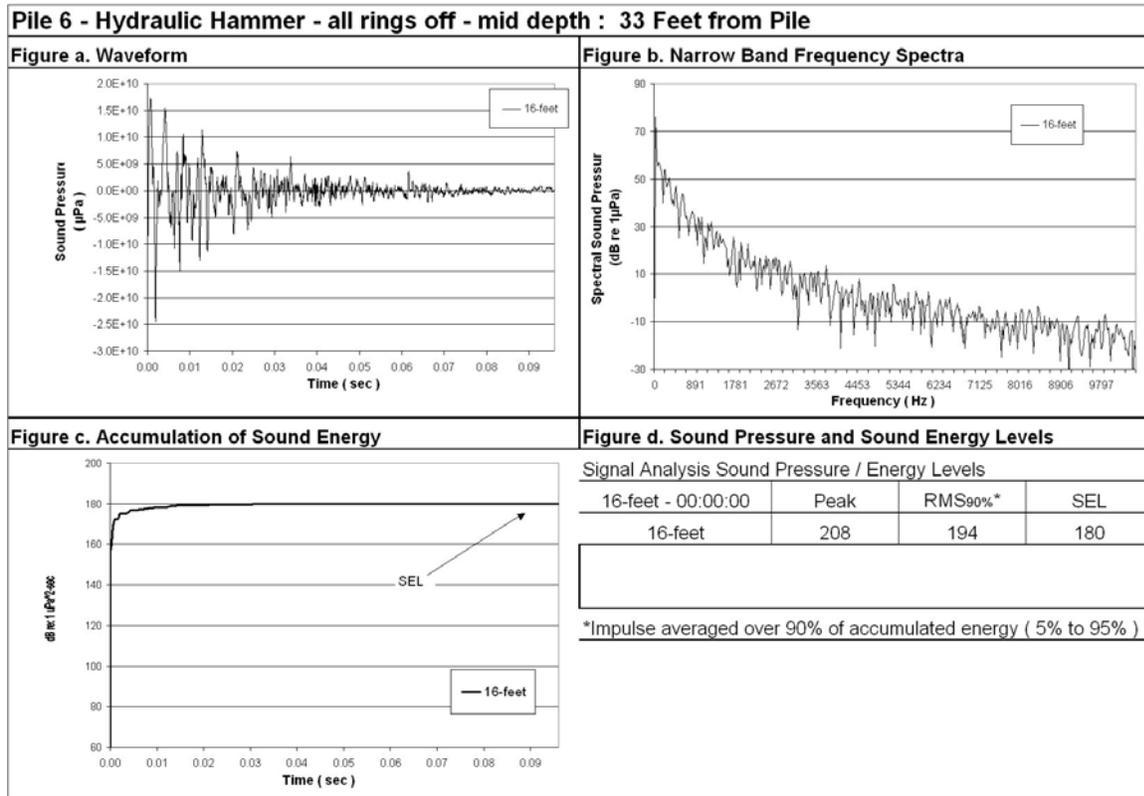
**Figure 100: Waveform Analysis for Pile Number 6, 16-Foot Deep, 33-Foot from Pile, All Rings Off.**

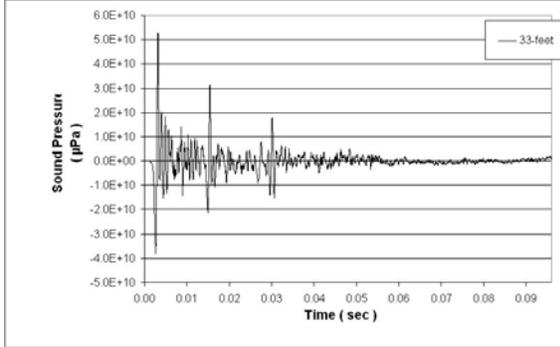
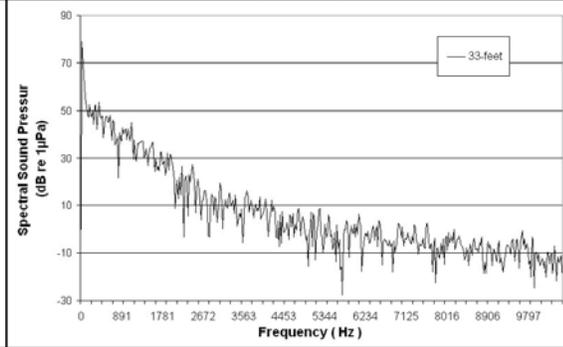
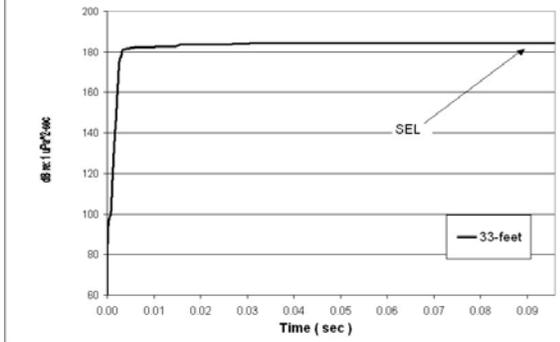
**Pile 6 - Hydraulic Hammer - all rings off - 1 foot from bottom: 33 Feet from Pile**

**Figure a. Waveform**

**Figure b. Narrow Band Frequency Spectra**

**Figure c. Accumulation of Sound Energy**

33-feet - 00:00:00	Peak	RMS <sub>90%</sub> *	SEL
33-feet	214	199	184

Figure 101: Waveform Analysis for Pile Number 6, 33-Feet Depth, (Bottom), 33-Feet from Pile, All Rings Off.	115
Figure 102: Waveform Analysis for Pile Number 7, 20-Feet Depth, 33-Feet from Pile, Bottom Ring On Full.	116
Figure 103: Waveform Analysis for Pile Number 7, 40-Feet Depth, (Bottom), 33-Feet from Pile, Bottom Ring On Full.	117
Figure 104: Waveform Analysis for Pile Number 7, 20-Feet Depth, 33-Feet from Pile, All Rings On Full.	118
Figure 105: Waveform Analysis for Pile Number 7, 40-Feet Depth (Bottom), 33-Feet from Pile, All Rings On Full.	119
Figure 106: Waveform Analysis for Pile Number 8, 14-Feet Depth, 33-Feet from Pile, Bottom Ring on full.	120
Figure 107: Waveform Analysis for Pile Number 8, 34-Feet Depth, (Bottom), 33-Feet from Pile, Bottom Ring on full.	121
Figure 108: Waveform Analysis for Pile Number 8, 14-Feet Depth, 33-Feet from Pile, All Rings On Full.	122
Figure 109: Waveform Analysis for Pile Number 8, 34-Feet Depth, (Bottom), 33-Feet from Pile, All Rings On Full.	123

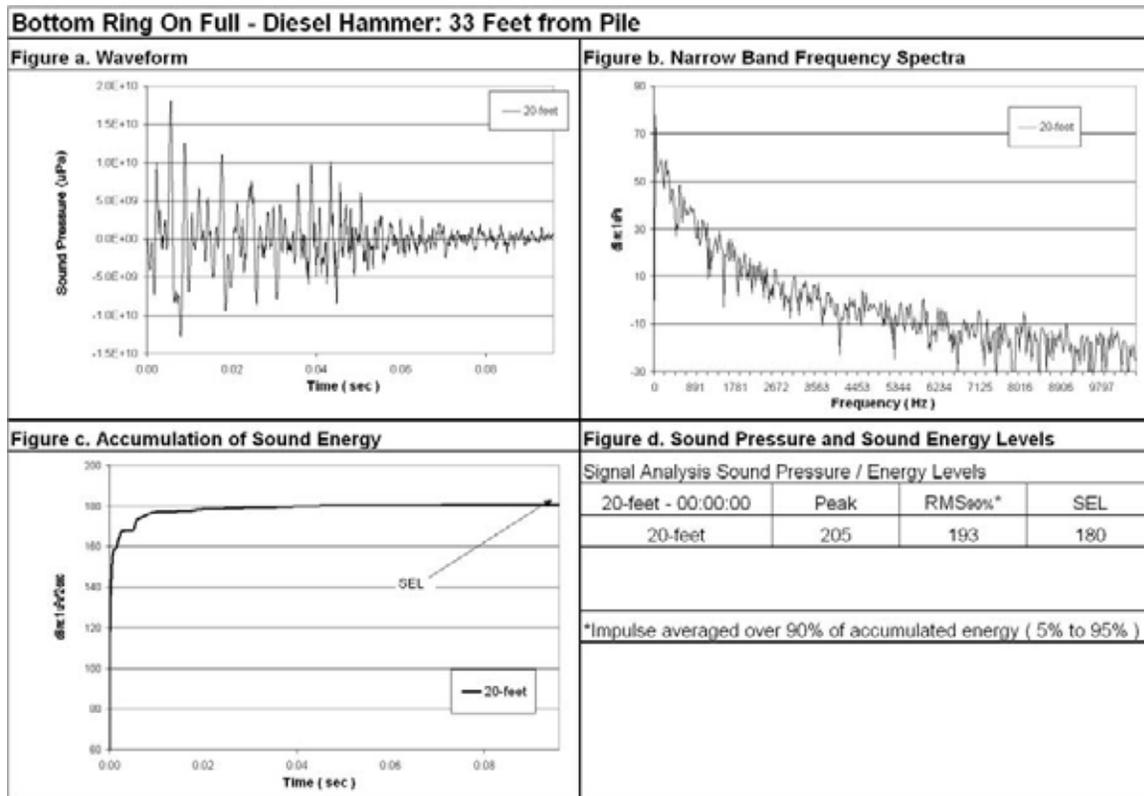
**Figure 102: Waveform Analysis for Pile Number 7, 20-Foot Deep, 33-Foot from Pile, Bottom Ring On Full.**

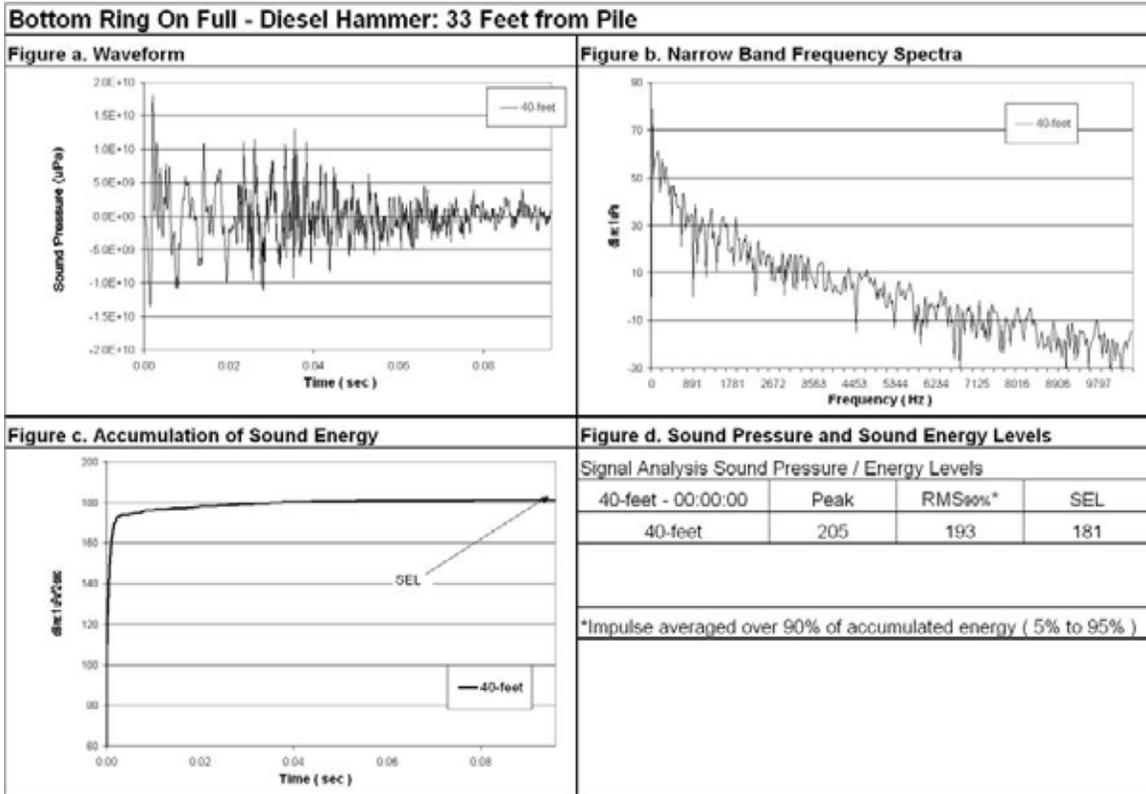
**Figure 103: Waveform Analysis for Pile Number 7, 40-Foot Deep (Bottom), 33-Foot from Pile, Bottom Ring On Full.**

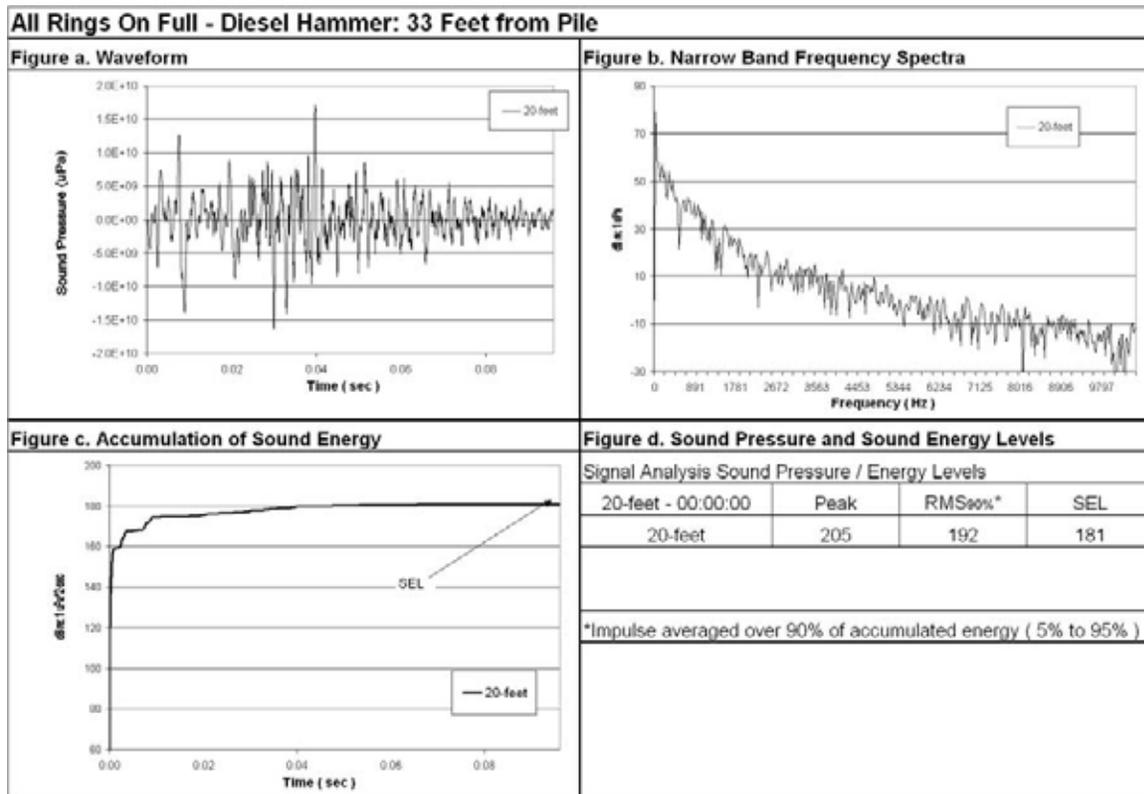
**Figure 104: Waveform Analysis for Pile Number 7, 20-Foot Deep, 33-Foot from Pile, All Rings On Full.**

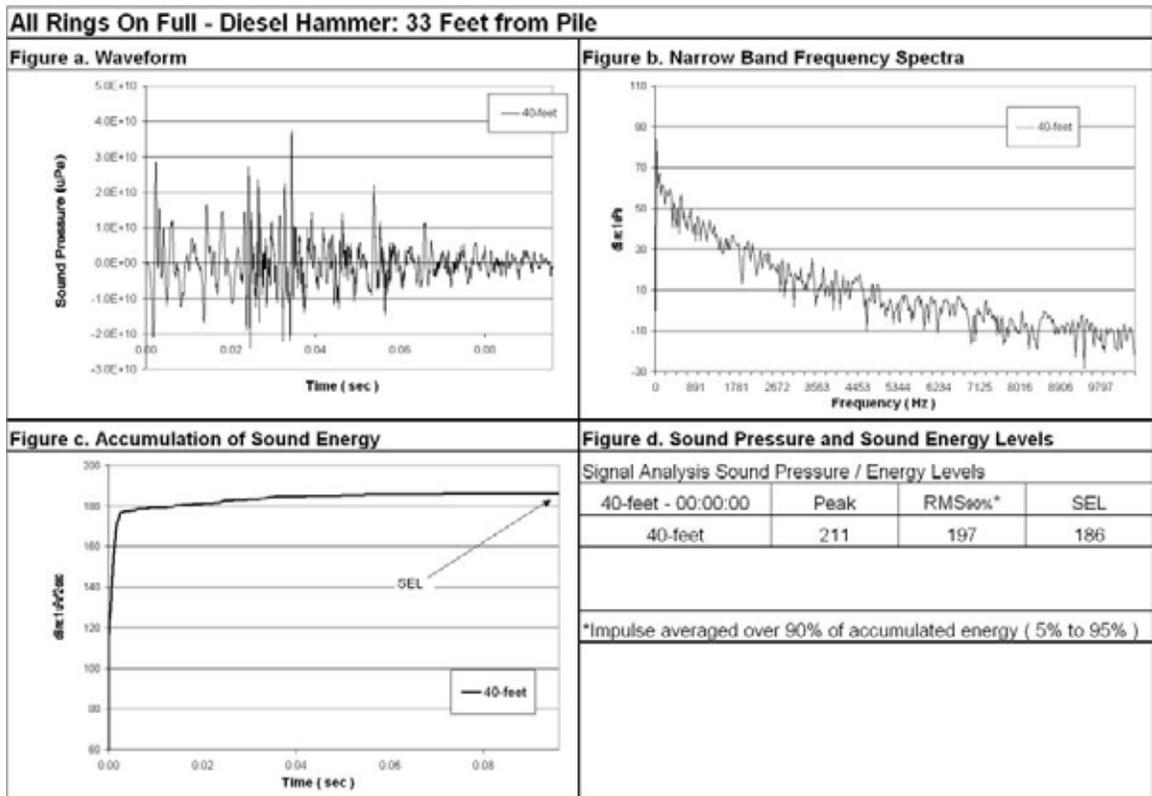
**Figure 105: Waveform Analysis for Pile Number 7, 40-Foot Deep (Bottom), 33-Foot from Pile, All Rings On Full.**
