*FRIDAY HARBOR FERRY TERMINAL RESTORATION PROJECT*

**UNDERWATER SOUND LEVELS  
ASSOCIATED WITH RESTORATION OF  
THE FRIDAY HARBOR FERRY  
TERMINAL**

*Prepared by:  
Jim Laughlin  
Washington State Department of Transportation  
Office of Air Quality and Noise  
15700 Dayton Avenue North, P.O. Box 330310  
Seattle, WA 98133-9710*

**May 2005**

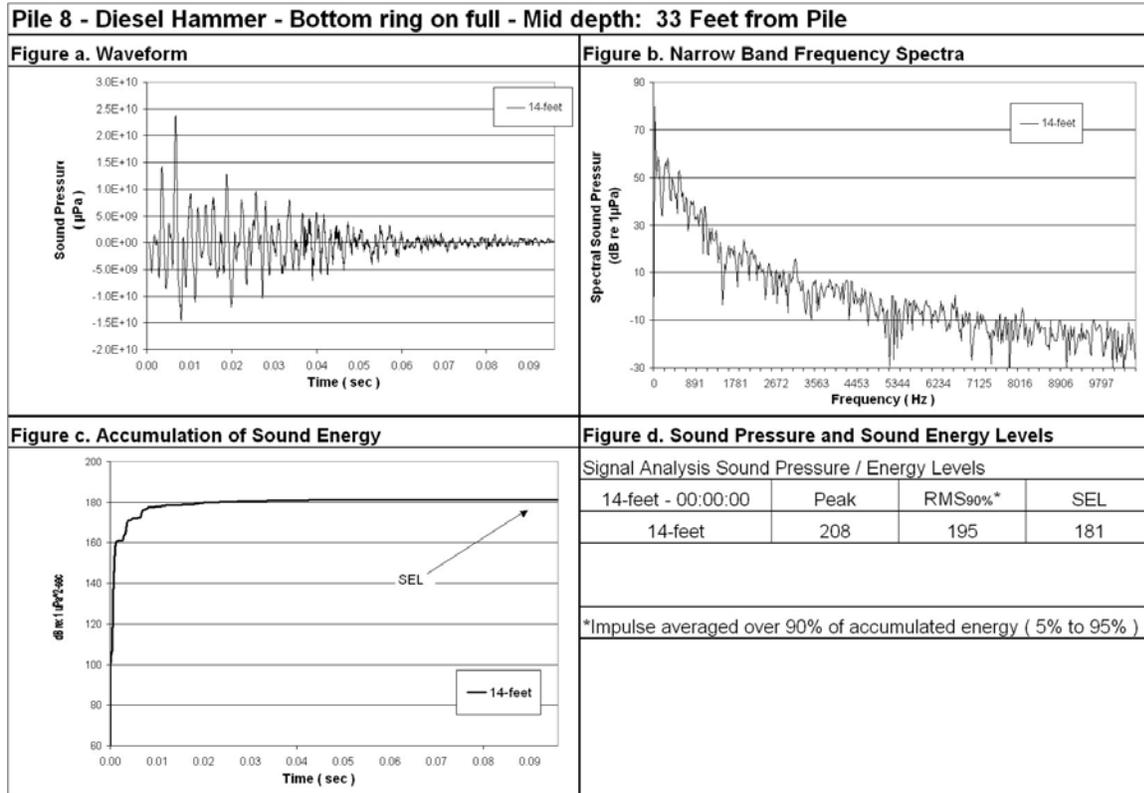
**Figure 106: Waveform Analysis for Pile Number 8, 14-Foot Deep, 33-Foot from Pile, Bottom Ring on full.**

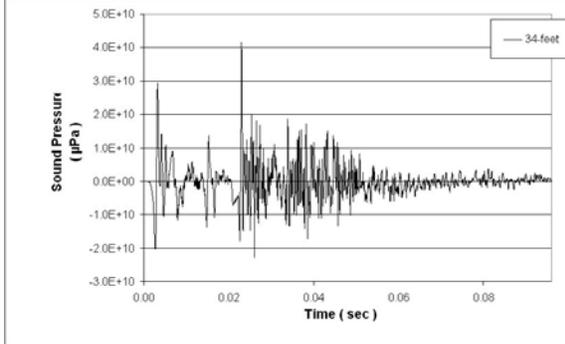
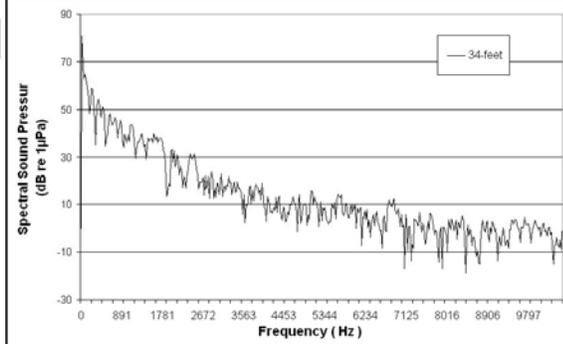
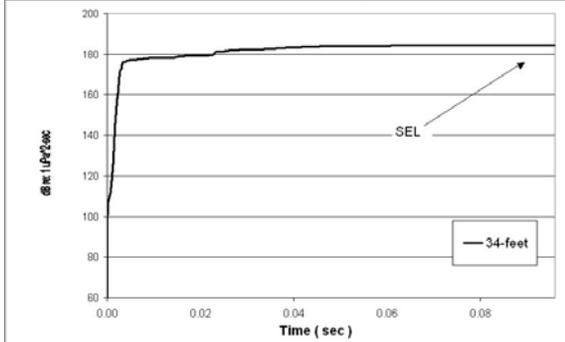
**Pile 8 - Diesel Hammer - Bottom ring on full - One foot from bottom: 33 Feet from Pile**

**Figure a. Waveform**

**Figure b. Narrow Band Frequency Spectra**

**Figure c. Accumulation of Sound Energy**

Signal Analysis Sound Pressure / Energy Levels			
34-feet - 00:00:00	Peak	RMS <sub>90%</sub> *	SEL
34-feet	212	197	184

**Figure 107: Waveform Analysis for Pile Number 8, 34-Foot Deep (Bottom), 33-Foot from Pile, Bottom Ring on full.**

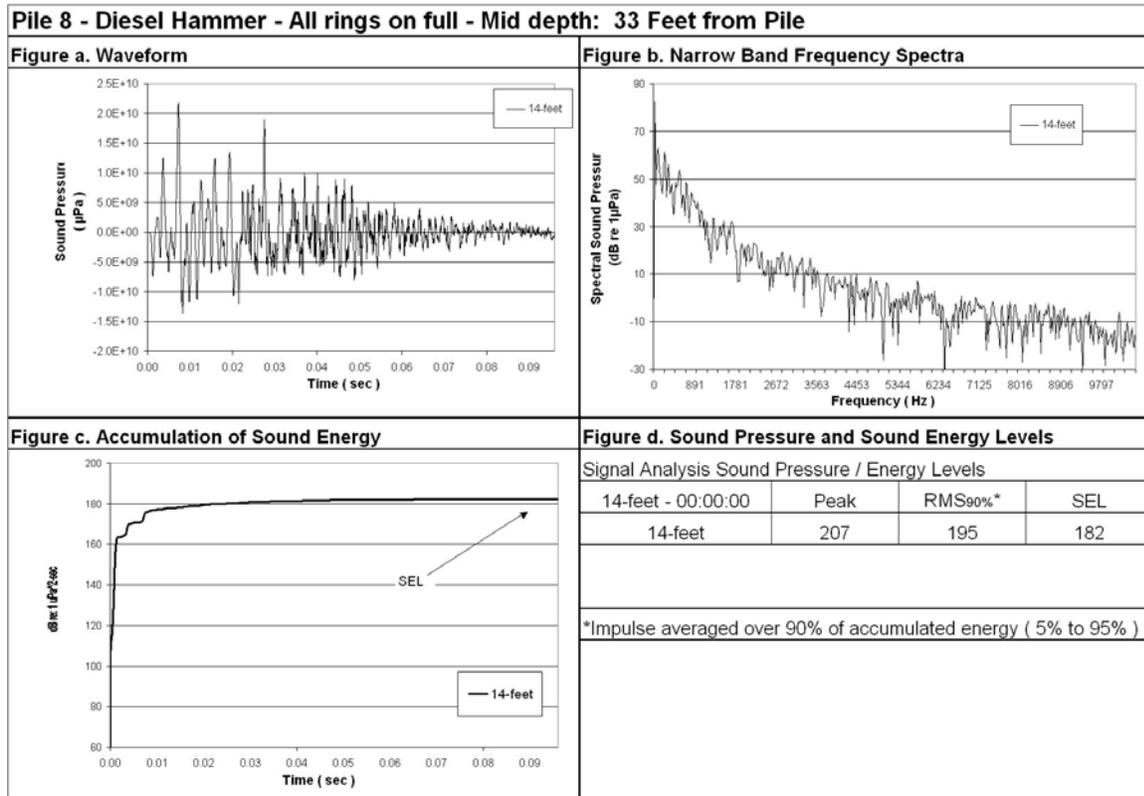
**Figure 108: Waveform Analysis for Pile Number 8, 14-Foot Deep, 33-Foot from Pile, All Rings On Full.**

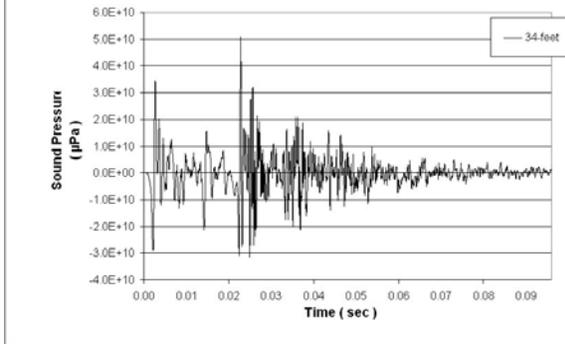
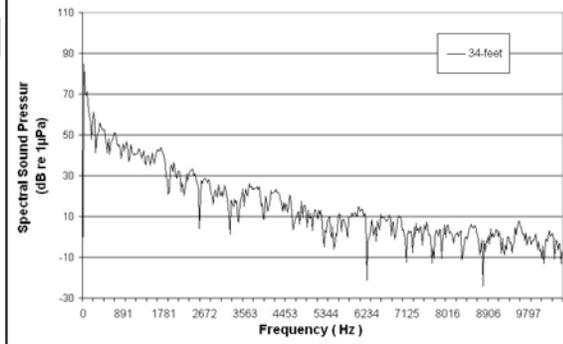
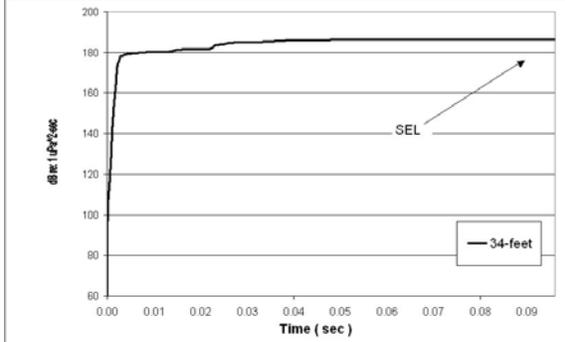
**Pile 8 - Diesel Hammer - All rings on full - One foot from bottom: 33 Feet from Pile**

**Figure a. Waveform**

**Figure b. Narrow Band Frequency Spectra**

**Figure c. Accumulation of Sound Energy**

**Figure 109: Waveform Analysis for Pile Number 8, 34-Feet Deep (Bottom), 33-Feet from Pile, All Rings On Full.**

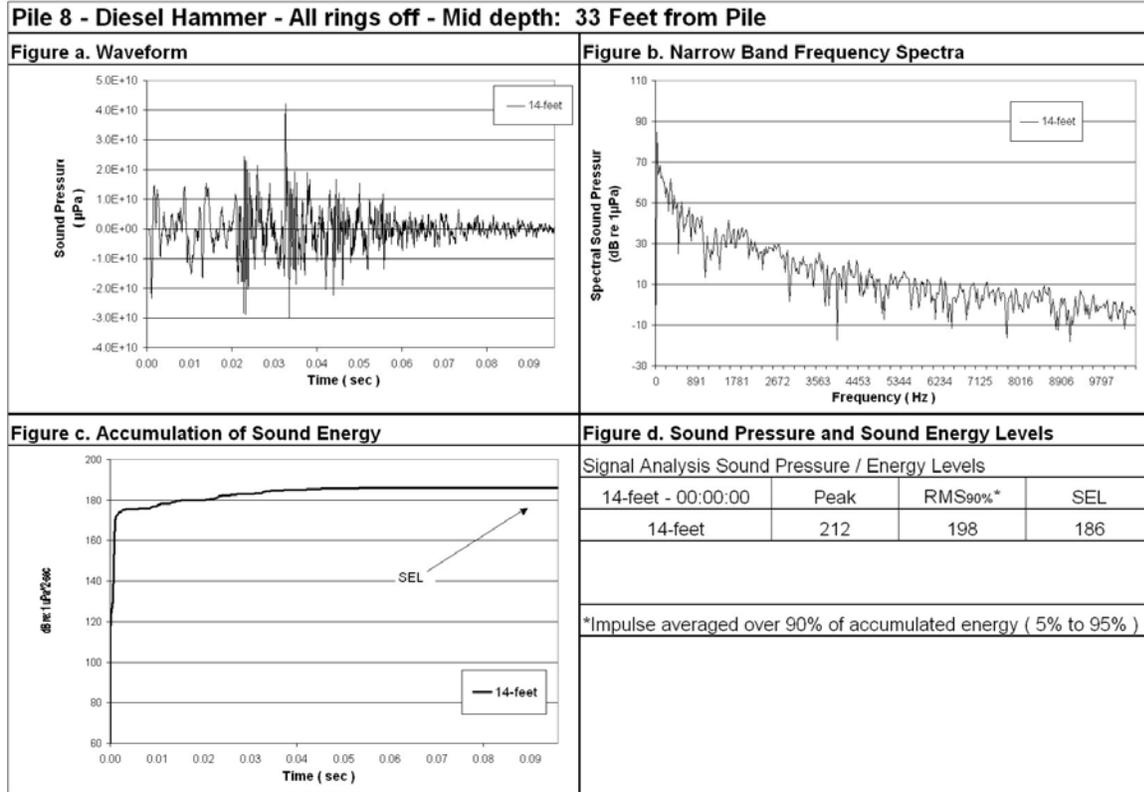
**Figure 110: Waveform Analysis for Pile Number 8, 14-Foot Deep, 33-Foot from Pile, All Rings Off.**

Figure 110: Waveform Analysis for Pile Number 8, 14-Feet Depth, 33-Feet from Pile, All Rings Off.	124
Figure 111: Waveform Analysis for Pile Number 8, 34-Feet Depth (Bottom), 33-Feet from Pile, All Rings Off.	125

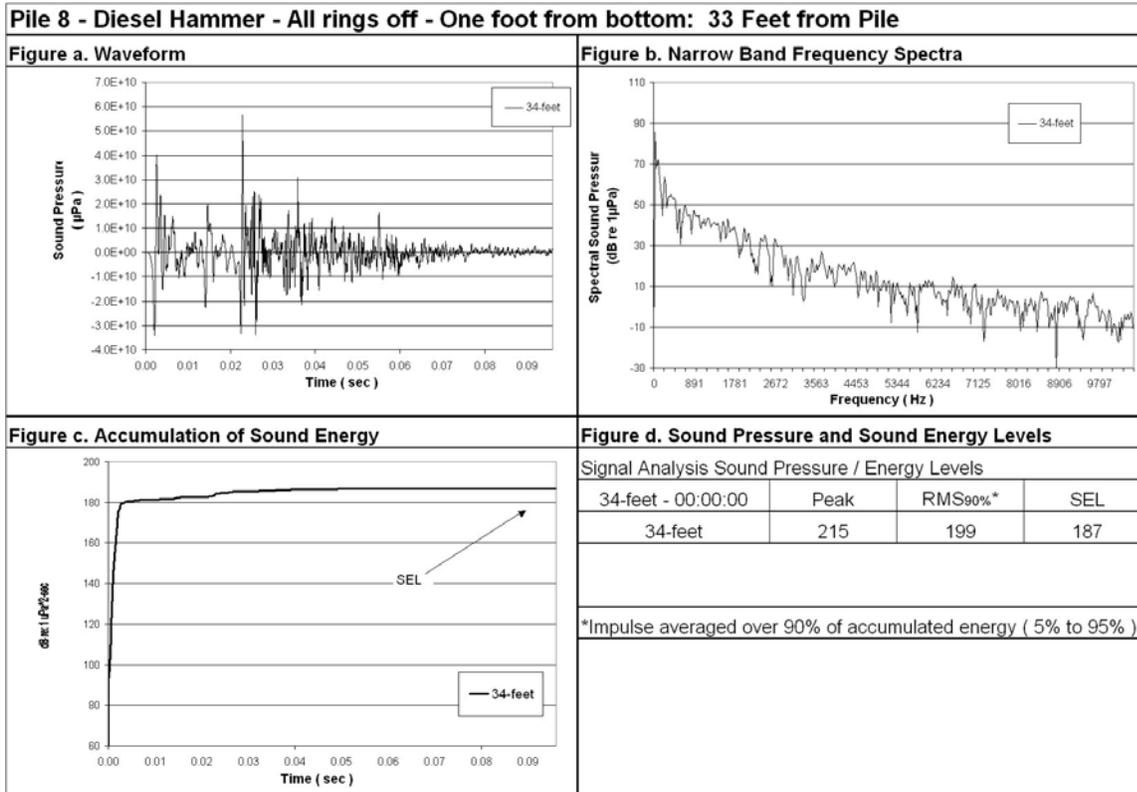
**Figure 111: Waveform Analysis for Pile Number 8, 34-Foot Deep (Bottom), 33-Foot from Pile, All Rings Off.**
